Article

# Physical Experiment and Numerical Modeling on the Failure Mechanism of Gob-Side Entry Driven in Thick Coal Seam

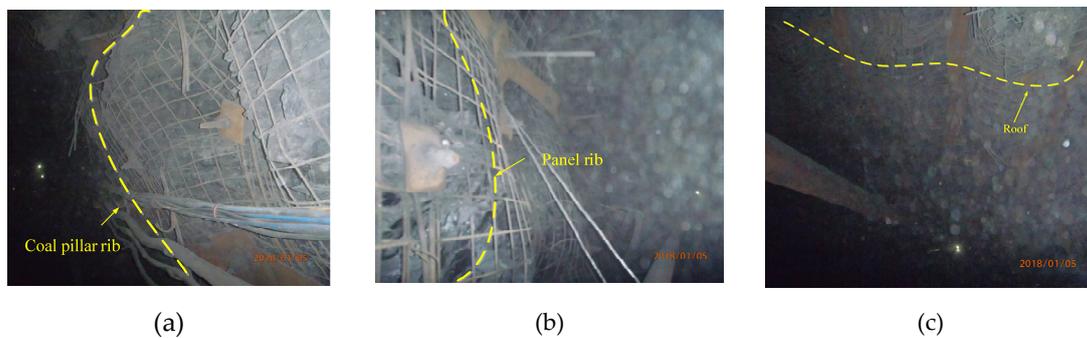
The roadway was arranged along the floor of the coal seam, with a cross-section of  $5.2 \times 4.0 \text{ m}^2$ . The roadway was primarily supported by a combination of bolts, cables, and W-shaped steel straps. The high-strength thread steel bolts were applied in the roof, and the two ribs were supported with the high-strength resin bolt of  $\Phi 20 \times 2200 \text{ mm}$ . The inter-row spacing of the roof bolts and rib bolts was  $800 \text{ mm} \times 1000 \text{ mm}$ . The detailed primary-support parameters were shown in Figure 2a. However, the gob-side entry underwent severe deformation under the primary-support parameters, as shown in Figure 3. The coal-pillar rib was seriously fractured and deformed, appearing to have larger expansion than the panel rib. Besides which, the roof also encountered large-scale sagging deformation (Figure 3c).

**Figure 3.** The deformation and failure of roadway surrounding rock. (a) Coal pillar rib; (b) Panel rib; (c) The roof.

Thus, to solve the large deformation problems of the roadway, the mine proposed the optimized-support parameters. First, three  $\Phi 17.8 \times 7800$  mm anchor cables were installed in the roof to strengthen the strength of the roof strata, and the length of the roof bolt was increased to 2.5 m respectively. In addition, the resin bolts used in the coal-pillar rib were adjusted as the high-strength thread steel bolt of  $\Phi 20 \times 2200$  mm, and two  $\Phi 17.8 \times 4200$  mm anchor cables were installed to improve the bearing capacity of the coal pillar. The detailed support parameters are displayed in Figure 2b.

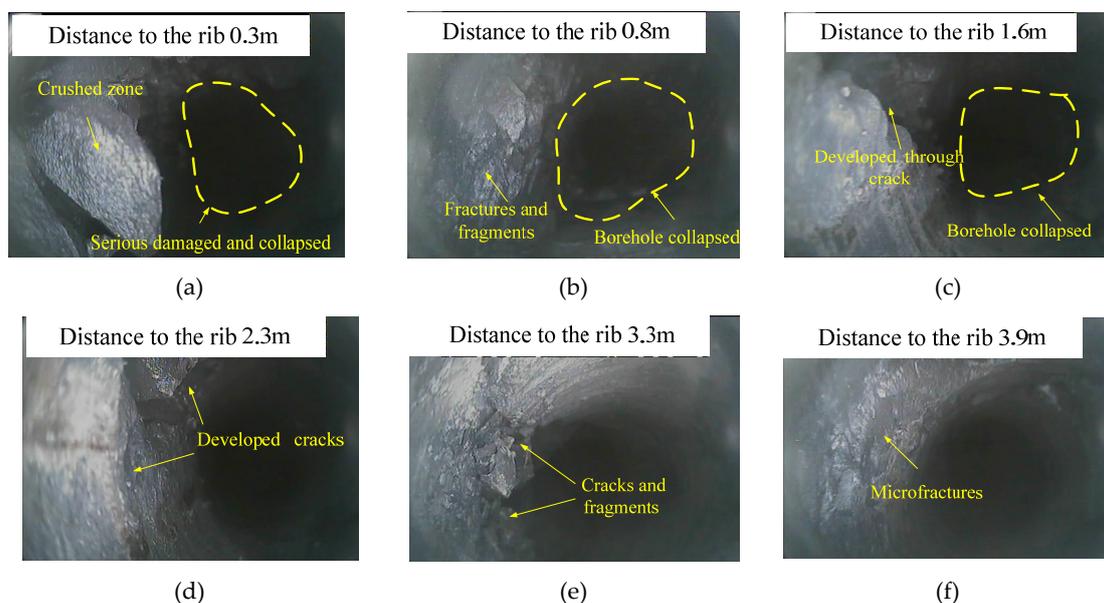
Unfortunately, field observation indicated that the reinforced support technologies failed to solve the large deformation problems of the roadway. The coal-pillar rib was severely damaged due to the larger loads from the overlayer strata. A digital borehole camera device was used to monitor the internal damage of the coal-pillar rib. Figure 4 shows the probe images of the borehole at different depths. The shallow regions of the coal-pillar rib have severely failed, and some crushed zones, significant fragments, huge through-cracks, and borehole collapse can be observed clearly within a depth of 0–2 m. In the range of 2–4 m, some developed cracks and fractures can also be observed on the wall of the borehole. All of the phenomena demonstrate that the integrity of the coal-pillar rib has been severely destroyed. This was because the overlying strata loads and rotation and sagging of the lateral roof caused the internal stress of the coal pillar to increase sharply, thus exceeding the bearing capacity of the coal pillar. According to the previous studies [34–40], pre-splitting blasting technology is commonly applied to cut down the lateral roof to release the stress acting on the coal pillar, and the overburden loads can be easily transferred into the gob area. In this research, the key to ensuring the stability of the gob-side entry is to grasp the overhanging roof characteristic and determine an optimal roof-cutting parameter.

**Figure 4.** The internal damage of the coal-pillar rib at different depth. (a) Distance to the rib 0.3 m; (b) distance to the rib 0.8 m; (c) distance to the rib 1.6 m; (d) distance to the rib 2.3 m; (e) distance to the rib 3.3 m; (f) distance to the rib 3.9 m.

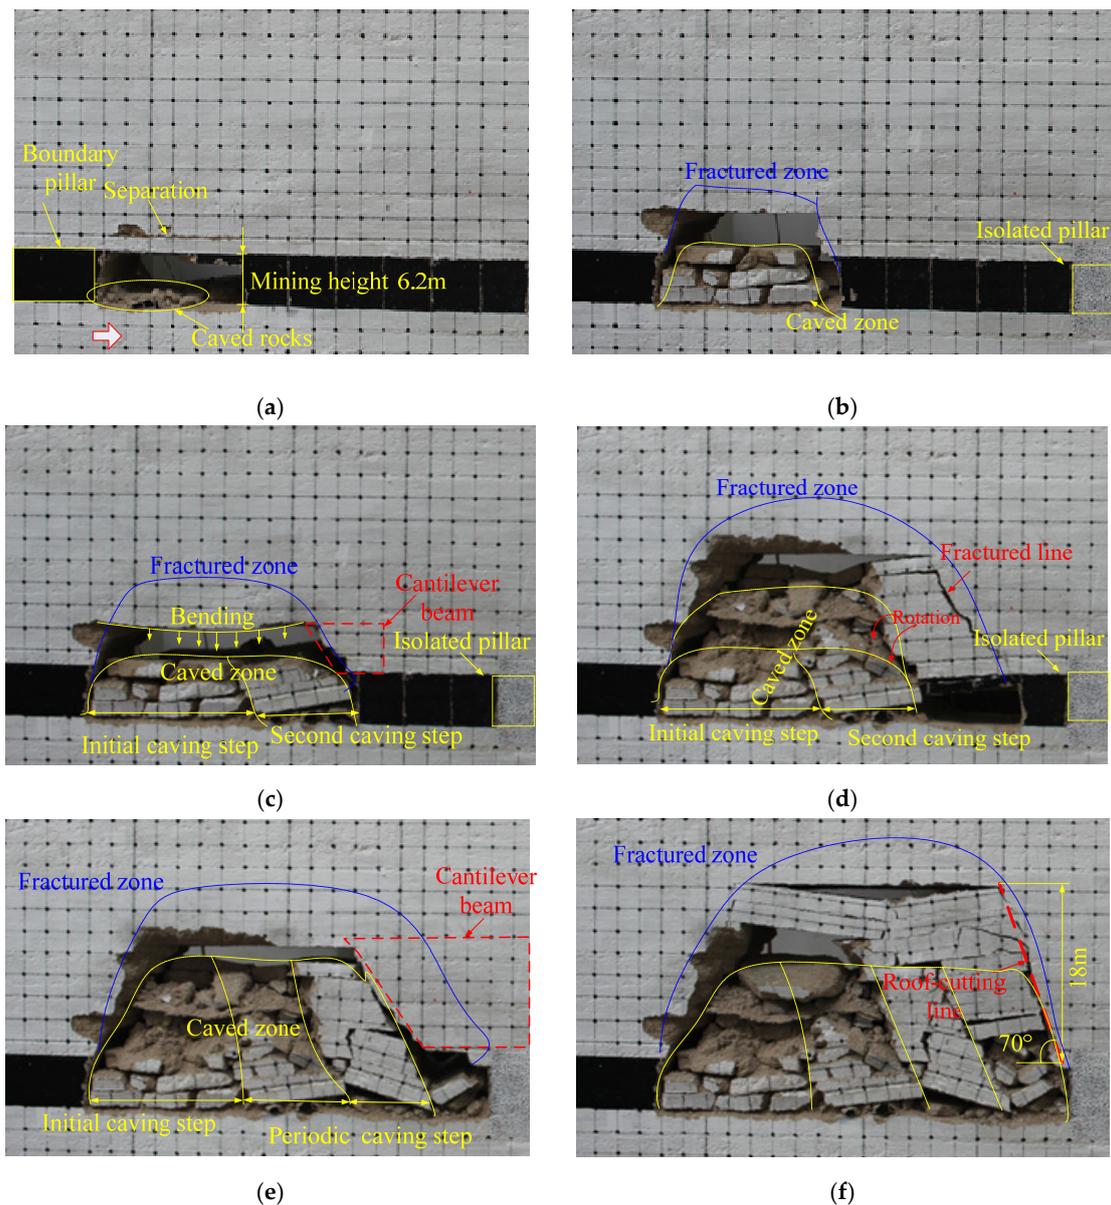
The roof movement evolution during the mining of the 2101 panel is presented in Figure 8. The mining direction was from the left to the right of the model, with a mining height of 6.2 m. When the coalface advanced 21 m (Figure 8a), some caved rock and a developed separation in the immediate roof can be observed. When the coalface advanced 26 m (Figure 8b), the immediate roof first collapsed with a caving step-distance of 25 m; the height of the caved zone was about 9 m. When the coalface advanced 45 m (Figure 8c), the immediate roof strata collapsed in the gob for the second time, and apparent bending subsidence can be observed in the upper roof strata. After advancing a short distance (Figure 8d), the main roof began to fracture and collapse; the height of the caved zone increased to 32 m. When the 2101 panel was fully mined out (Figure 8e), a large hanging block was formed above the gob, which acted as a cantilever beam structure.

**Figure 8.** Overburden strata movement process during the excavation of the 2101 panel. (a) Advanced 21 m; (b) advanced 27 m; (c) advanced 45 m; (d) advanced 47 m; (e) advanced 70 m; (f) after roof-cutting.

The above experimental results indicate that: when mining the upper slice of the 2106 panel, the height of the excavation void is relatively smaller. The broken block can easily form a stable voussoir beam structure after a small rotation (Figure 7e). However, when mining the 2101 panel, the height of the excavation void increased to 6.2 m. With the increase of extraction height, the roof strata activity has been enhanced, and the movement space of the overlying rock has been enlarged. Thus, the stable voussoir beam cannot be developed under this condition—due to a large amount of rotation—and an overhanging cantilever beam was formed over the gob, as shown in Figure 8e. On the one hand, the heavy self-weight of the cantilever beam and the larger overburden pressure leads to a stronger abutment pressure in the lower coal pillar. On the other hand, the sudden breakage or rotation of the hanging roof may also result in a more considerable advanced abutment pressure or dynamic pressure, which greatly threatens the stability of gob-side entry [9,10,35]. Thus, it is vital to cut down the hanging roof to provide a more favorable stress environment for the excavation of the roadway.

The physical test results showed that the hanging roof strata mainly included the scope of the immediate roof and the main roof strata. Therefore, the roof-cutting height was set as 18 m, and the roof-cutting angle was adopted 70° for the convenience of on-site construction. The roof structure characteristics of the 2101 coalface after adopting the roof-cutting measure are displayed in Figure 8f. The hanging roof and the overburden strata rotation and slip to the gob after adopting the roof-cutting measure can be observed. As a result, the overburden pressure supported by the lower coal pillar was significantly released.

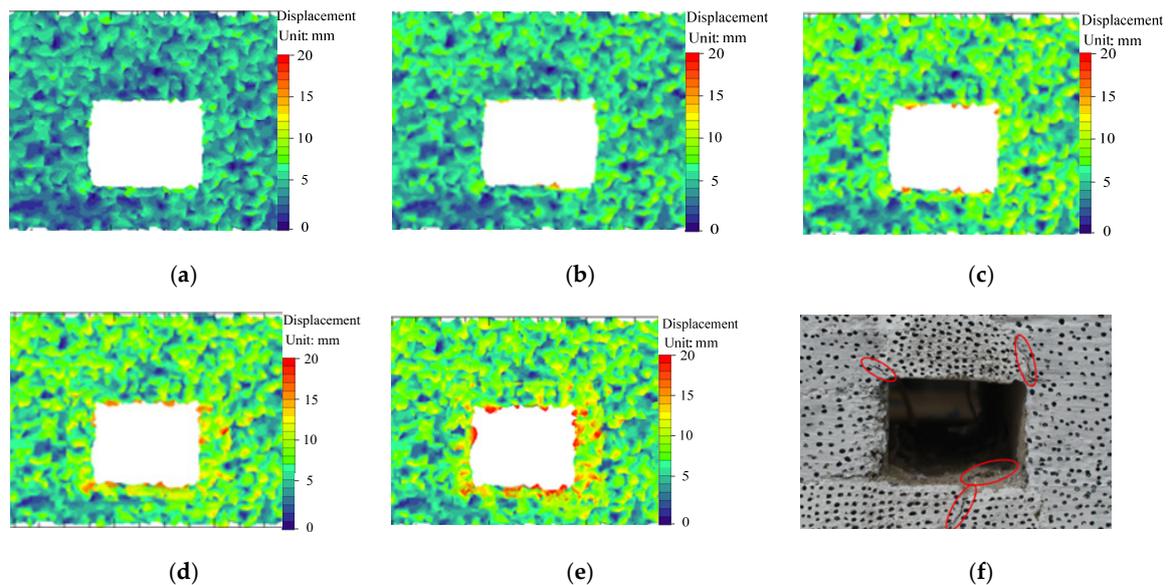
The displacement cloud diagrams of the roadway post-scripted through the DIC system are displayed in Figure 10. At the initial phase (Figure 10a), the contour of the roadway was relatively flat and almost no deformation occurred. Then, the roof and floor started to show slight deformation, as shown in Figure 10b,c. After that, sporadic deformation appeared at the upper ribs of the roadway (Figure 10d). Eventually, several shear cracks can be observed in the upper corners and floor of the roadway (Figure 10f). The final deformation was mainly concentrated at the corners of the rectangular roadway (Figure 10e), and the maximum deformation is 20 mm. The test results indicate that the deformation of roadway driven in the remaining coal pillar can be effectively controlled after adopting the roof-cutting measures.

**Figure 10.** The displacement cloud diagrams of the surrounding rock mass at different excavation times. (a) After 5 min; (b) after 15 min; (c) after 25 min; (d) after 35 min; (e) after 45 min; (f) final failure image.

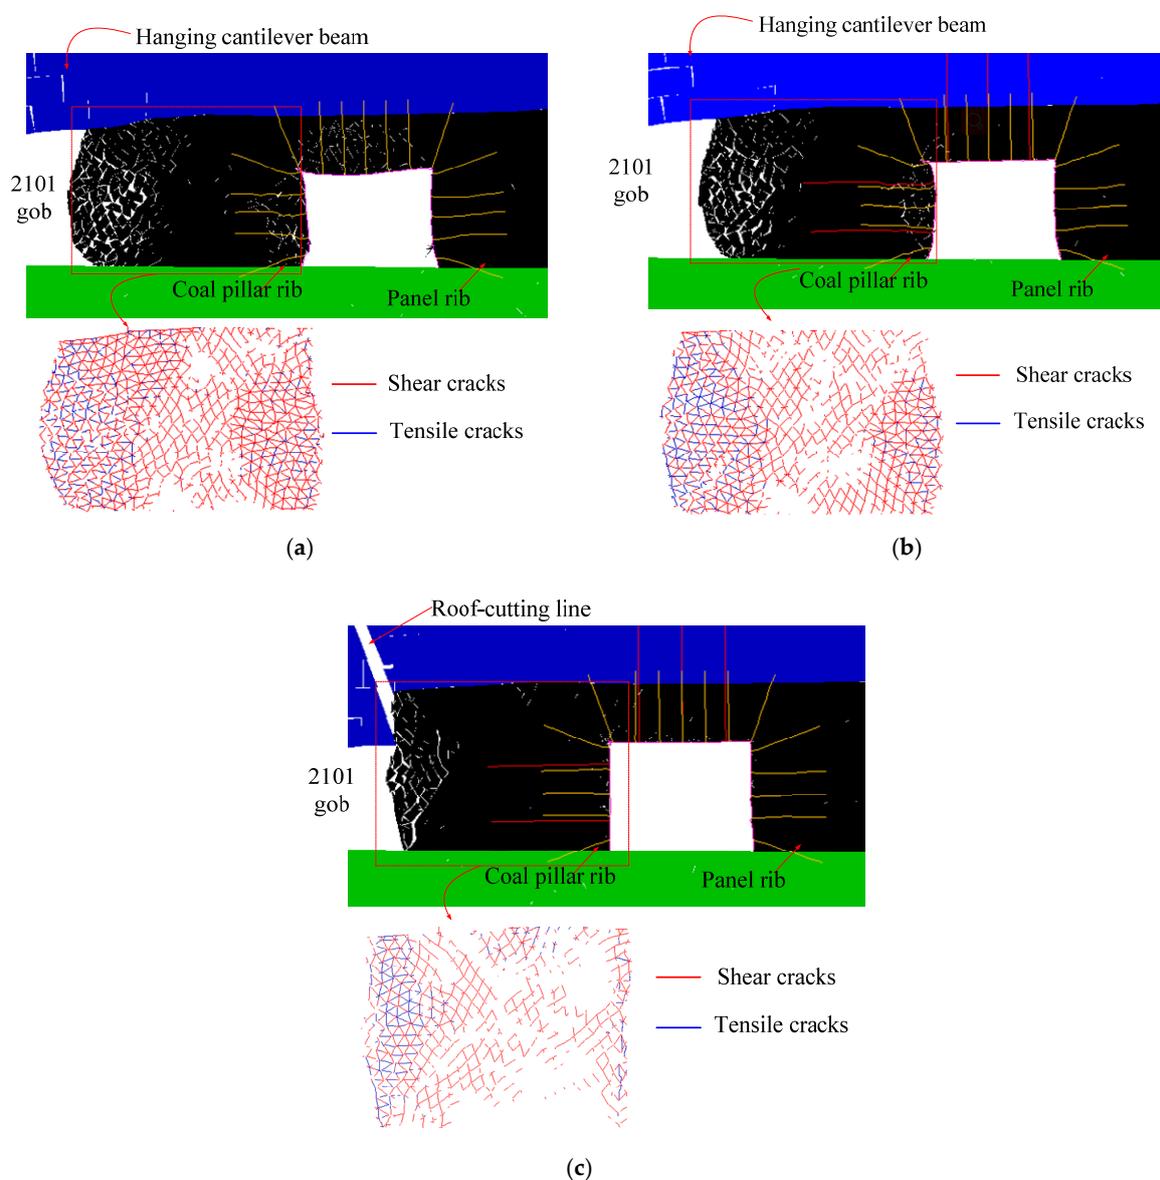
Figure 13 shows the failure modes of the roadway, and the distribution of cracks of the coal pillar is also displayed in detail. As shown in Figure 13a, under the primary-support parameters, the gob-side entry structure was severely damaged due to the larger overburden loads, forming the dangerous V-shaped damage zone in the coal-pillar rib and the roof. Meanwhile, the floor remained quite stable compared with the coal-seam roof, and minor cracks could be observed there. The coal-pillar rib near the 2101 gob underwent larger and more severe deformation than the panel rib near the 2106 upper panel's gob. Under the load of the hanging cantilever beam, the coal-pillar rib experienced enormous pressure, resulting in a large number of tensile cracks and shear cracks generated inside, which significantly weakened the integrity and strength of the coal pillar. It also should be noted that the number of shear cracks in the coal pillar is significantly more than the number of tensile cracks, implying that the shear failure was the dominant failure pattern.

After adopting reinforced-support measures, the deformation and damage of the roadway were slightly improved, as shown in Figure 13b. The generation of the cracks in the coal pillar was restricted compared with the cracks generated after primary-support. However, the coal-pillar rib still bore enormous concentrated stress induced by the overlying cantilever beam, resulting in severe internal damage to the coal pillar. It is clear that the optimized-support parameters failed to ensure the stability of the coal pillar. Thus, it is essential to relieve the pressure exerted by the overburden on the coal pillar by cutting down the hanging cantilever.

After cutting down the hanging roof for the reinforced roadway (Figure 13c), the deformation and damage degree of the roadway were dramatically improved, and the cracks generated within the coal pillar were also significantly reduced. This is because the disturbance stress acting on the coal pillar was greatly reduced after the fractured hanging roof caved into the gob, which greatly reduced damage to the gob-side entry structure.

**Figure 13.** The failure patterns and cracks evolution in the coal pillar. (a) Primary support; (b) optimized support; (c) reinforced-support support + roof-cutting.

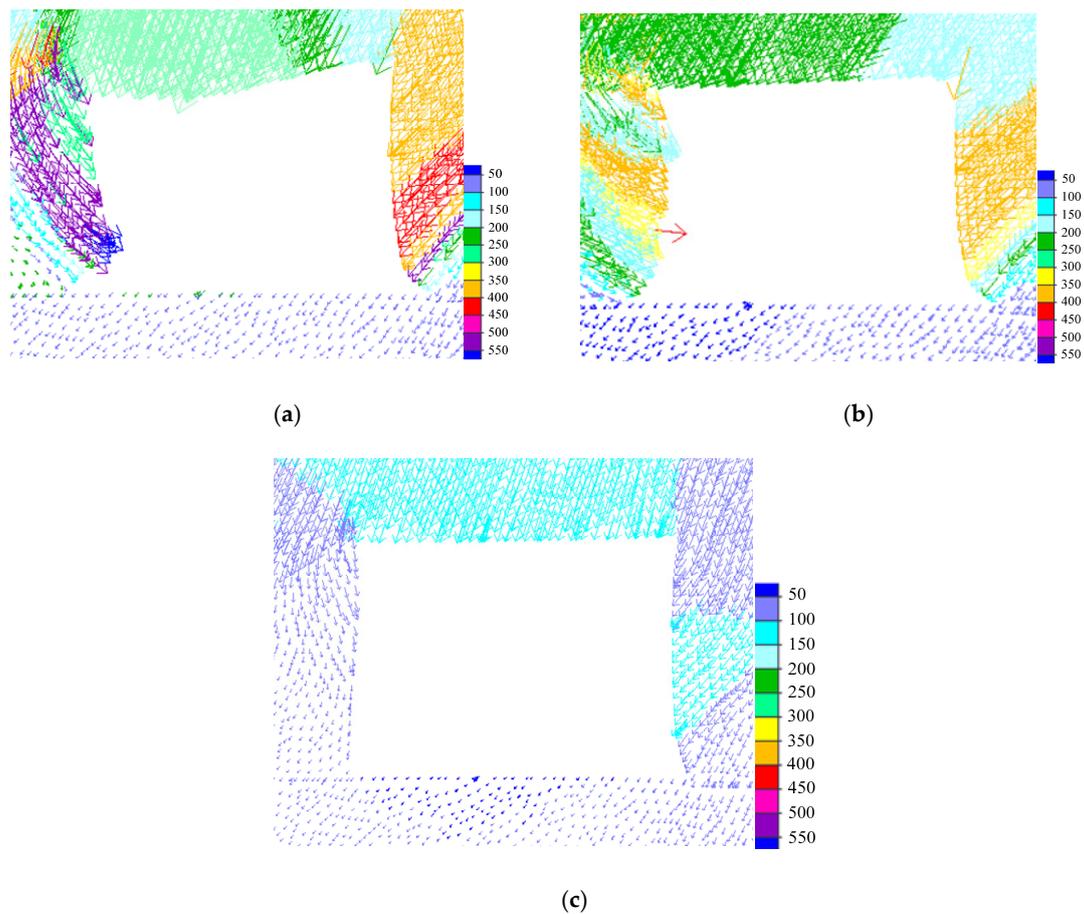
Figure 16 presents the simulated displacement vector diagram of the surrounding rock of the roadway. As shown in Figure 16a, the primary-supported roadway had severe uneven deformation, particularly with rib spalling and the roof falling. Also, the deformation in the coal-pillar rib was significantly higher than that of the panel rib, which was due to the coal pillar bearing heavier loads from the hanging roof. After strengthening the roadway with the optimized-support parameters (Figure 16b), the deformations in the roof and coal-pillar rib remained extensive and severe, implying that the optimized-support parameters failed to ensure the stability of the gob-side entry. After adopting the control measures of optimized-support parameters combined with the roof-cutting measures (Figure 16c), the deformation of the roadway tended to be uniform, and no visible collapses or spalling could be observed in the roof and the ribs.

**Figure 16.** Simulated displacement vector map of the surrounding rock. (a) Primary support; (b) optimized support; (c) optimized support + roof-cutting.

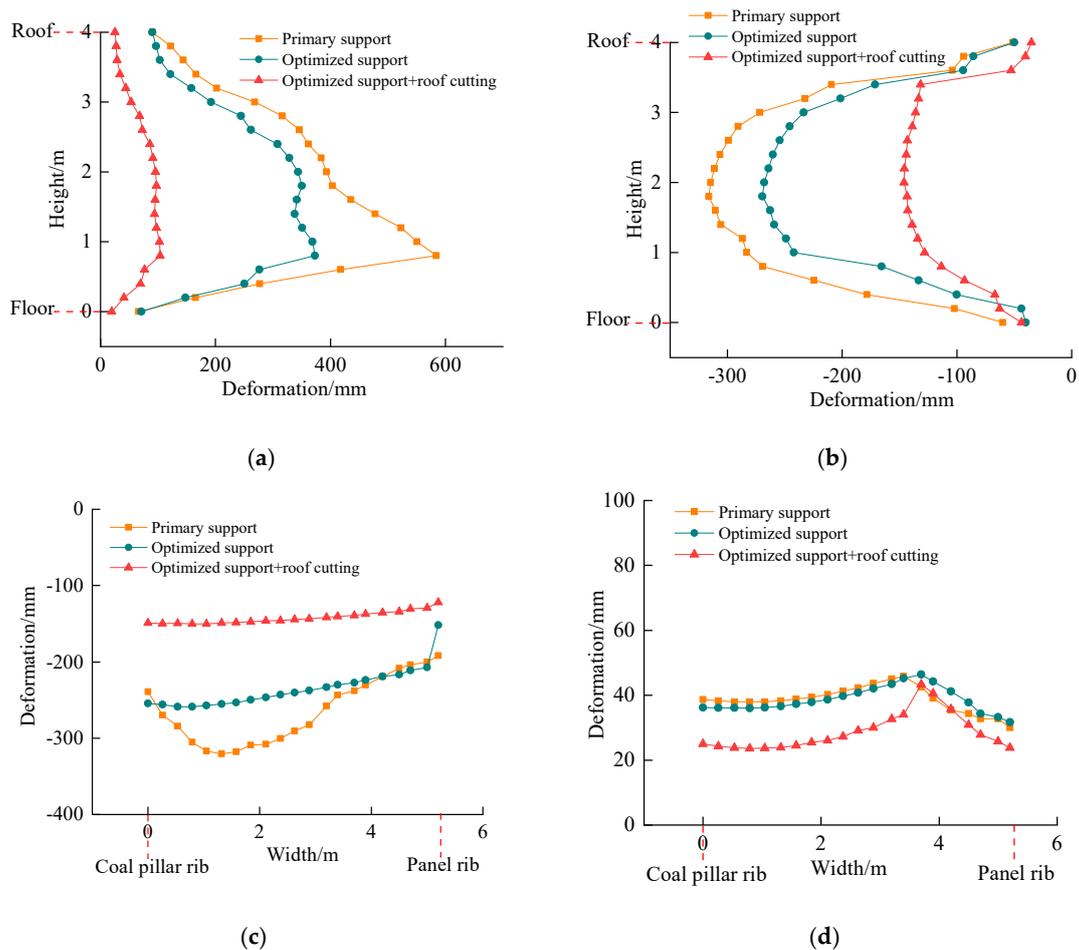
According to the recorded displacement data of the four measuring lines along two ribs, the roof, and the floor of the roadway, the final displacement of the surrounding rock is displayed in Figure 17. It can be observed that the roof and two ribs show more serious deformation, while the deformation of the floor is relatively gentle. As shown in Figure 17a, the coal-pillar rib swelled and deformed seriously under the primary-supported condition, with a maximum horizontal expansion of 590 mm. After adopting the optimized-support parameters and roof-cutting measures, the maximum expansion of the coal-pillar rib was reduced to 92 mm, with a reduction rate of 84.4%. The maximum expansion of the panel rib decreased from 342 mm to 148 mm, with a reduction rate of 56.7%. It also should be noted in Figure 17c that the roof sagging adjacent to the coal-pillar rib was larger than that adjacent to the panel rib, and the maximum roof sagging was 330 mm for the primary-supported roadway. After reinforcing the roadway and cutting down the hanging roof, the maximum roof sagging decreased to 168 mm, with a reduction of 49.1%.

**Figure 17.** Deformation of the surrounding rock of the roadway. (a) Coal-pillar rib; (b) panel rib; (c) roof sagging; (d) floor bulging.
