Effect of the Shape of Styrene–Acrylonitrile Water-Filter Housings on the Destructive Pressure, Crack-Initiation, Propagation Conditions and Fracture Toughness of Styrene–Acrylonitrile

Borut Zorc ^{1,2,*}, Matija Zorc ², Borut Kosec ² and Aleš Nagode ²

Abstract: A destructive pressure test of styrene–acrylonitrile (SAN) water-filter housings showed the influence of the shape and specific details of the housings on their critical areas and their destructive pressure. The destructive pressure varies by as much as 37 bar due to different dominant stresses in the individual types of housings. In critical areas of the housings, geometrical stress concentrators generally exist. For this reason, the stress caused by the internal pressure is locally 2.75–3.4 times greater than that expected based on the water pressure, which means that cracks are initiated in these places. However, the bottom of the housings can be in a form such that the maximum stress and the crack originates in its central part without the influence of local stress concentrators. The tensile strength of the SAN is theoretically estimated at 73 N/mm², which is comparable with the literature data. The fracture toughness

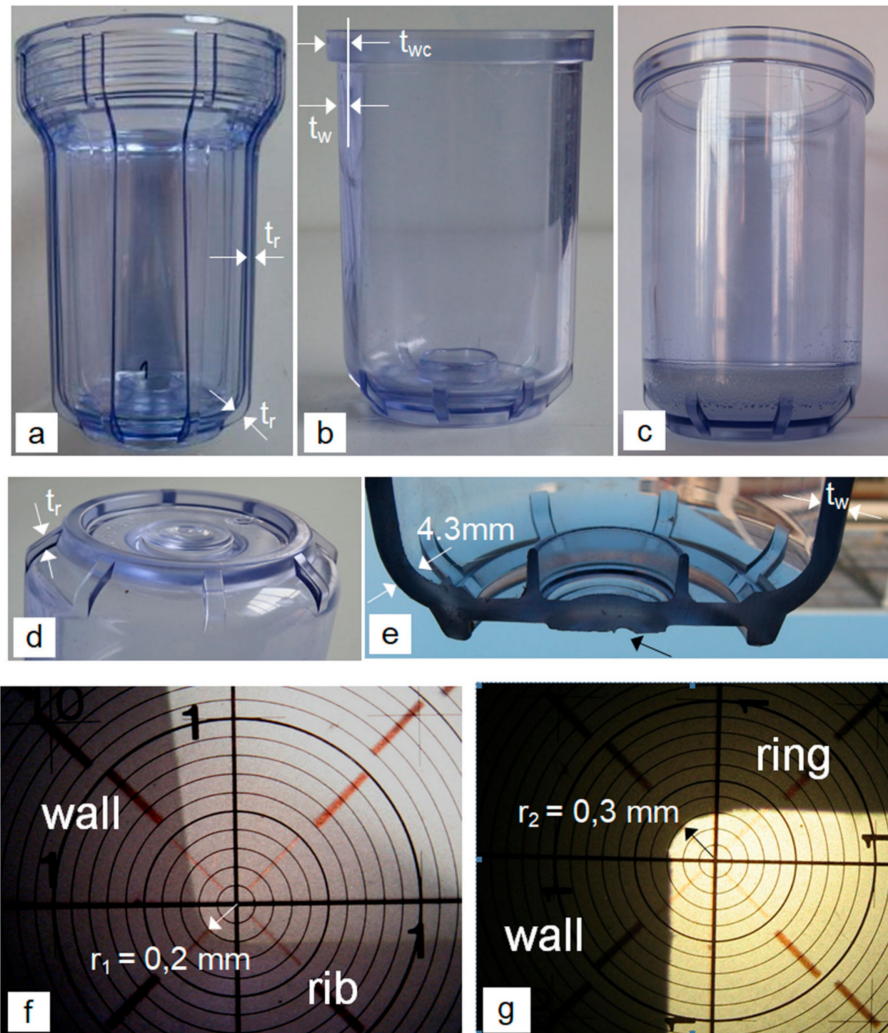
Figure 1. Types of water-filter housings and some of their geometric characteristics (a) housing with the external vertical ribs [1] (b) housing without the vertical ribs (c) housing without the vertical ribs with an increased base thickness (d) the base of the housing without the vertical ribs (e) the cross-section of the base between the ribs (f) the transition radius r_1 between the ribs and the wall (g) the transition radius r_2 between the clamp ring and the wall.

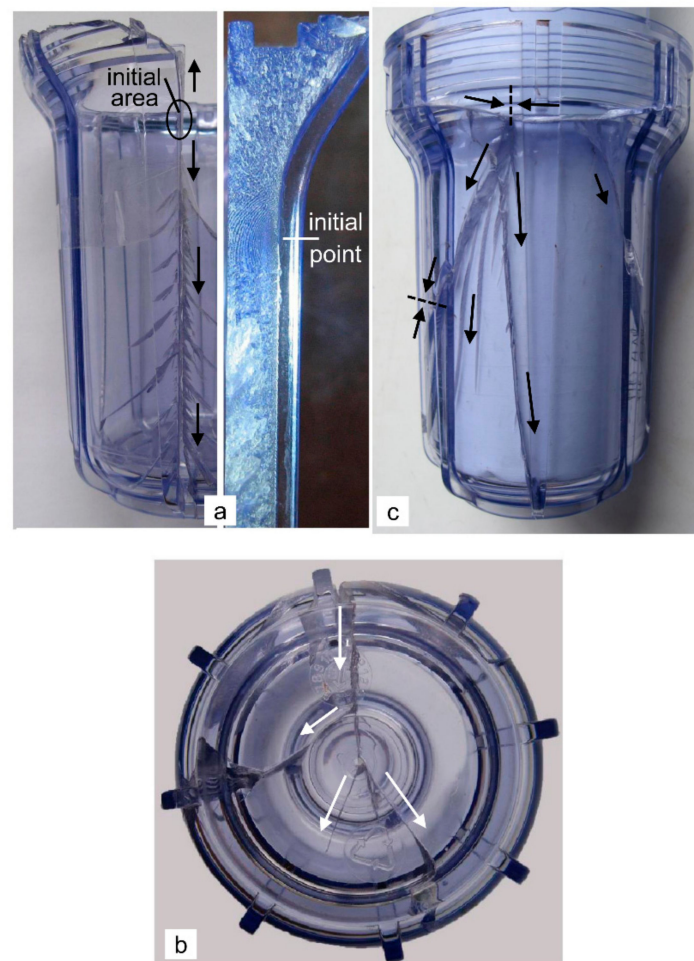
The shape of the housing has been studied in detail in [2]; however, here we briefly summarize the findings. The critical area of the housing with the external vertical ribs, which is directly threaded onto the housing of PP, is a sharp transition $r_1 = 0.2$ mm between the rib and the wall on the outside of the upper part of the housing. This is indicated by the macroscopically visible Wallner lines (Figure 3a). The primary vertical crack spreads along the rib to the bottom and upwards to the threaded region (Figure 3a). It is characterized by a smooth initial area and a lot of short secondary cracks (they grow in the downwards direction from the primary crack with an orientation of approximately 45° relative to the basic crack) and, in general, the fracture surface is rough and non-transparent with a white shade. The downwards-growing primary crack at the rib enters the base and branches in its central part into several secondary cracks, which generally stop in the base or at its edges (Figure 3b). The cracks with

sufficient energy can pass the base and continue to grow vertically along the housing upwards, without the external ribs influencing their propagation (Figure 3c).

Figure 3. Specific characteristics of the initiation and propagation of the cracks in the sample of series A (a) the location of the initiation and downwards growth of the primary crack at the rib [2] (b) branching the primary crack in the middle of the base [2] (c) the junction site of the two oppositely growing horizontal cracks and the branching of the newly formed downwards-growing crack on the rear side of the filter housing [2]; the arrows indicate the direction of the crack growth.

The upwards-growing primary cracks in the screw groove split into two oppositely growing horizontal cracks, which grow in the threaded grooves. On the rear side of the housing (the front side is that with the primary crack), the horizontally growing cracks join together, and the growth of these new cracks is downwards, to the base (Figure 3c). It is known that shock waves travel in front of each crack, the speed of which is greater than the crack's growth speed [10,11]. If they encounter a free surface, they reflect back, and in the crack tip this increases the stress-intensity factor K_I . Due to the mutual interaction of the shock waves of both oppositely growing horizontal cracks with the shock waves of the cracks that have passed the base of the housing and due to the reflection from the free surfaces, the stress-intensity factor at the tip of the one newly formed downwards-growing crack greatly increased. Therefore, this crack is immediately branched into several secondary cracks, which extend along the housing towards the base without the influence of the external vertical ribs on its growth direction (Figure 3c). Some of these cracks are joined together on the wall of the housing (Figure 3c) or on the edge of the base with oppositely growing cracks that have been caused by the branching of the primary crack in the middle of the base. This results in the fragmentation of the filter

housing into several pieces, in which the threaded part of the housing is most often torn off in the form of a ring. The surface of the cracks on the back side of the housing (rapidly growing cracks) is much smoother and more transparent compared with the primary crack. Due to the initiation of the primary crack on the external surface of the housing, the primary crack grows through the wall first from the external to the internal surface, but as soon as conditions that are characteristic of a pressure vessel are created, its growth through the wall changed direction from the internal to the external surface of the housing. Such growth is a logical consequence of the higher stress-intensity factor on the internal surface of the housing due to the additional water-pressurized crack opening. It is also evident that the cracks grow much faster along the wall than through the wall (Figure 3c).

The crack initiation showed that the critical location of the housing with vertical ribs is a sharp transition between the rib and the wall on the outside of the housing. The sharp transition with radius $r_1 = 0.2$ mm is a strong elastic stress concentrator K_t . This was theoretically determined from Peterson's diagrams, in which K_t is defined on the basis of the geometrical characteristics. It is reasonable to determine K_t from all the appropriate diagrams and then calculate its mean value, which is used in stress calculations. To estimate the stress concentrator along the vertical rib, a diagram with a one-sided reduction of the pressure vessel's wall is appropriate (chart 3.6 in [5]). The ratio between the different wall thicknesses is $H/h = (t_w + t_r)/t_w = (4.7 + 2.1)/4.7 \approx 1.45$, while the ratio between the transition radius and the thinner wall is $r/h = r_1/t_w = 0.2/4.7 = 0.0425$. With the extension curve for $H/h = 1.5$ to the lower values of r/h , the value $K_{t1}^* \approx 3.1$ can be obtained. Newer studies suggest that the K_t values from Peterson's diagrams should be approximately 10% higher [6,21,22], which means the value $K_{t1}^\# \approx 3.1 \cdot 1.1 = 3.4$. Also, diagrams for the tensile loaded strip with a two-sided reduced height are suitable. From Figure 12.6b [4] and chart 3.1 [5] for the same ratio H/h and r/h $K_{t2}^* \approx 2.8$ can be obtained and from Figure 3.11 in [6] for the same ratio $r/h = r/t$ and the ratio $h/H = t/T = 0.667$ (in our case $h/H = 4.7/6.8 = 0.69$), $K_{t3}^* \approx 3.0$ can be obtained. In the case of a one-sided reduction of the cross-section of the strip, the stress concentrator is approximately 10% lower at a similar ratio H/h and r/h [23]. However, since the values from the Peterson's diagrams should be approximately 10% higher, the final values are $K_{t2}^\# = 2.8$ and $K_{t3}^\# = 3.0$. The mean value of the stress-concentration factor in the sharp transition between the ribs and the wall is therefore $K_t^\# = (3.4 + 2.8 + 3.0)/3 \approx 3.1$. However, since the crack is initiated in the line where the external diameter and the wall thickness change simultaneously, due to the large rigidity the stress concentrator is also slightly larger. If we assume a 10% larger stress concentration in this area, the final value is $K_t = 3.1 \cdot 1.1 = 3.4$.

Since the crack initiates and grows along a vertical rib, the tangential stress in the cylindrical part of the housing is responsible for the burst and was calculated using Equation (1). By inserting $p = p_d = 34$ bar, $t_w = 4.7$ mm, $D_{in} = D_{ex} - 2t_w = 70 - 2 \cdot 4.7 = 60.6$ mm, and $K_t = 3.4$, the destructive stress of the filter housing with vertical ribs is $\sigma_t = R_m = 74.5$ N/mm², which is in the range of the literature values for the strength of SAN.

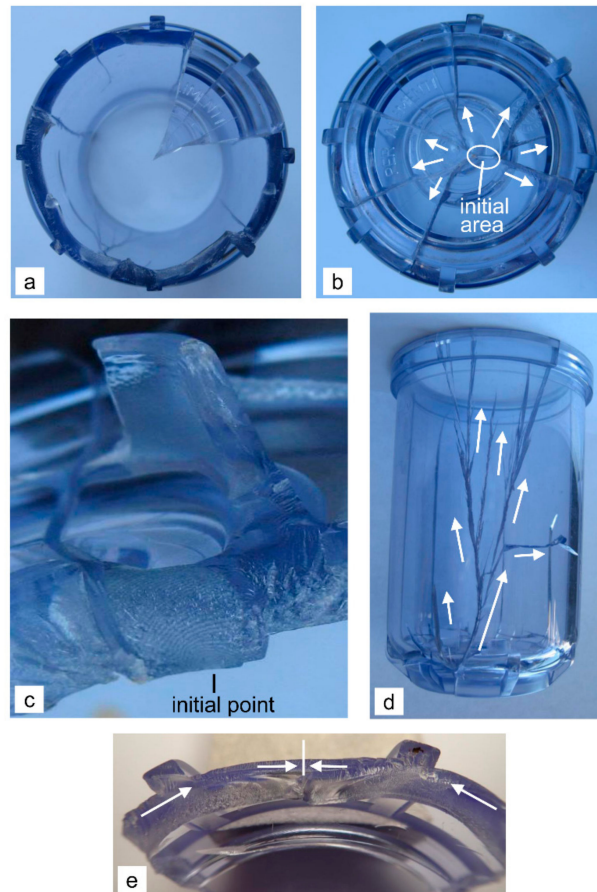
The critical area of the housing without the ribs, which was fixed to the steel head by a steel ring, is its base. The base of the housing was broken into several fragments with the shape of a circular sector (Figure 4a,b). The glued fragments show the crack initiation in the central, thickened part of the base (Figure 4b), while the macroscopically visible Wallner lines indicate that the crack initiated on the external surface in the marginal area of the thickened cylindrical part (Figure 4c). The initial crack branched into four major energy-comparable cracks with a mutual orientation of approximately 90° , which is characteristic of a burst due to internal pressure [7]. These cracks are already branched into several secondary cracks at the very beginning (Figure 4b). All the cracks are radial spreading towards the base and they pass into the wall of the housing. The main cracks grow upwards to the upper edge of the housing (Figure 4d), but the secondary cracks generally stopped at the half-height of the housing. It seems that the short outer ribs in the curved part do not affect the initiation and growth of the cracks (Figure 4b). Interestingly, only the one upwardly growing crack is severely split (Figure 4d), although all are generally of the same length. This is due to the increased stress-intensity factor at the tip of this crack. There are probably two reasons for this. One possibility is that this crack had more energy than the rest and therefore released more powerful impact waves, which also means that the reflected waves from the upper free surface of the housing had higher energy. Another possibility is the interference between the original and the reflected waves, their summing and the formation of the stronger return waves.

The surfaces of all the radial or vertical cracks are more or less rough and non-transparent, with only a slightly white shade. The highest degree of whiteness is on the surfaces of the vertically growing cracks as a result of the partial shear tearing due to a slower growth. The fracture in the curved part of the base and the formation of circular sector's fragments is the consequence of horizontal cracks that are formed later than the radial cracks (if it were otherwise, the radial cracks could not reach the top of the housing or would not even pass into the housing from the base). Additional evidence also comes from the way of the horizontal cracks spread in the curved part of the individual circular sector's fragments. It is clear that the fracture in the curved part consists of the two opposing cracks that grew from the adjacent radial cracks and joined together in the middle of the circular sector's fragments (Figure 4e). Together with the initial site this proves that the maximum stress is in the middle of the base. However, the stress in the curved part cannot be much smaller than in the central part of the base, otherwise the tearing of practically the whole base would not occur. After the initiation and the final achieved length of the radial-vertical cracks in the wall of the housing, in the final stage of the bursting, the stress in the curved part of the base became a priority. This resulted in the rapid growth of two opposite cracks between the radial cracks in the curved part. This is why the surface of these cracks is smoother and more transparent compared with the others. The cracks grow from the

internal to the external surface of the wall and the growth along the wall is much faster than through the wall (Figure 4e). Due to such a growth of horizontal cracks, a bending moment caused by the water pressure is generated in the final phase of bursting the housing, which pushed and broke the circular sector's fragments of the base from the housing.

Figure 4. Specific characteristics of the initiation and propagation of the cracks in the sample of series C (a) the breaking base (b) an initiation area in the central thickened cylindrical part of the base and radial spreading of the cracks through the base (c) an initiation point on the external side of the thickened cylindrical part (d) the branched upwards-growing crack (e) the oppositely growing horizontal cracks joining at the middle of the fracture in the arc of the circular sector's fragment; the arrows indicate the direction of the crack growth.

The crack initiation showed that the critical site of the housing without vertical ribs is the central part of its base. The torn off base also shows large stresses at the edges of the base. For the analysis of the stress state it is necessary to know the exact geometrical characteristics of the lower part of the housing. From the cross-section through the base it is evident that on the inside and on the outside the central area of the base is additionally thickened (Figure 1e). The surface of this area on the inside of the housing is convex and its diameter is smaller than the diameter of the outer thickened part. The maximum thickness of the middle of the base is $t_w \approx 7.0$ mm and it does not represent a critical point, despite the local surface reduction of the thickness due to a production defect on the outside of the base. The crack was initiated on the outer side of the base at the edge of the thickened part, without the influence of a nearby stress concentrator (Figures 4c and 6c), so $K_t = 1$. The thickness at the crack-initiation point is $t_w = 5.5$ mm. Due to the complex shape of the base, the internal diameter was assumed to be $D_{in} = D_{exb} - 2t_w = 68.6 - 2 \cdot 4.3 = 60$ mm. The calculations show that the base of the housing is fixed. If $D_{in} = 60$ mm, $t_w = 5.5$ mm and $p = p_d = 50$ bar are inserted into Equation (3) for the supported bottom, the stress is too high ($\sigma_{max} = 184$ N/mm²) and the burst would be at a much lower pressure. Using Equation (6) for the fixed bottom, the stress in the middle of the base at the initiation site is $\sigma_r = \sigma_t = 72.6$ N/mm² and is consistent with the strength of the SAN.

Why did the crack not initiate on the edge of the base in the curved part, where the maximum stresses exist? The reason is the ring on the outer side of the base (Figure 1d,e), which increases the thickness of the base wall from $t_w = 4.3$ mm to $t_w \approx 10$ mm in the region of maximum stresses. From Equation (4) it follows that at the point of maximum stresses, at the pressure $p_d = 50$ bar, the actual

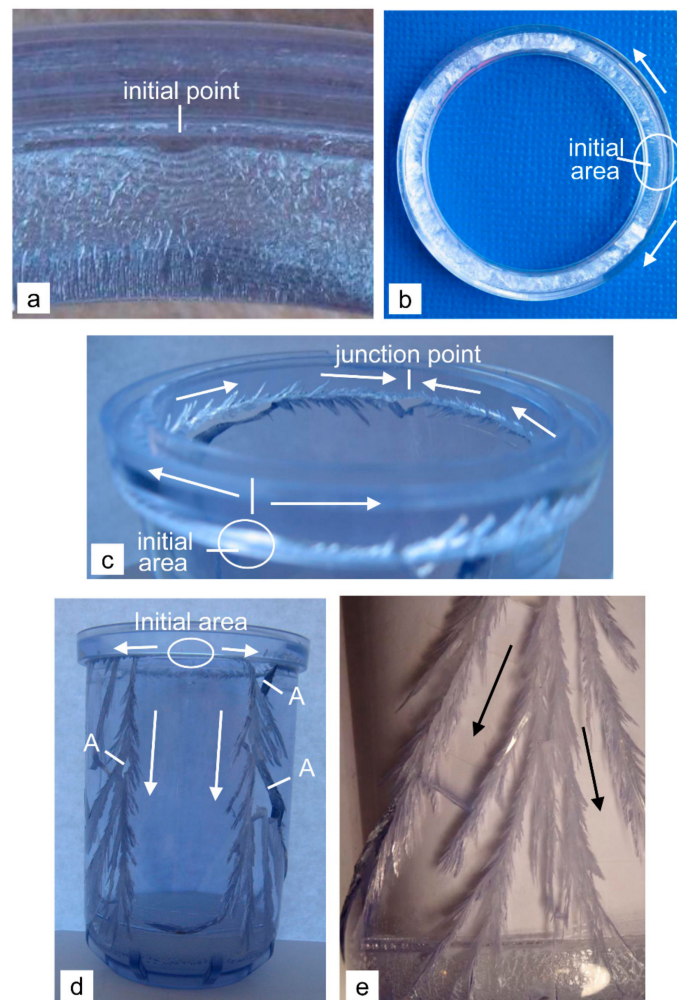
The critical area of the housing without the ribs and with the thicker base, which was fixed on the steel head with a steel ring, is the sharp transition radius $r_3 = 0.3$ mm between the upper clamping ring and the wall on the external side of the housing, where the crack also initiates. This is indicated by the macroscopically visible Wallner lines (Figure 5a). As a result, the water pressure tears off the clamping ring at this line from the remaining housing in one piece (Figure 5b). The direction of the short secondary cracks that grow from the main cracks with an orientation of approximately 45° , show two oppositely growing horizontal cracks with the same speed that joined on the opposite side of the housing (Figure 5c). At this point, a small triangular fragment was pulled out from the housing due to the junction of oppositely growing cracks and the high-pressure operation. Due to the slow growth of both cracks, the impact waves were too small to initiate a new, downwardly growing crack at this site. In this series of samples, two vertical cracks were formed at a distance of 15–20 mm from the initial site, which grew with approximately same speed in the downwards

direction (Figure 5d). Obviously, in these two places, the effect of the first oblique, short, secondary cracks and shock waves has an influence (until this point the secondary cracks do not exist), and due to this the tangential stress also starts to influence, but it did not prevail over the axial stress because of the stress concentrator between the clamping ring and the wall. The proof of this is a tear-off of the clamping ring in one piece due to the axial stress. However, the vertical downwards-growing cracks began to split at the very beginning (Figure 5d), indicating the effect of the reflected waves from the base on increasing the stress-intensity factor at their peaks. With their propagation, the branching was intensified. Interestingly, both cracks constantly grow vertically downwards at approximately the same distance from the place of their formation, splitting away from each other and negligibly in the direction from one to the other (Figure 5d). This is certainly due to the large difference in the surface of the housing between the cracks on the front side (small surface, $\approx 2800 \text{ mm}^2$) and the rear side of the housing (large surface, $\approx 13,000 \text{ mm}^2$). Consequently, the pressure is more effective for the formation of tangential stresses due to the stronger expansion and inflation of the rear side of the housing. At the base there is an interconnecting lateral crack, which is in an orientation with the surface of the epoxy resin (Figure 5d). Even in a uniform housing with such a thick base, the same condition would arise, as this is a typical example of the spread of the crack along the line of least resistance.

Figure 5. Specific characteristics of the initiation and propagation of the cracks in the sample of series D (a) an initiation point (b) a detached clamping ring (c) junction of the oppositely growing horizontal cracks with a small detached triangular fragment (d) strong splitting of vertically downwards-growing cracks (e) very densely arranged short secondary cracks along the main cracks; the arrows indicate the direction of the crack growth.

Due to the very large number of short and densely arranged secondary cracks, all the downwards-growing cracks have the appearance of a pine twig or feathers (Figure 5e), which is not typical for the branched cracks in the samples of series A and C (Figures 3c and 4d). A similar, but less pronounced, condition is seen for the primary downwards crack in the housing of series A (Figure 3a). This confirms that all the cracks in the D series samples are slowly growing with a strong shear tearing, leading to a large plastic deformation of the material. This is also proven by a more roughly and completely non-transparent, whitish fracture surface, which is also characteristic of the fracture surface of the torn clamping ring (Figure 5b). Cracks without short secondary cracks have a smoother and slightly more transparent surface. Because of the very densely arranged secondary cracks that are interconnected, the high pressure at the end of the test detached individual smaller fragments from the housing (Figure 5d, points A).

The crack initiation showed that the critical location of the housing without vertical ribs with the thicker base is a sharp transition between the clamping ring and the wall on the outside of the housing. The sharp transition $r_2 = 0.3 \text{ mm}$ is a strong elastic stress concentrator K_t and was determined from the same diagrams as in the case of a housing with vertical ribs. From the diagram with the one-sided reduction of the wall of the pressure vessel (chart 3.6 in [5]), it follows that the ratio between the different wall thicknesses is $H/h = t_{wc}/t_w = 7.2/4.3 \approx 1.7$, while the ratio between the transition radius and the thinner wall is $r/h = r_2/t_w = 0.3/4.3 = 0.07$. With an imaginary curve slightly above $H/h = 1.5$ we obtain the value $K_{t1}^* \approx 2.9$. In reality the values from Peterson's diagrams need to be increased by approximately 10% [6,21,22], so a decisive value is $K_{t1}^\# \approx 2.9 \cdot 1.1 = 3.2$. Also, the diagrams for a tensile loaded strip with the two-sided reduced height are suitable. From Figure 12.6b [4] and chart 3.1 [5], with the same ratio H/h and r/h , $K_{t2}^* \approx 2.45$, from Figure 3.11 in [6] for the same ratio $r/h = r/t$ and the ratio $h/H = t/T = 0.667$ (in our case $h/H = 4.3/7.2 = 0.6$), $K_{t3}^* \approx 2.6$ can be obtained. In the case of a one-sided cross-section reduction, the stress concentrator is approximately 10% lower for a similar ratio H/h and r/h [23]. However, since the values from the Peterson's diagrams need to be increased by approximately 10%, the final values are $K_{t2}^\# = 2.45$ and $K_{t3}^\# = 2.6$. The mean value of the stress concentrator in the sharp transition between the clamping ring and the wall is $K_t^\# = K_t = (3.2 + 2.45 + 2.6)/3 \approx 2.75$.

Since the crack is initiated and grows along the clamping ring, the axial stress in the housing is responsible for the burst, which is calculated using Equation (2). By inserting $p = p_d = 71 \text{ bar}$, $t_w = 4.3 \text{ mm}$, $D_{in} = D_{exu} - 2t_w = 71.6 - 2 \cdot 4.3 = 63 \text{ mm}$ and $K_t = 2.75$, the destructive stress of the water-filter housing without the vertical ribs is $\sigma_a = R_m = 71.5 \text{ N/mm}^2$. The value is consistent with the strength of the SAN and is comparable with previously obtained results.

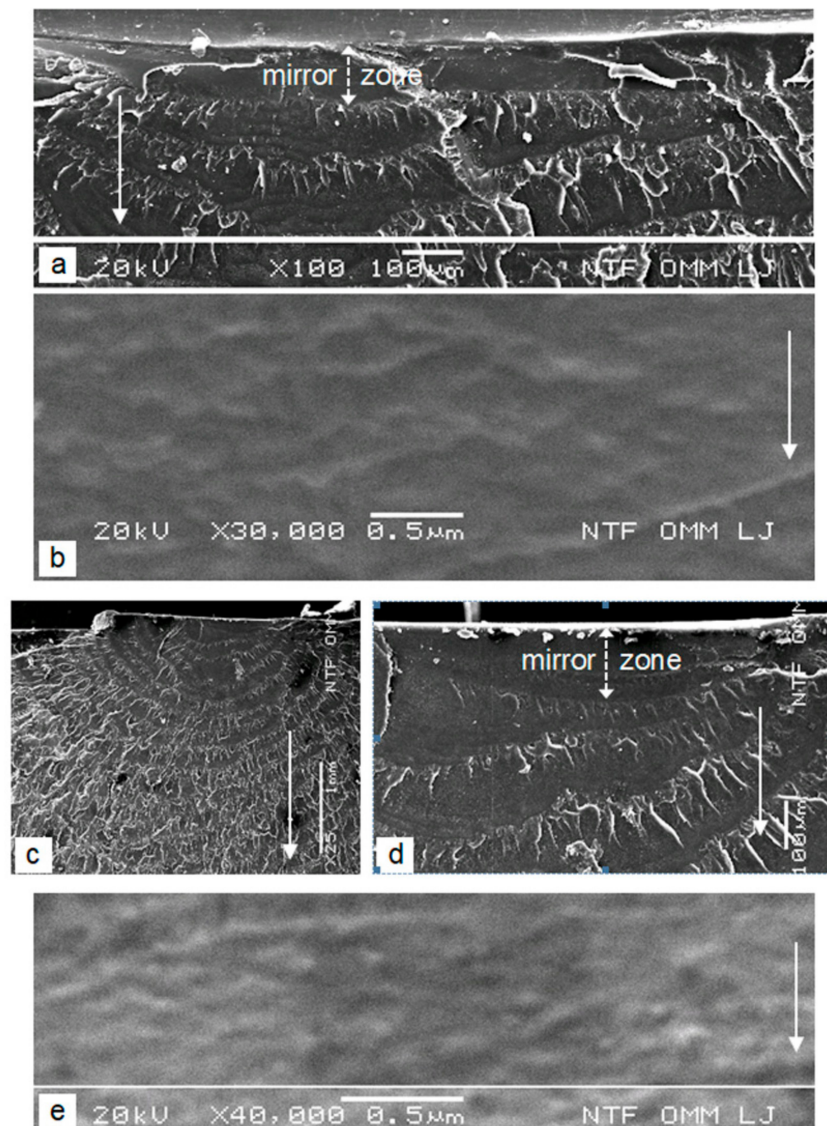
At smaller magnifications, the initial point of the cracks has generally the same texture in all cases. The initial surface of the cracks appears smooth (Figure 6a,c,d and Figure 7a) and is called a mirror zone. Its depth represents the critical depth of the crack [2,7], when uncontrolled growth of the crack leads to the final break. The depth of the mirror zone a_{mz} is different depending on the different series of tested samples: in series A it is $a_{mz} \approx 100 \mu\text{m}$, in series C it is $a_{mz} \approx 150 \mu\text{m}$ and in series D it is $a_{mz} \approx 600 \mu\text{m}$. The greater is the speed of increasing the load or the growth in velocity of the subcritical crack v_{mz} , the lower are their critical depths, which shows that a_{mz} is proportional to v_{mz}^{-1} (in series C the speed of increasing the load is 1.5 times slower than in series A, and in series D it is 2 times slower than in series A). In the case of series D, there are few micro-unhomogeneities in the initial area, which did not affect the crack initiation (Figure 7a). In the case of series C, it is clear that the stress concentrator on the external surface of the base, despite its proximity, did not affect the crack initiation (Figure 6c).

The very large magnification shows the very fine rough surface of the mirror zones (Figure 6b,e and Figure 7b), which proves the initiation and growth of the cracks in the mirror zone with the pre-formation and tearing of the crazes. The micro-texture of the mirror zone can be very different and is obviously related to the stress-increasing rate in the wall or the growth velocity of the subcritical cracks. This is evident from the comparison of the cracks' surfaces. The fine roughness is expressed in the form of more or less visible lines (Figure 6b,e and Figure 7b), the orientation of which in the series A and C samples is consistent with the growth front of a subcritical crack.

Figure 6. Characteristics of the mirror zones (a,b) sample of series A [2] (c–e) sample of series C; the solid arrows indicate the direction of the main crack growth.

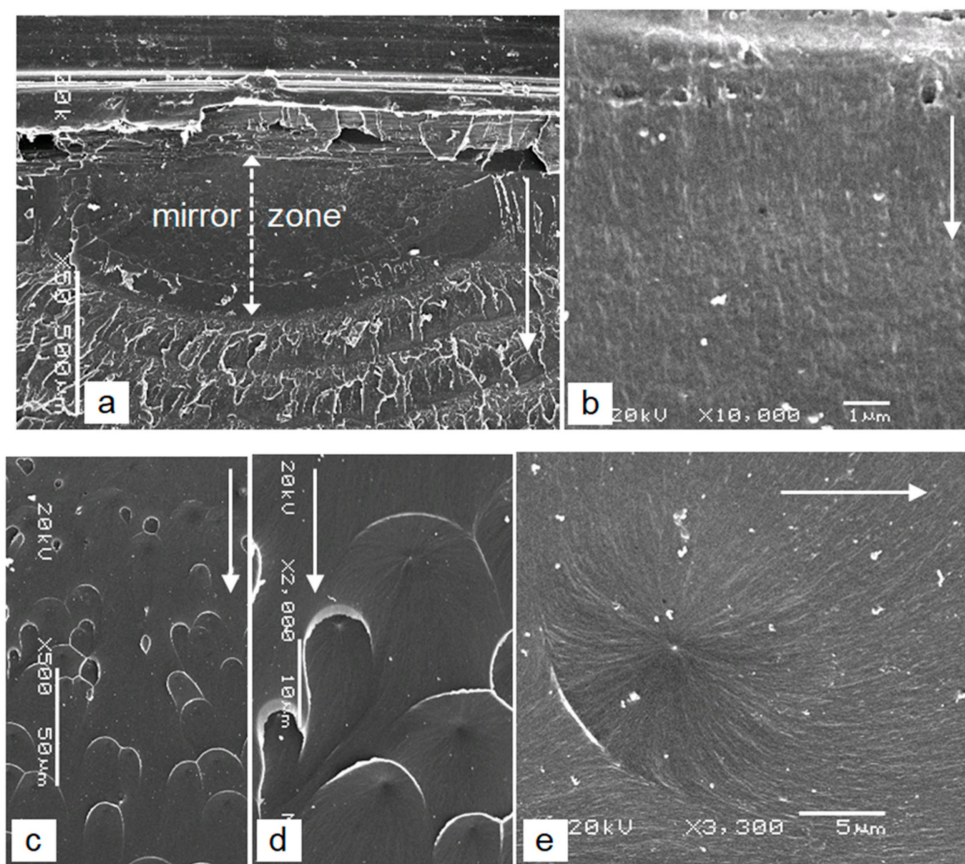
The surface of the mirror zone of the slowest-growing cracks (series D) differs significantly from the other two. Here, the more visible lines are directed towards the direction of the crack growth, while the lines oriented in the transverse direction are much less pronounced (Figure 7b). In addition to the lines, the so-called parabolic markings are generally also present on the crack surface of the mirror zone (Figure 7c). These contours are due to the junction of the main crack with the secondary micro-cracks [11], which are initiated ahead, near the front of the main crack at the sites of micro-unhomogeneities in the material due to the local stress concentration at these sites (the initials are at the focus of the parabola, Figure 7d). In the very initial field just below the surface of the housing, there are no parabolic markings (Figure 7c, upper part of the image). In this area darker spots with no pronounced boundaries and circular and droplet-like markings exist on the crack surface (Figure 7c). A larger magnification shows that the dark spots are the micro-craters that form due to the circular growing micro-cracks from the initial sites (Figure 7e). Even slightly deeper (approximately $100 \mu\text{m}$ below the surface), the typically parabolic markings exist on the crack surface, the number and size of which are increasing, and their open sides are in the direction of the main crack growth (Figure 7c).

Figure 7. Characteristics of the mirror zone of the sample of series D (a) symmetric semi-elliptic form of the mirror zone (b) lines in the direction of the main crack (c) different tips of contours in the crack surface of the mirror zone (d) parabolic markings with the initials in their focus (e) micro-crater with the initial in its center; the solid arrows indicate the direction of the main crack growth.

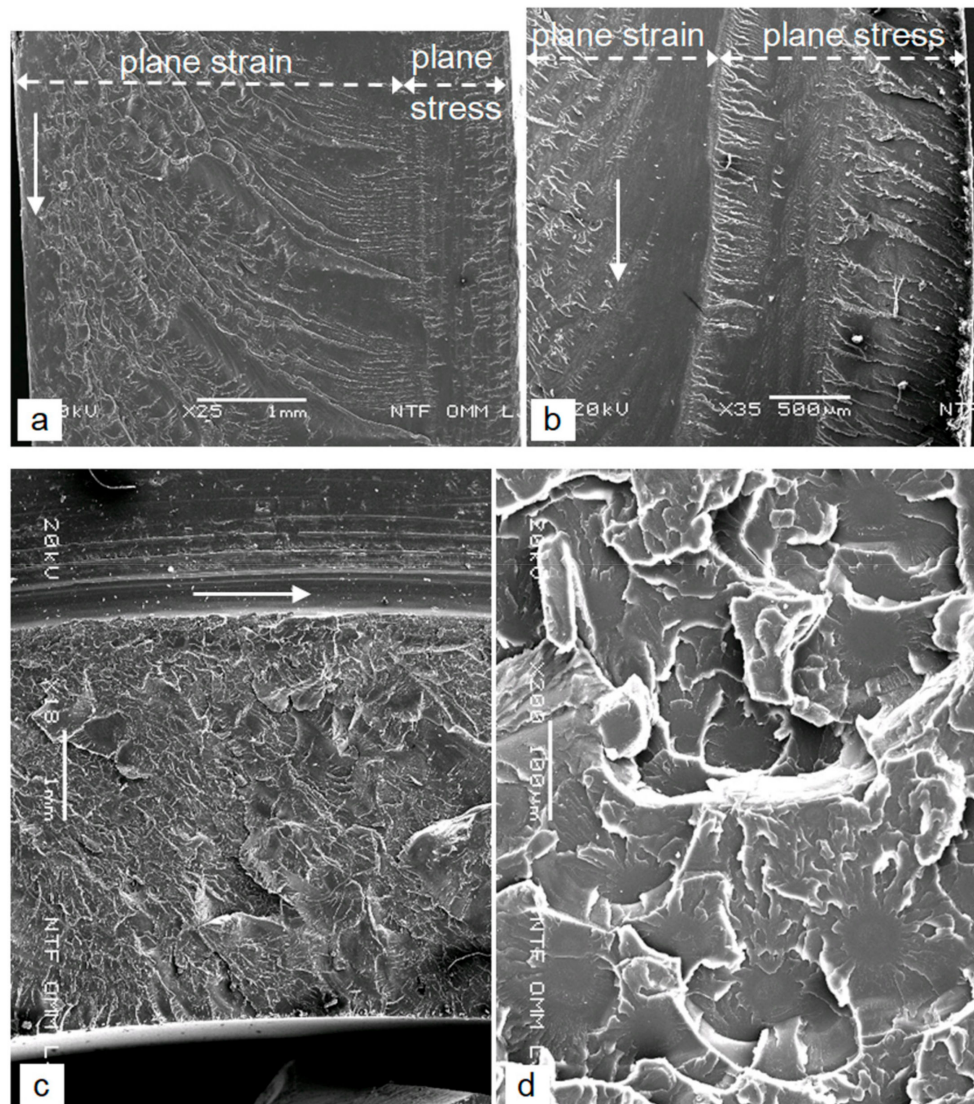
The fracture surface of the crack at depth $a > a_{mz}$ is no longer smooth, but its texture is the same in all samples. Close to the mirror zone there are macroscopically and microscopically visible semi-elliptic Wallner lines, and outward divergent hackle lines pointing along the crack-propagation direction are characteristic of this situation (Figure 6a,c,d and Figure 7a). Both types of lines indicate a slow, ellipsoid spread of the cracks in the initial phase of uncontrolled growth. In a later, rapid phase of uncontrolled growth, the hackle lines are curved (Figure 8a), which also indicates a different crack growth rate along the wall thickness of the filter housing. The cracks first grow through the wall in the plane-strain state and finally, pass through the plane-stress state, which is shown by the Wallner lines,

which are parallel with the external surface of the wall (Figure 8a,b). In the case of series C, the surface of the transverse crack indicates that the wall area in the plane-stress state consists of the two planes at different levels (Figure 8b). We think that is the result of bending the circular sector's fragments right before the burst due to the pressure action. The Wallner lines and hackle lines generally intersect each other at an angle of about 90° (Figure 8a,b) and from the mathematical point of view they form a system of a single-parametric family of curves with a family of orthogonal trajectories. In the case of the several differently oriented free surfaces, from which shock waves are reflected back towards the front of the growing crack, the Wallner lines can form a complex network, which can lead to an incorrect estimation of the direction of the crack growth.

Figure 8. Crack surface texture of the area that is far away from the initial sites (a) curved hackle lines in the field of very rapid crack growth and the growth transition from the plane-strain to the plane-stress condition, the sample of series A [2] (b) the growth transition from the plane-strain to the plane-stress condition, horizontal crack in the curved part of the bottom of the sample of series C (c) slowly growing crack of the detached clamping ring, the sample of series D (d) the mixed brittle-ductile character of the crack surface with strong shear plastic tearing, the sample of series D; the solid arrows indicate the direction of the main crack growth.

The surface texture of the crack that slowly grows by shear tearing with a strong plastic deformation and with a lot of short secondary cracks and the appearance of a pine twig (series D) macroscopically

looks like a brittle fracture in metallic materials (Figure 8c). There are hackle lines on the surface, while the Wallner lines are not seen. This is due to the splitting of the crack front, where a large number of differently oriented free surfaces at different levels are present, which diffusely breaks up the returned waves. The microscopic analysis confirmed a very strong shear plastic tearing, which due to the brittle SAN appears as a mixed brittle-ductile fracture (Figure 8d). On the fracture surface strong shear tearing appears due to the large number of secondary micro-cracks. These initiated ahead, close to the front of the main crack on the micro-unhomogeneities of the material, which act as a local stress concentrator (similar to the mirror zone). The micro-cracks grow independently at first, and after some time, they merge with the main crack. The initial independent growth of the micro-cracks appears on the fracture surface as more or less circularly symmetrical rosette shapes with a smooth round initial area in the middle, from which the hackle lines radial diverge (Figure 8d).
