Earth Dam Monitoring in the Soil Take Care Project [†]

[†] Presented at the 2nd International Research Conference on Sustainable Energy, Engineering, Materials and Environment (IRCSEEME), Mieres, Spain, 25–27 July 2018.

Published: 21 November 2018

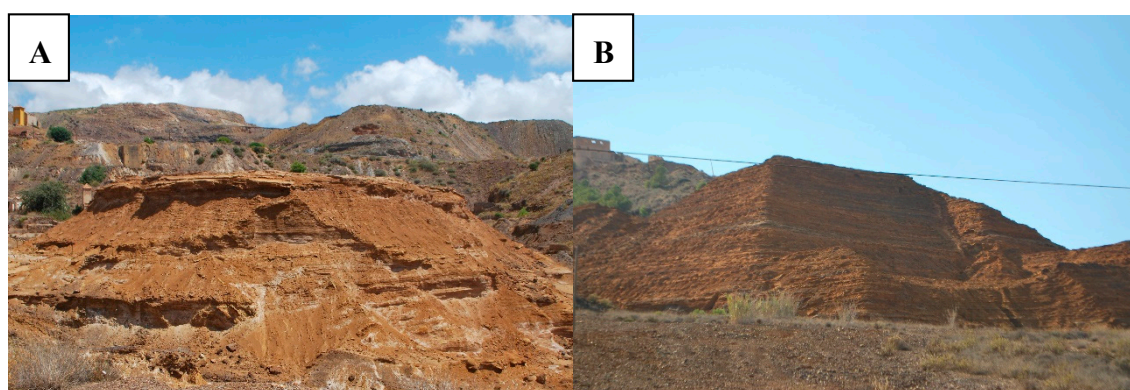
Figure 1. Earth dams in El Avenque (A) y El Descargador (B).

Among all present earth dams in this area, the named one as 0977-4-0037 (according to IGME's nomenclature) was chosen because it shows a displacement scar at the bottom and too vertical slopes, so it is liable to undergo new displacements.

During the reconnaissance, the presence of wet zones in the limited number of benches was observed. As consequences, six moisture sensors were installed under the surface, in order to check the seasonality of these ponds, and its possible connection with the rainy seasons.

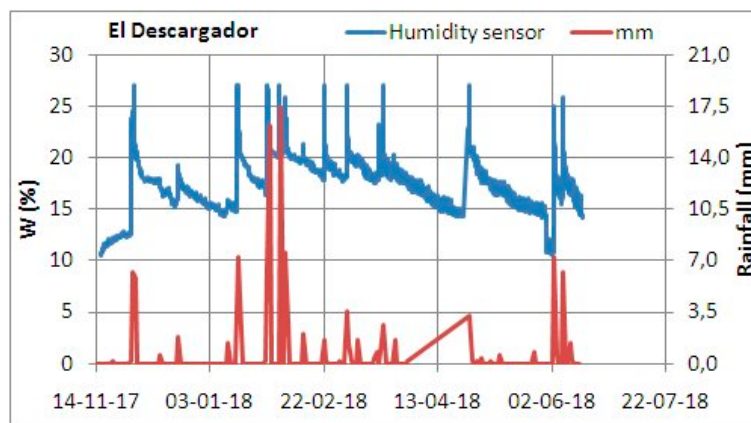
So far, preliminary results shows fast rainfall infiltration into the superficial soil layers of the ground and a certain water retention capacity, being discharge curves slower than the charge one (see Figure 2).

Figure 2. Connection between moisture and precipitations.

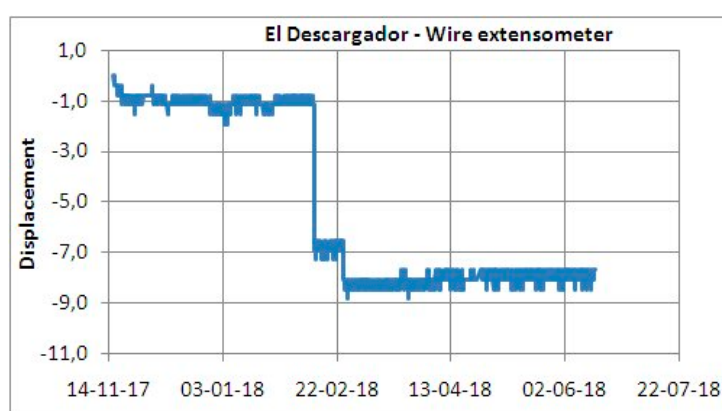
Finally, regarding the control of cracks and possible instability phenomena, it should be emphasize the movement detected by one of the extensometers placed on *El Descargador* spot that, at the beginning of 2018, detected a 6 mm leap (see Figure 3).

Also, it should be underlined the 0.2° movement registered in the same earth dam by the biaxial inclinometer placed a short distance away from extensometer, three months later. In any case there is no direct connection with the rainfall seasons.

Figure 3. Wire extensometer placed on *El Descargador* spot.
