Collapse of a Coastal Revetment Due to the Combined Effect of Anthropogenic and Natural Disturbances

Keywords: coastal erosion; coastal structure failure; video monitoring system

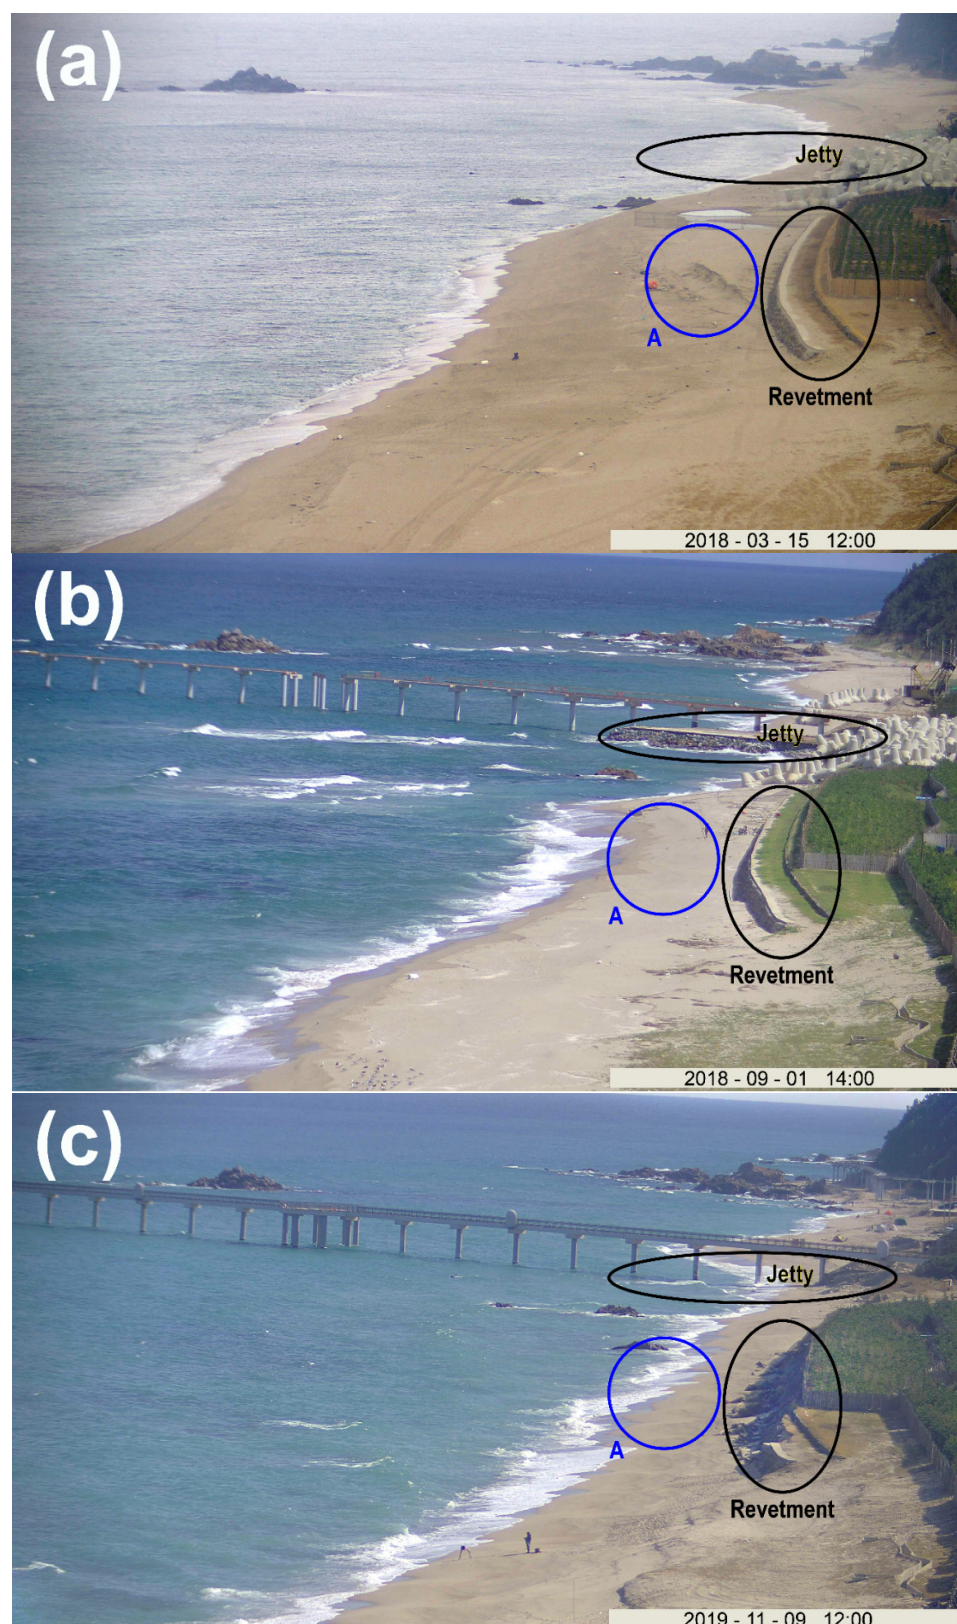
Figure 3a–c show three images taken by the VMS on 15 March 2018 (before the jetty construction), 1 September 2018 (after the jetty construction), and 9 November 2019 (after the jetty removal). As shown in Figure 3b, the rip-rap jetty was constructed perpendicular to the shore, parallel to the observatory pier, thus preventing the movement of sand in the longshore direction. In addition, hundreds of tetrapods for the construction of the SBW were stacked on the beach facing the jetty. As shown in Figure 3a,c, the shoreline in front of the revetment insignificantly changed due to the jetty construction.

Figure 3. (a) VMS image of the revetment location on 15 March 2018, before the jetty construction. The black circles denote the locations of the revetment and jetty construction. The blue circle, A, marks the area where erosion occurred in front of the revetment; (b) VMS image of the revetment location on 1 September 2018, after the jetty construction; (c) VMS image of the revetment location on 9 November 2019, after the jetty was removed.

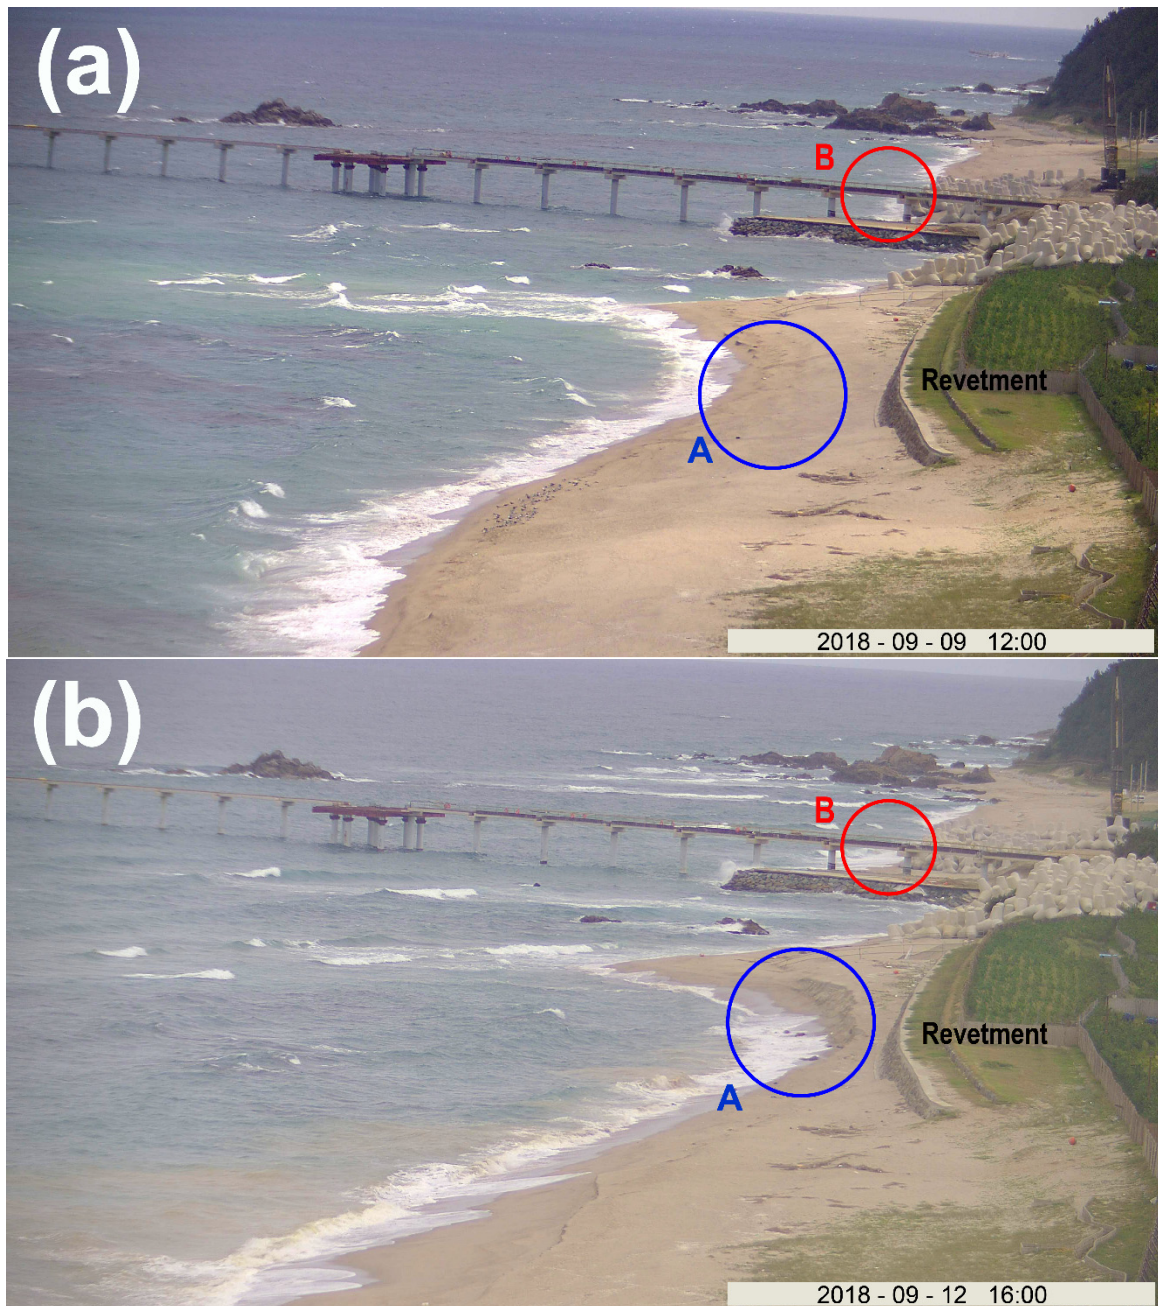
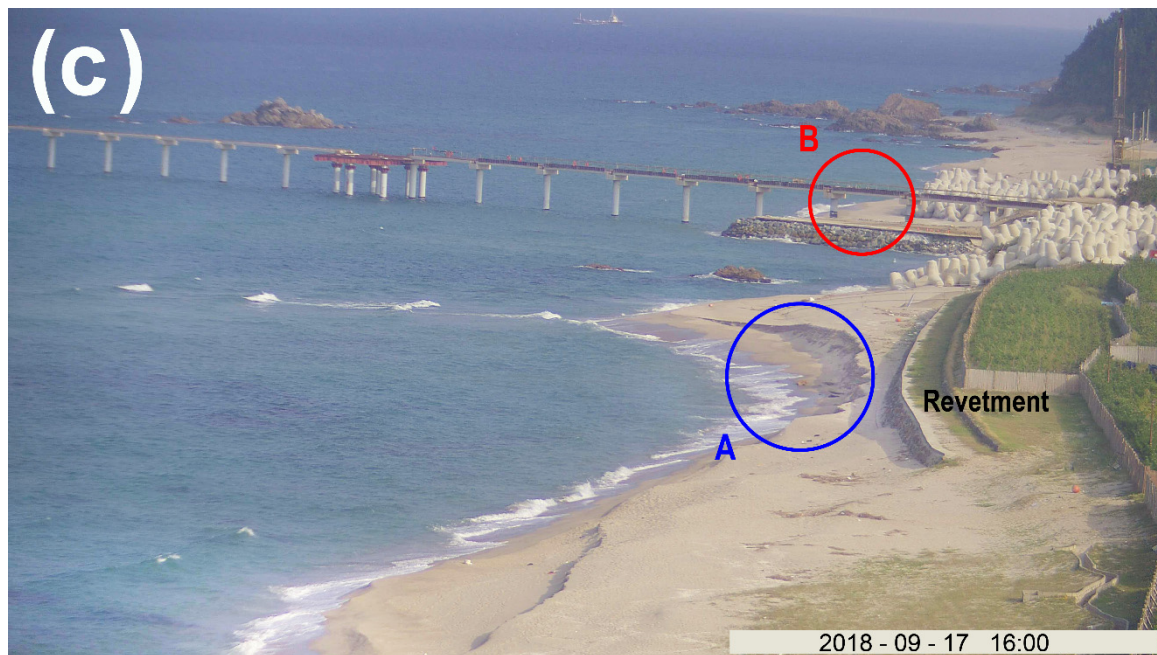
In early September, severe and rapid erosion occurred in front of the revetment, which led to its destruction. Figure 4a–c show that the area in front of the revetment (marked with the letter A) was rapidly and severely eroded over a period of 8 days from 9 to 17 September. Compared with Figure 3b (1 September), the shoreline in Figure 4a (9 September) significantly retreated toward the revetment.

Figure 4. (a) VMS image of the revetment on 9 September 2018 (T1). The blue circle, A, denotes the area in which erosion occurred in front of the revetment. The red circle, B, denotes the area south of the jetty in which accretion occurred. Note that the time of Figure 4a is earlier than that of Figure 3c; (b) VMS image of the revetment on 12 September 2018 (T2). Compared with T1, the erosion progressed significantly at location A, while accretion started at location B; (c) VMS image of the revetment on 17 September 2018 (T3). Note the severe erosion of the shoreline at location A and significant accretion at location B.

Additional evidence for the longshore sediment transport that caused the erosion at location A can be found at the other side of the jetty in area B (Figure 4a–c). Although the beach face was rapidly eroded at location A for a period of ~9 days, the shoreline significantly advanced toward the sea at location B. This indicates that the longshore sediment motion on the right side of the beach caused by the waves with $D_p \sim 90^\circ$ was blocked by the jetty, causing the shoreline accretion at location B, whereas the sediment transport at location A continued and the erosion at this location intensified.

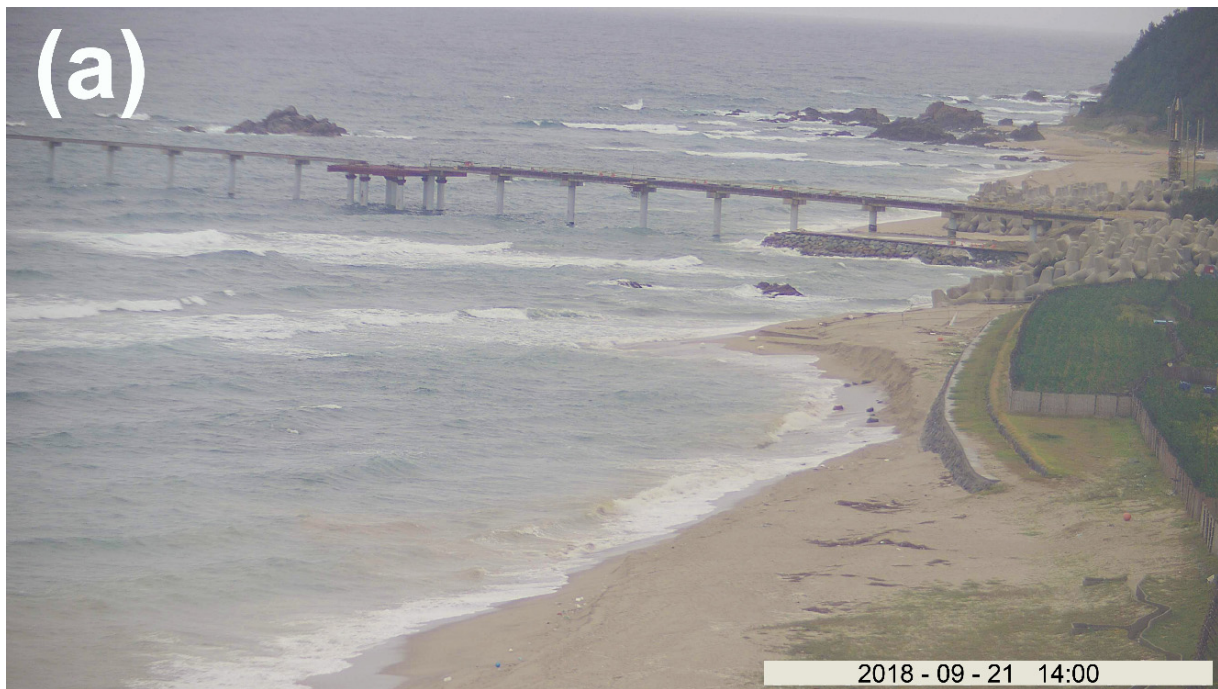
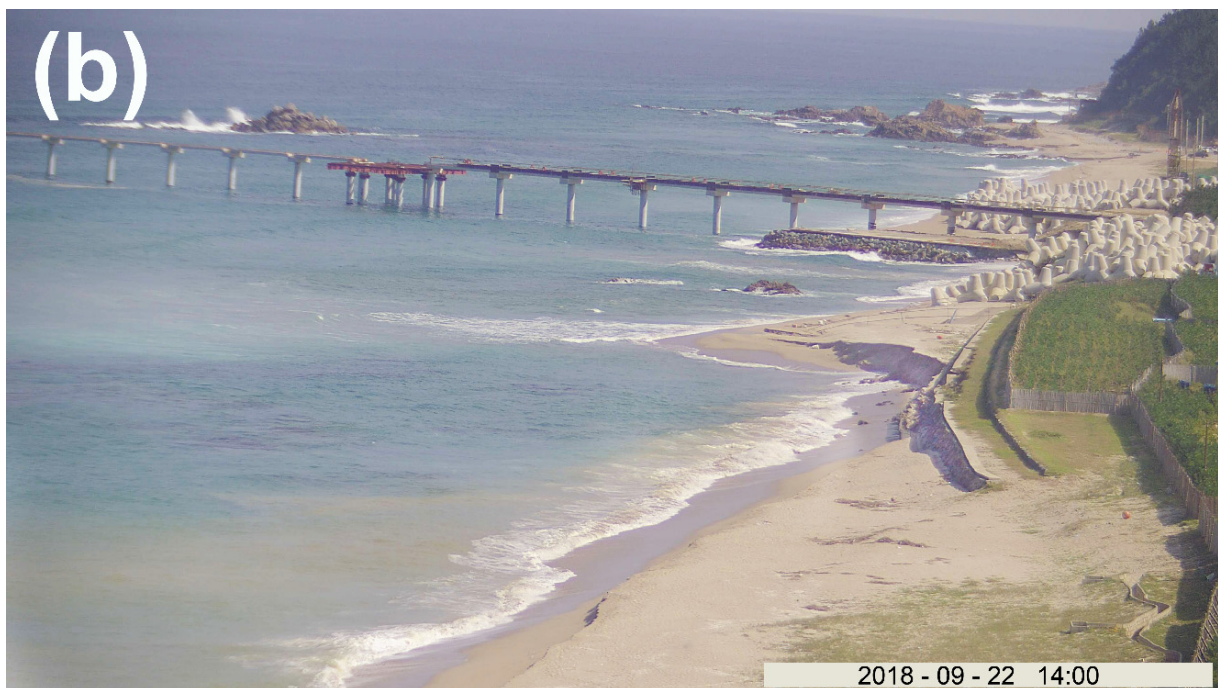
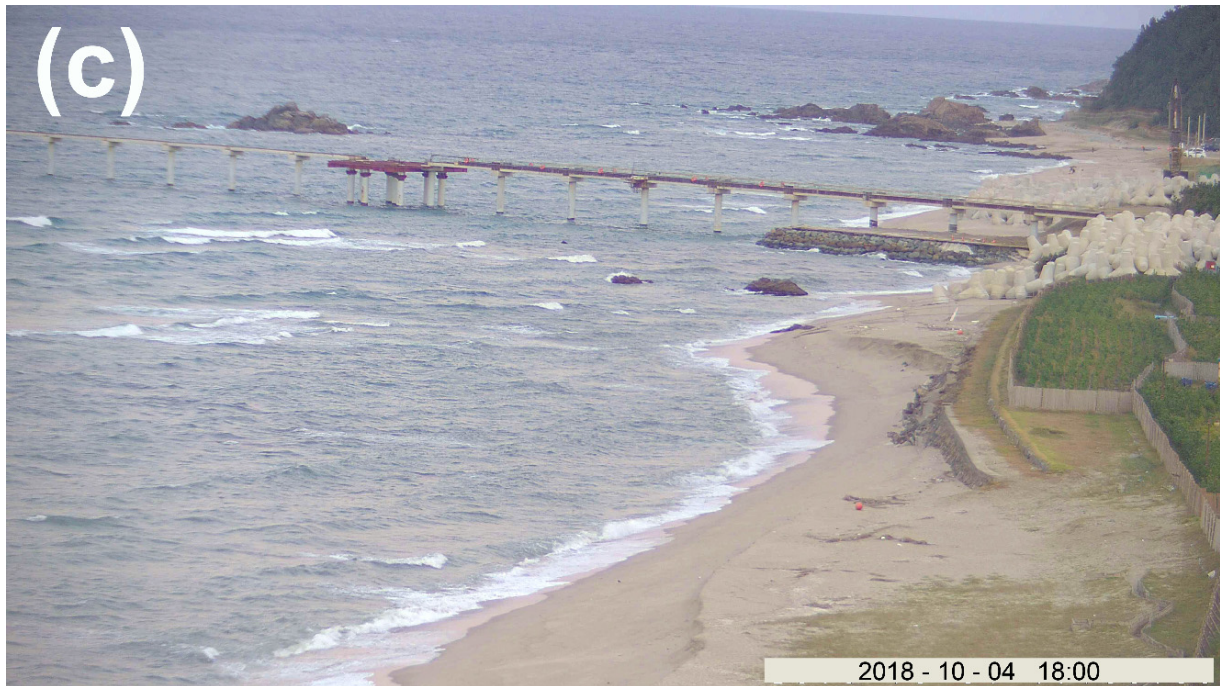
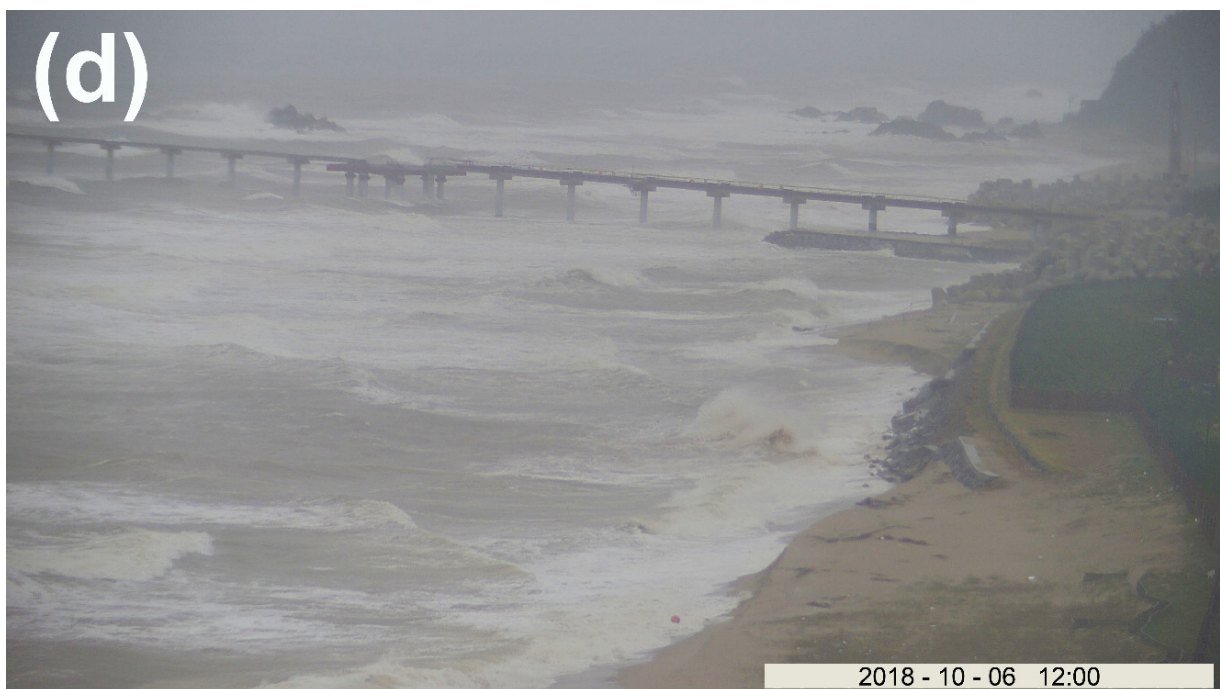
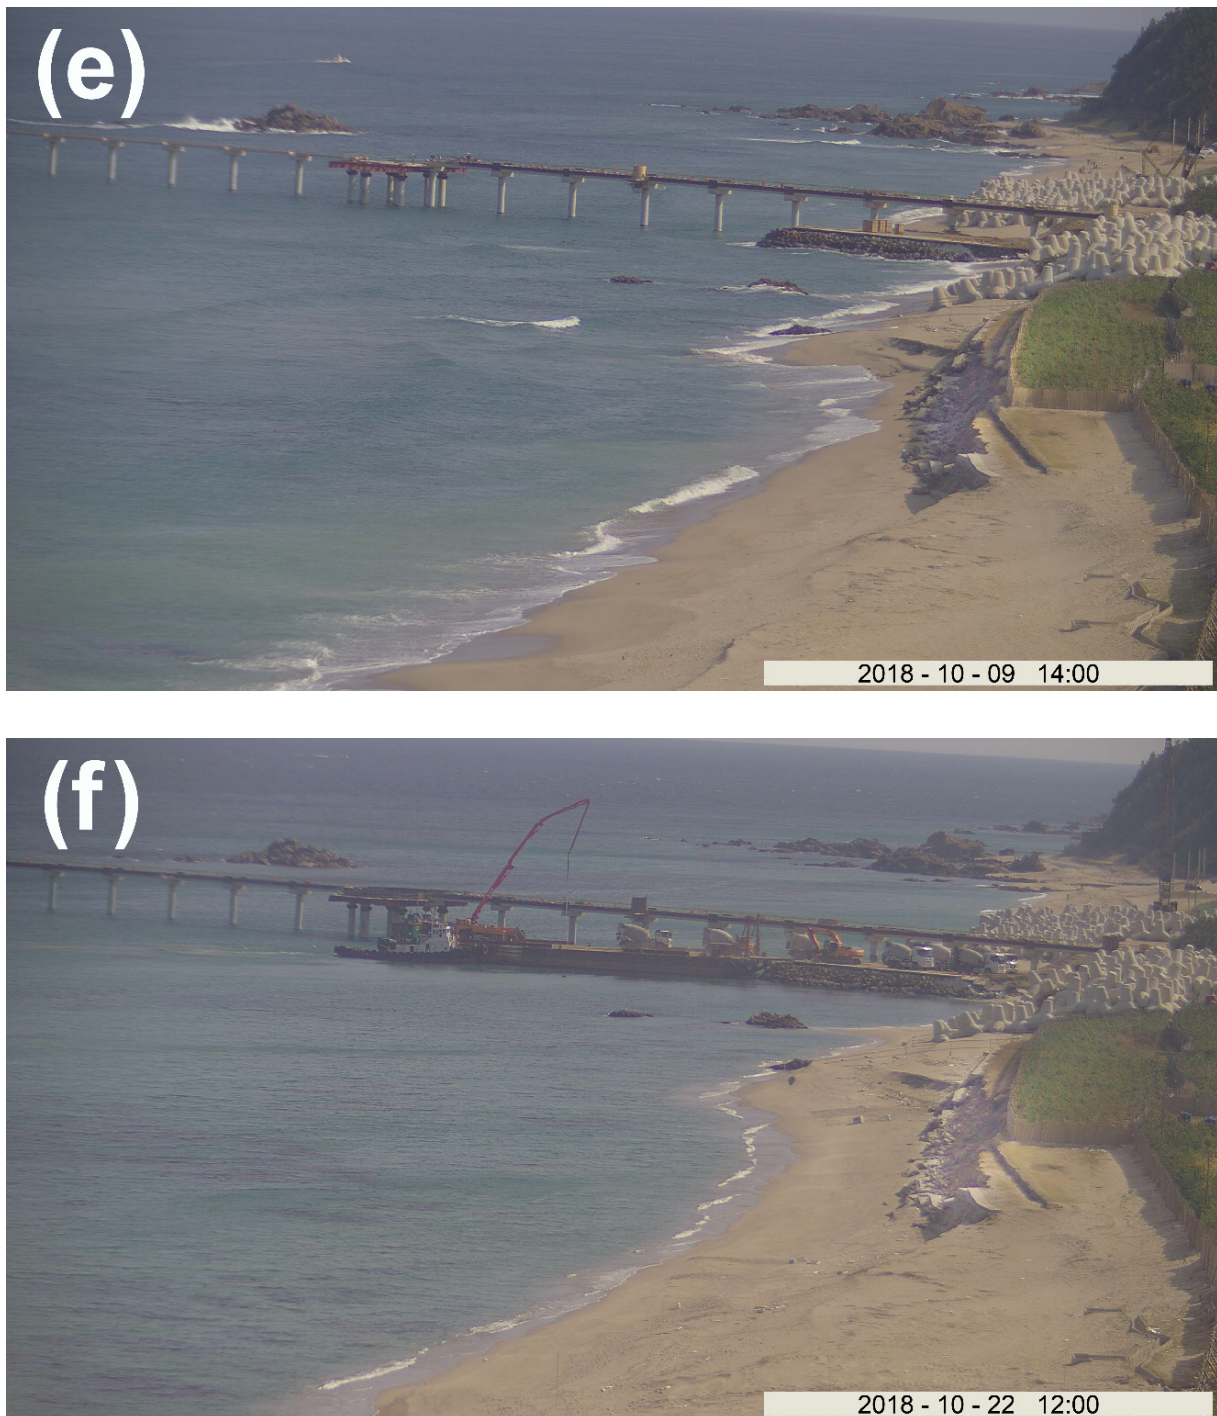
The first revetment damage occurred on 21 September 2018 (T4), and it completely collapsed on 6 October 2018 (T7). The wave propagation direction rapidly changed on 17 September when D_p sharply decreased at T3 (Figure 7b). Subsequently, the wave conditions were calm with a H_s value below 1 m until 21 September when H_s increased to ~1.7 m and D_p increased to $\sim 90^\circ$. Figure 8a,b show the VMS images taken on 21–22 September 2018, marked as T4 and T5 in Figure 7a, respectively. The erosion at T4 was similar to that observed at T3. The shoreline at location A retreated close to the revetment and a scarp formed in front of it. Figure 8a shows that the wave conditions were rough at this time and breaking waves attacked the beach face in front of the revetment. Therefore, the beach was significantly eroded and no sediments remained in front of the revetment at T5, i.e., one day after T4 (Figure 8b). In addition, the revetment partially collapsed, as indicated by the observation of revetment debris at the beach face. Therefore, the revetment was likely damaged during the attack of the waves at T4. However, note that the wave energy at T4 was not maximal because H_s was below 2 m. The revetment would not have been destroyed under these wave conditions unless severe erosion occurred in front of it.

Figure 8. VMS image of the revetment location on the following dates: (a) 21 September 2018 (T4); (b) 22 September 2018 (T5) when the revetment was damaged for the first time; (c) 4 October 2018 (T6) where the amount of debris at the beach face is increased compared with that at T5; (d) 6 October 2018 (T7), when the area was hit by Typhoon Kong-rey. The image captures a moment during which a high breaking wave hit the revetment; (e) 9 October 2018 (T8) when the revetment was completely destroyed. Piles of debris are scattered at the beach face at the bottom of the revetment; (f) 22 October 2018. The beach recovered after the storm waves passed.

After the revetment was first damaged on 22 September (T5), the high wave conditions continued until 26 September (Figure 7a) and the damage continued. Figure 8c shows the VMS image obtained on 4 October 2018 (T6). Compared with that taken at T5, the amount of debris at the beach face is increased, confirming the continuation of the revetment

destruction after T5. During this period, the wave direction fluctuated instead of remaining constant at $D_p \sim 90^\circ$, and the width of the beach face at T6 slightly increased compared with that at T5. Typhoon Kong-rey that passed the Korean Peninsula on 6 October 2018 led to the most severe damage of the revetment. The time series in Figure 7a,b show that H_s reached 4 m on 6 October 2018, and D_p increased to $\sim 90^\circ$ on 5–6 October. Figure 8d shows the VMS image captured on 6 October (T7) when the area was hit by Typhoon Kong-rey. The image captures a moment during which a high breaking wave hit the revetment. The revetment completely collapsed after the typhoon passed. Figure 8e shows the VMS image taken on 9 October (T8), which clearly shows that the revetment was completely destroyed. Piles of debris were scattered at the beach face at the bottom of the revetment. Once the revetment was destroyed, the beach gradually recovered under milder wave conditions. The VMS image taken on 22 October 2018 shows that the shoreline significantly advanced toward the sea and the debris of the collapsed revetment remained behind the shoreline (Figure 8f).

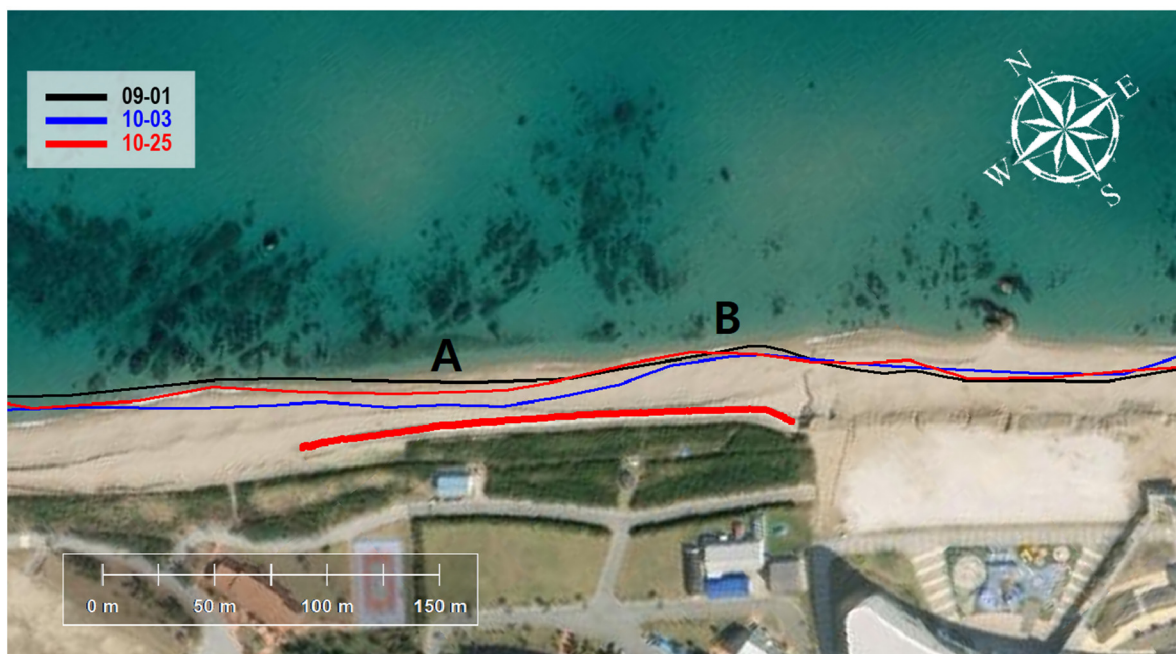
In order to analyze the shoreline changes in a quantitative manner, the shoreline positions calculated by VMS on 1 September, 3 October, and 25 October are marked on a Google map in Figure 9 as these times denote the time before the erosion, when the erosion was in progress, and after the erosion, respectively. Note that the shoreline positions could be estimated only on the days with mild wave conditions. On days with harsh wave conditions, wide noise bands were observed in the swash zone due to wave breaking, which increased errors in detecting the shoreline positions manually. Therefore, the shoreline position data were not available when the erosion was most severe on T4 and T5. However, the positions in Figure 9 still prove that the shoreline was eroded in A from 1 September to October by a maximum retreat distance of ~ 10 m. After that, the shoreline in A was recovered until 25 October with a maximum advance distance of ~ 7 m. On the contrary, the shoreline positions in B did not change significantly, confirming the data from the images in Figure 8.

Figure 9. Shoreline positions marked on a Google Earth map. The thick solid red line marked inland denotes the location of the revetment. The thinner colored lines denote the shorelines calculated by the VMS on 1 September (black), 3 October (blue), and 25 October (red).

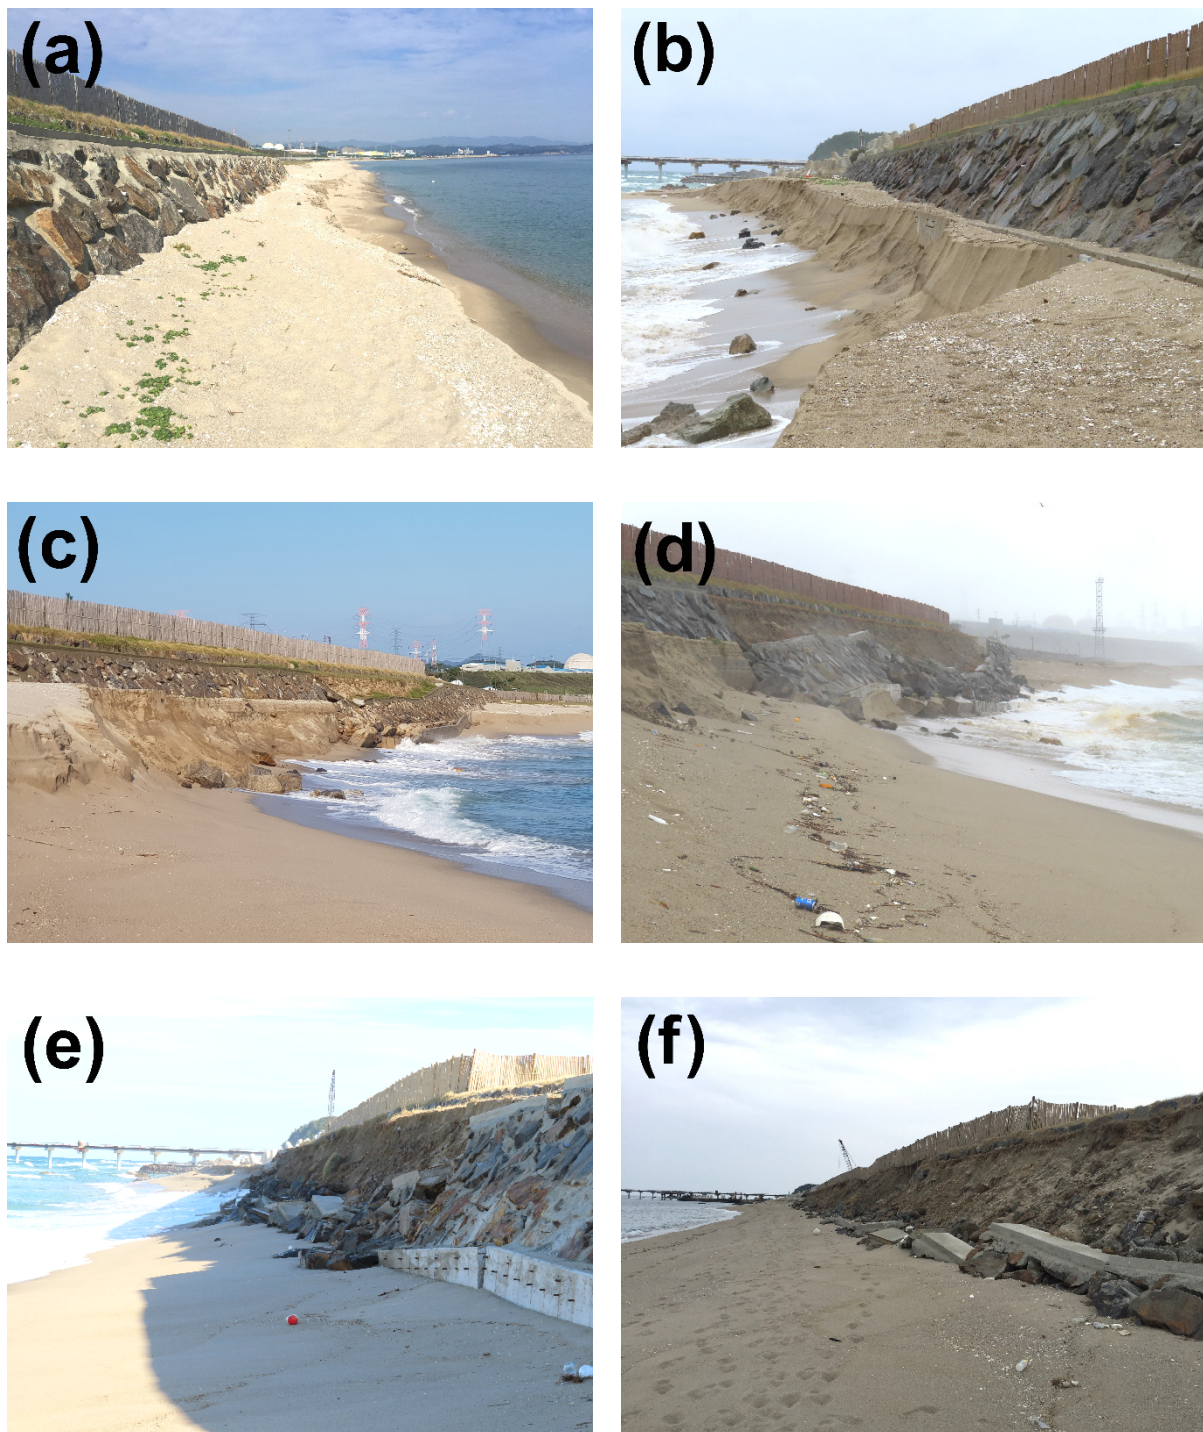
Figure 10 compares the six photographs of the revetment taken on (a) 18 September, (b) 21 September (T4), (c) 22 September (T5), (d) 5 October, (e) 8 October, and (f) 21 November 2018. The revetment was built using boulders and cemented with concrete for the protection of the MIRE. It was expected to withstand attacks by storm waves. The effective wave height, H_e (excess of the significant wave height for 12 h/year or 1.137% of the time considered), in this region is ~ 3.9 m (Do et al., 2019); thus, the revetment was at least expected to withstand the storm waves with height of H_e . However, the results show that a part of the concrete top of the revetment was destroyed between T4 and T5 although the wave conditions were not extremely severe as H_s was less than 2 m (Figure 7a). In addition, a larger part of the revetment was destructed on 5 October (between T6 and T7), when H_s was less than 2 m, before the impact of Typhoon Kong-rey was maximal in the beach. In contrast, the revetment was not damaged earlier in March 2018 although extreme waves with H_s higher than 4 m were observed (Figure 5a). Below, factors driving the revetment destruction at this specific time (T4–T8) are discussed on the basis of observations of simultaneously occurring processes.

Figure 10. Photographs of the revetment before the destruction on (a) 18 September 2018 and (b) 21 September (T4), after the partial destruction on (c) 22 September (T5) and (d) October 5, and after collapse on (e) 8 October and (f) 21 November 2018.

It is beyond a doubt that the most significant effect on the revetment was the repeated attacks of storm waves. Although the jetty construction and associated erosion provided an environment that could trigger the destruction of the revetment, they did not directly cause the destruction. The revetment collapsed when its durability decreased by repeated storm wave attacks within a short time frame. After the revetment was first damaged on 22 September 2018, two more storm waves attacked the beach on 30 September and 6 October. The succession of these storm events led to a continuous unstable status of the revetment; thus, the revetment was less durable and finally collapsed when Typhoon Kong-rey hit.

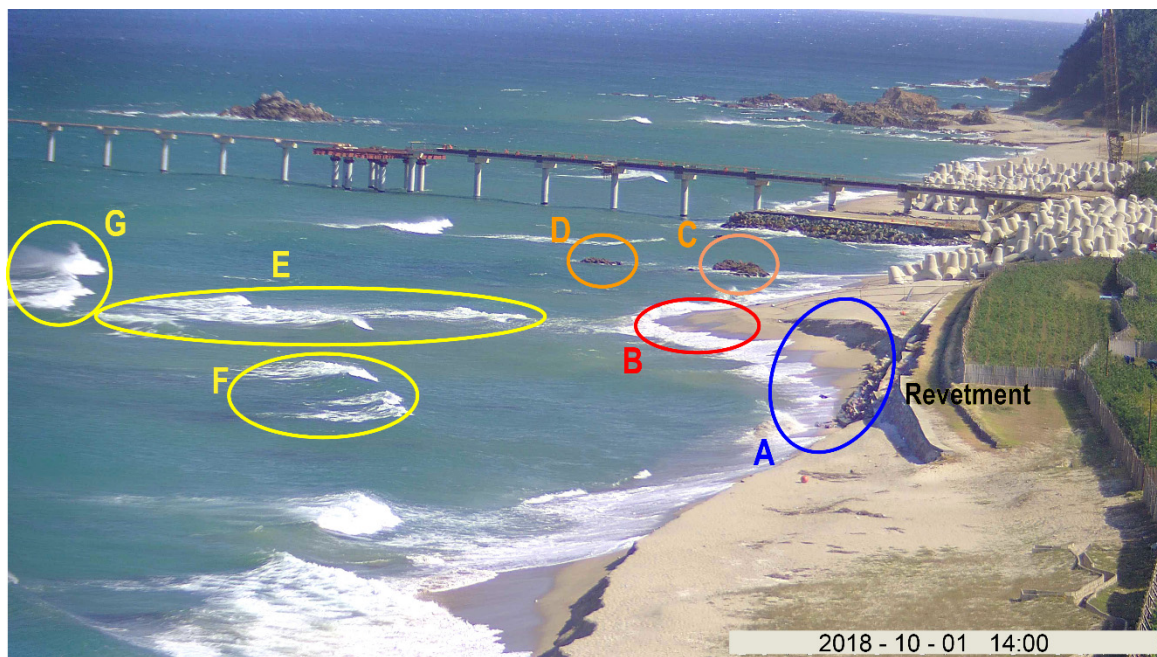
Another important factor that triggered the revetment destruction was the geography. Note that the shoreline only severely retreated in front of the revetment, whereas severe erosion was not observed in other areas. Figure 11 shows a photograph taken by the VMS on 1 October 2018. The shoreline was retreated at location A but not at location B. This unbalanced shoreline evolution is likely due to the protection of area B by the rocks in areas C and D. In addition, area E shows that the waves approaching area B started to break earlier than those approaching location A due to the shallower water depth. The same phenomenon can be observed in the two breaking areas F and G, indicating that the waves started to break at different locations in front of locations A and B, respectively.

Figure 11. VMS image of the revetment on 1 October 2018. The blue circle, A, denotes the area in which erosion occurred in front of the revetment. The red circle, B, denotes the location in which the shoreline was not eroded. The orange circles, C and D, denote the locations of the rocks. The yellow circles, E, F, and G, denote the locations where the waves broke in front of the locations A and B.

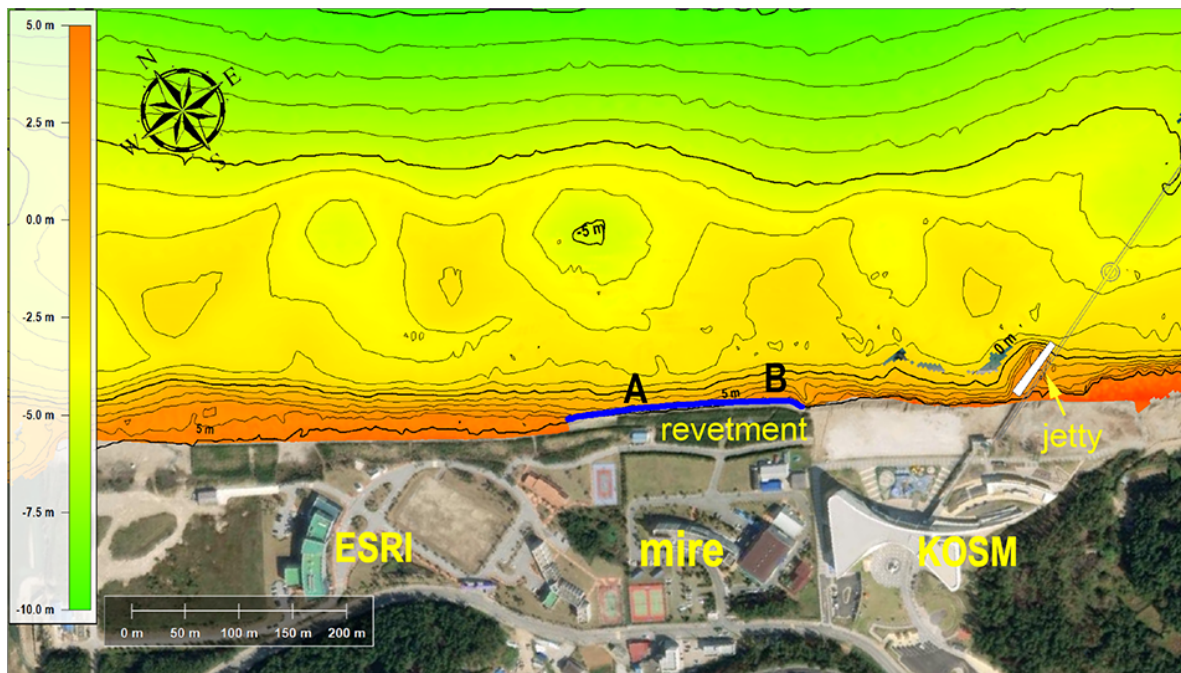
In order to examine the reason of difference in the wave breaking positions between E, F, and G, the water depth contours are plotted in Figure 12 using the bathymetry data measured by a single-beam echosounder on 21 October 2018. The figure shows that crescentic sandbars developed in the nearshore area of the experimental site where the water depth was shallower than 5 m. Because of these underwater structures that had a crescentic pattern, the water depth was deeper in front of location A where a sandbar bay developed, whereas it was shallower in front of B where a sandbar horn developed. This difference in water depth between the two locations confirms that the wave energy at location A was higher than that at location B, which additionally supports the concentration of erosion in the former area. It is noted, however, that the bathymetry in Figure 12 was measured at a time when the shoreline was considerably recovered after the erosion. Therefore, the data do not show the water depth information on the days when the severe erosion occurred in A exactly, and they only support the hypothesis extracted from the wave breaking pattern in Figure 11.

Figure 12. Bathymetry contours measured by single-beam echosounder on 21 October 2018. It shows that crescentic sandbars developed in the nearshore areas where the water depth shallower than 5 m, which rendered the water depth to be shallower in front of A, whereas the water depth was deeper in front of B where a sandbar horn developed.
