Damage Mechanisms of Polymer Impregnated Carbon Textiles Used as Anode Material for Cathodic Protection

Abstract: Carbon textiles as anode material for cathodic corrosion protection (CP) have been used in several reinforced steel structures. However, experience with durability is limited. To date, various influencing factors have been discovered and systematic tests on different carbon textiles with different impregnation materials in various environmental media have been carried out and considered the degradation of the impregnation materials. In this work the boundary potentials are determined at which the impregnation and sizing is destroyed under anodic polarization and the damage mechanisms are described.

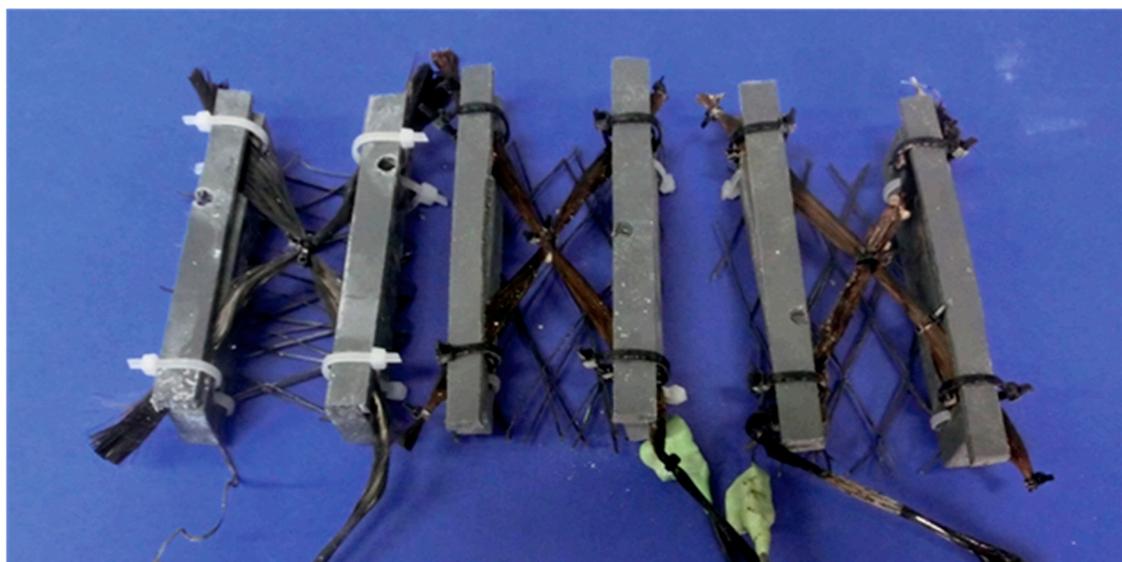
On most specimens, optical changes could already be detected after polarization. Photos of all specimens from the potentiostatic tests with unimpregnated carbon fibres are shown in Figure 11. The unimpregnated carbon fibres were glossy and soft, comparable to a brush before the test was carried out. After polarization at level 1, the carbon fibre is still soft but less shiny. This could be explained by the deposits of calcium carbonate. The solution of the tests at levels 1 and 2 showed no difference. The solution of the experiment at level 3, on the other hand, was discoloured brown and small black particles floated in the solution. The particles deposited on the ground after a few days. These sediments were freeze-dried with a small remainder of the solution and identified as calcium carbonate by Fourier transform infrared spectroscopy. Since the substance, unlike pure calcium carbonate, was not white but grey, further components must be present. However, these could not be detected by infrared spectroscopy.

Figure 11. From left to right: specimen P1 of levels 1 to 3 after polarization.

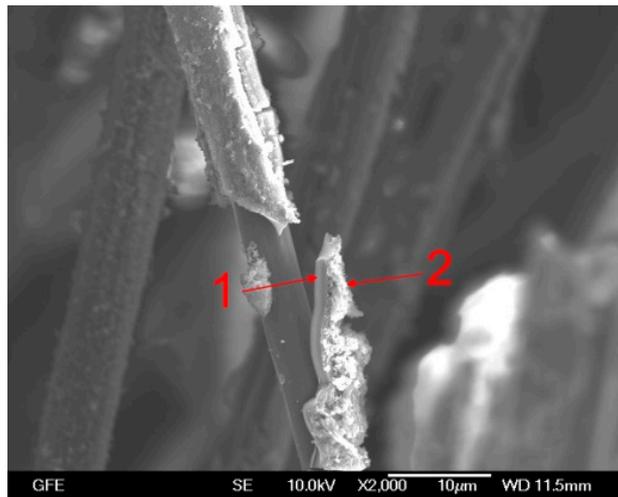
Figures 13 and 14 show that the inner part of the destroyed layer consists mainly of carbon, which could be part of the sizing. The outer layer indicates the presence of calcium, carbon and oxygen. These are the deposits formed due to chemical reaction between calcium of the solution and carbon from the sizing. These deposits can be found more strongly on the surface of the carbon as the polarization potential increases.

Figure 13. SEM image of unimpregnated carbon. 1 and 2 EDX analysis in the marked area.

EDX analysis was performed on an unimpregnated carbon (UC), in a region, where the deposited film was partly flaked off. So both sides of the film could be analysed.
