Article

Cultural Landscape Assessment: The Rural Architectural Heritage (13th–17th Centuries) in Mediterranean Valleys of Marina Alta, Spain

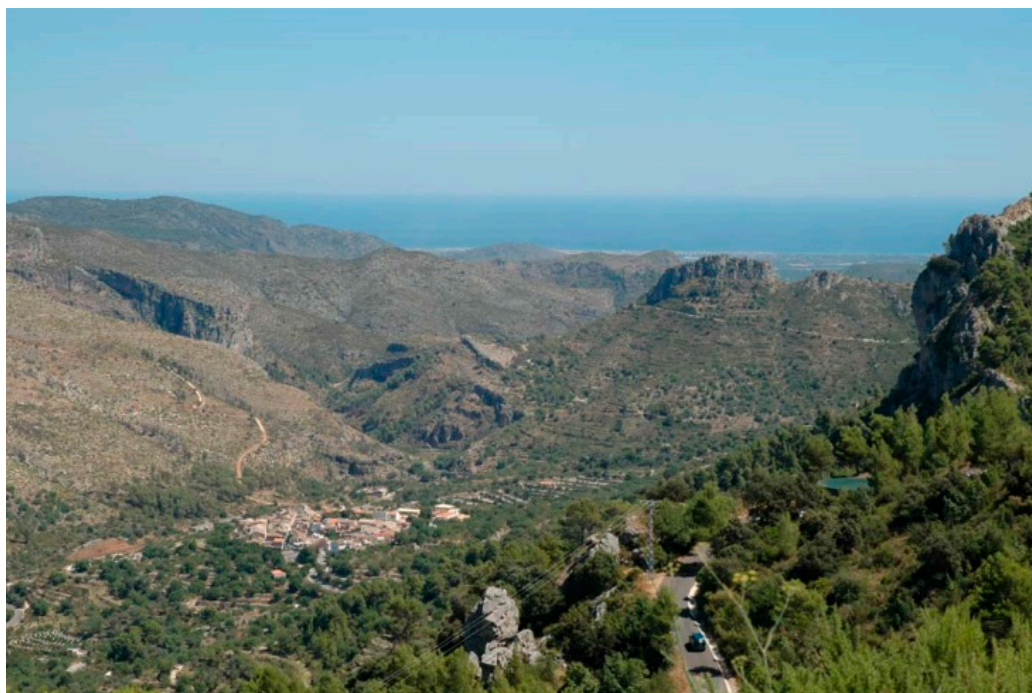
Figure 1. The natural and human landscape in Vall de Gallinera.

The study area’s geographical framework is constituted by a mountain range that spreads to the south of the Valencian Community. It is a well-known pre-Baetic domain characterised by strong limestone folds that shape a series of enclosed valleys around small fluvial watercourses. The dominant landscape responds to general Mediterranean mountain features, characterised by little irregular rainfall and rocky marked sloping lands (Figure 1).

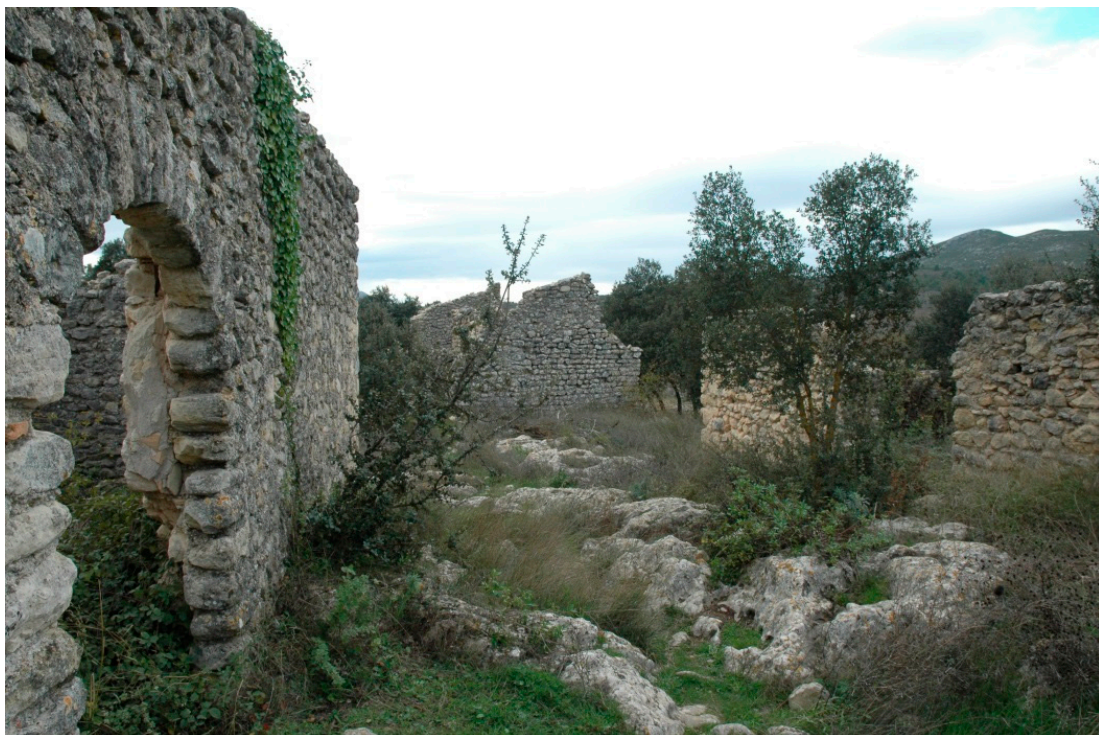
Figure 2. View of the current state of a case. Case: L’Atzuvieta, Vall d’Alcalà.

From the wide Al-Andalus context, most rural settlements have unfortunately disappeared, and only some barely recognisable ruins or archaeological vestiges can be found. Nevertheless, the study area is a notable exception because architectural features are still recognisable. Although these places are in ruins and in danger of disappearing, they are still useful for observing the features of the hamlets of the *Moriscos* who inhabited these lands, which was a point of cultural separation and abandonment. Some of these places have not been re-inhabited, but have been reused as sheds for sheep. Others were repopulated by Christian settlers and have remained inhabited to become today’s villages (Figure 2).

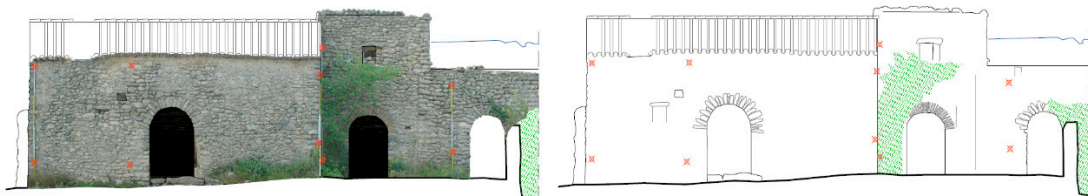
Figure 4. Example of the data collection process that has been applied to all the cases: Photogrammetry and architectural drawing.

Data collection methods are defined by taking into account certain difficulties given the status of abandonment, ruin, and invasive vegetation. The survey was carried out mainly by using digital photogrammetry (Figure 4) and combining traditional techniques of specific details, along with an extensive photographic report. Each case was surveyed and digital models were made to completely define the current state. A complete set of plans was drawn, starting with the site plans of hamlets. For each building, floor plans, sections, elevations, and specific details were produced. This valuable documentation takes into account the abandonment and imminent danger of disappearance (Figure 5). It acts as a starting point to support analyses and for the understanding of heritage and its related values as an essential part of the conservation process.

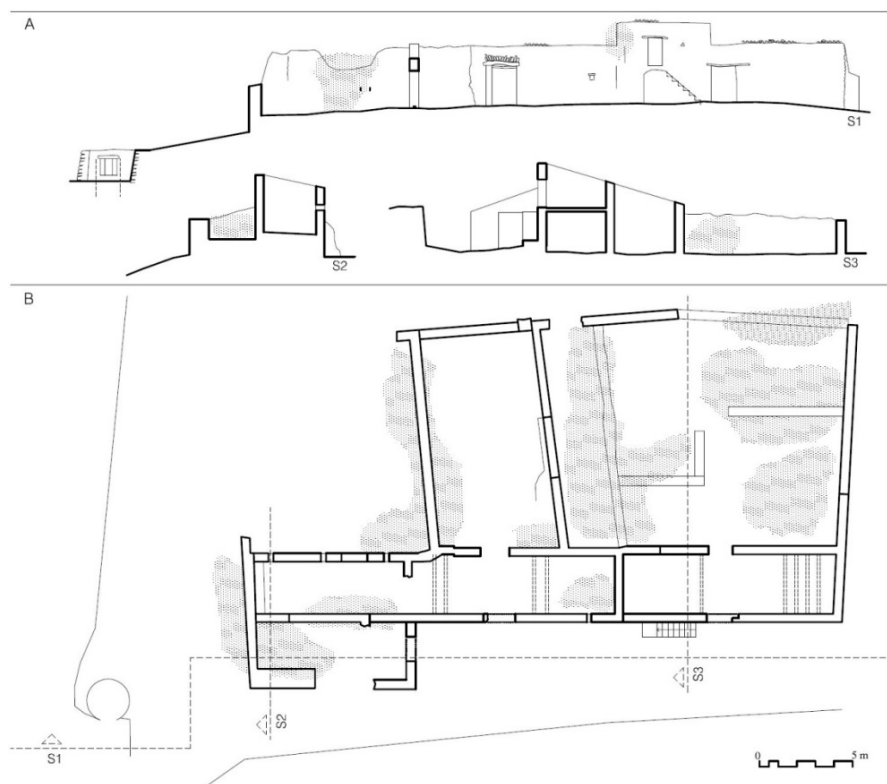
Figure 5. Architectural drawings. (A): Sections and elevations, (B): Floor plans. Case: Benialí, Vall d'Alcala.

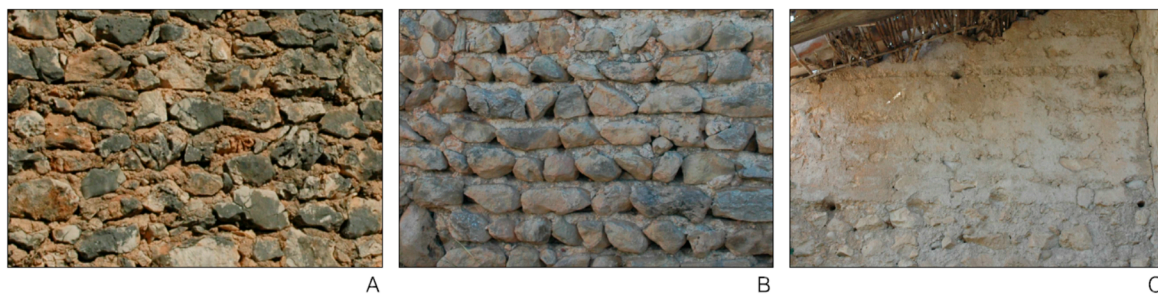
Figure 6. Compilation of detected wall fabrics. (A): Rubble stone masonry, (B): Coursed rough stone masonry (C): *Tapia*.

The construction materials of this vernacular architecture are related to their availability. Stone is the predominant material in the area, which is combined with some earth, lime, cane, and wood. In their current appearance, stone walls prevail and different fabrics are observed (Figure 6). After a thorough observation of wall surfaces, it was possible to define different kinds of stone masonry: rubble stone masonry, coursed rough stone masonry, and *tapia*.

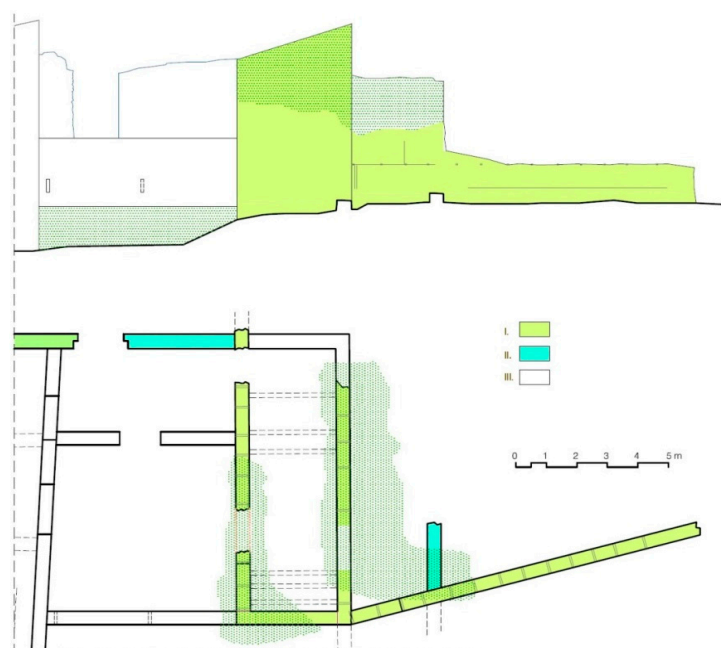
Figure 8. Construction techniques related to the temporary hypothesis. I: *Tapia*, II: Coursed rough stone masonry, III: Rubble stone masonry.

A stratigraphical analysis was carried out by observing the different parts and their temporary relations. This allowed the determination of some common phases associated with different construction techniques (Figure 8). Given the vernacular character of this architecture, some constructive techniques have persisted over time. Although the contributions from all periods to buildings must be respected, the identification of different phases allows us to advance in knowledge about primitive dwellings (Figure 9).

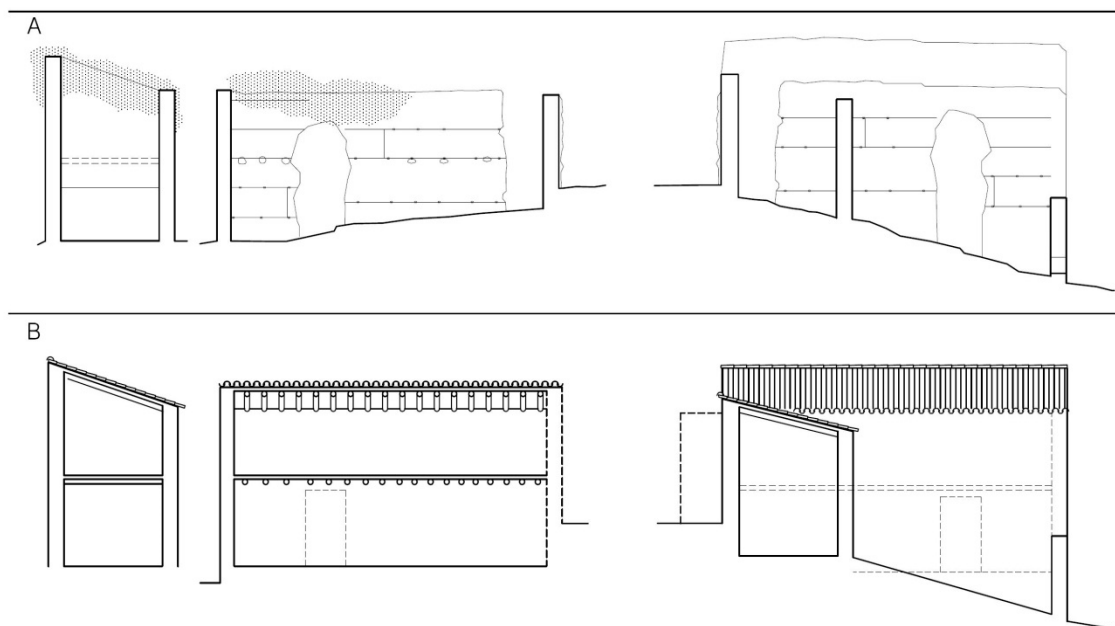
Figure 9. (A): The ruinous current state. (B): The graphic restitution of ancient architecture.
