Article

Experimental Campaign of a Low-Cost and Replaceable System for Passive Energy Dissipation in Precast Concrete Structures

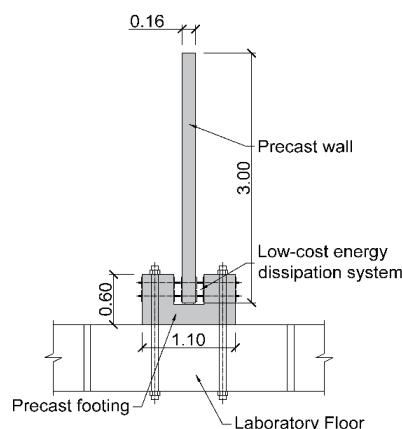
The structural wall is a conventional reinforced concrete precast element 3.0 m high, 2.0 m wide, and 16 cm thick. The wall is placed on a reinforced concrete precast footing, 1.1 m wide, 2.0 m deep, and 0.6 m high. In both cases, the concrete quality is C30/37, according to Eurocode 2 [35]. The compressive strength was obtained following the method described in standard EN 12390-3 [36]. The footing includes a longitudinal pocket 36 cm wide and 36 cm high, where the structural wall is placed. Underneath the wall, a 2 cm neoprene band is placed. The structural wall is rigidly connected to the footing through the low-cost energy dissipation system, which is described later (Figure 1).

Figure 1. Elevation view of the isolated structural wall.

The structural wall is reinforced on both faces with steel rebars 8 mm in diameter spaced 150 mm in both longitudinal and vertical directions.

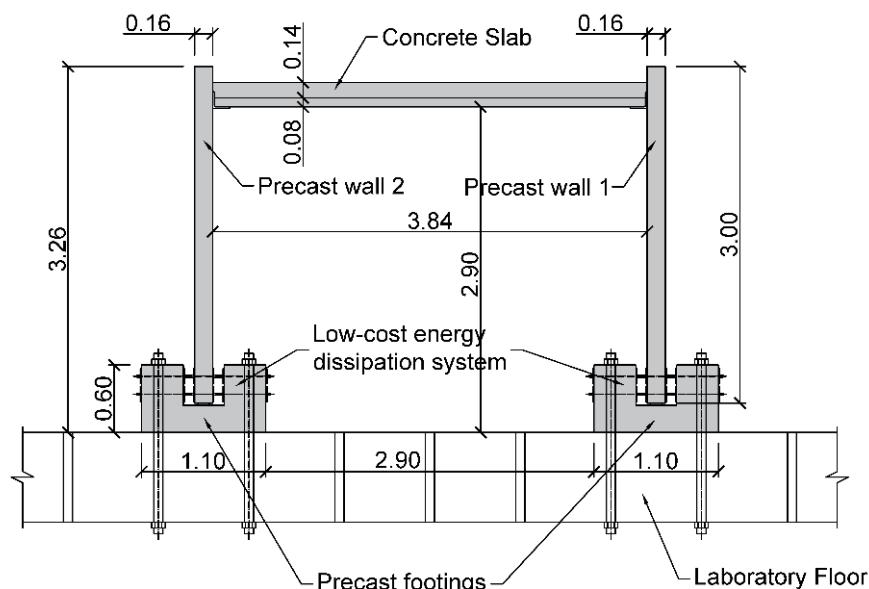
A “flexible” connection between the walls and the slab was used, which is described next. The self-supporting precast prestressed concrete slab rests on a steel corner profile anchored to the walls using a set of mechanical anchorages. Additionally, a row of conventional steel rebars sew the joint between the wall and the cast-in situ slab. The rebars are L-shaped with a length of 800 and 200 mm, respectively. The long leg of the rebar is placed horizontally inside the cast-in situ reinforced concrete slab, while the short leg is placed vertically inside the wall. The diameter of the rebars are 20 mm, with a spacing of 50 cm. From the structural point of view, this connection is very effective under vertical loads, such as self-weight, dead loads, and vertical live loads. Under horizontal loads, similar to the ones caused by the earthquake, this connection is able to withstand negative bending moments, but not positive bending moments, resulting in a semi-rigid joint. (Figure 2).

Figure 2. Elevation view of the structural frame.

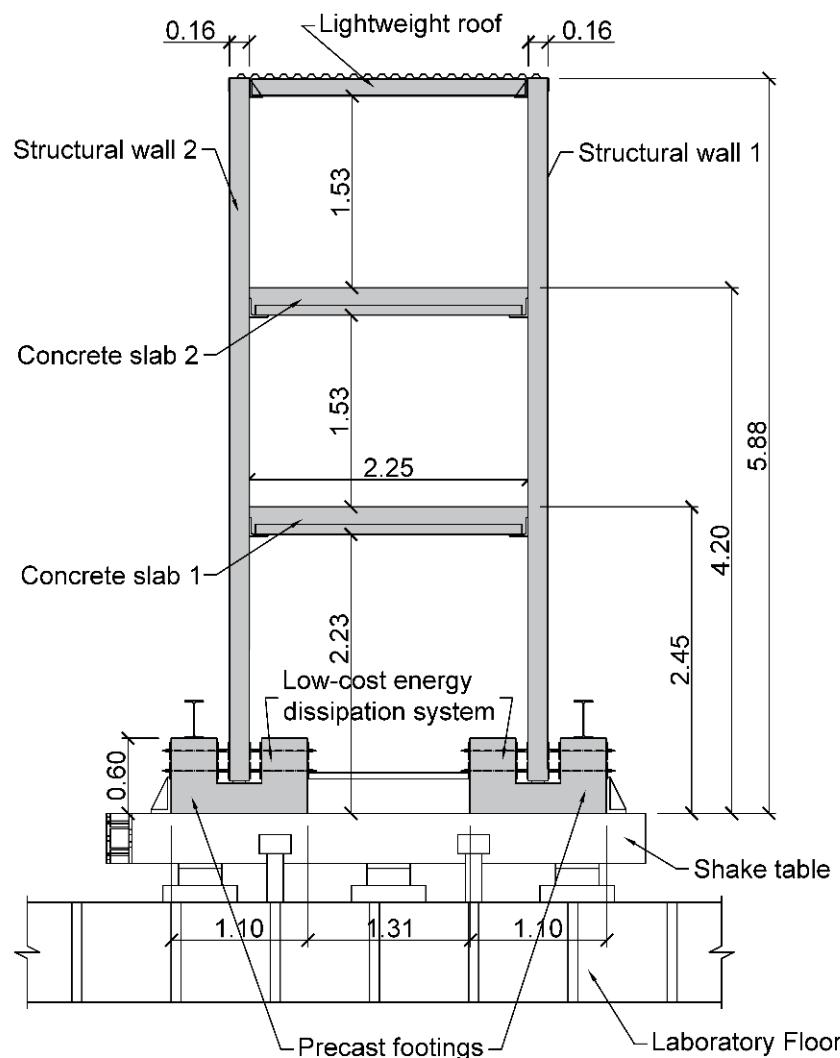
Each of the two concrete slabs is composed of a self-supporting precast prestressed concrete slab with a thickness of 8 cm and an upper layer of 14 cm of cast in situ reinforced concrete. The connection between the slab and the wall is the same as the one described in the previous subsection. The slabs are located at 2.45 m and 4.20 m high. Finally, the roof is located at the top of the walls. It is a lightweight roof formed by an aluminium sheet which is bolted to two I-beams. (Figure 3).

Figure 3. Elevation view of the real-scale three-storey precast concrete building, including the shake table.

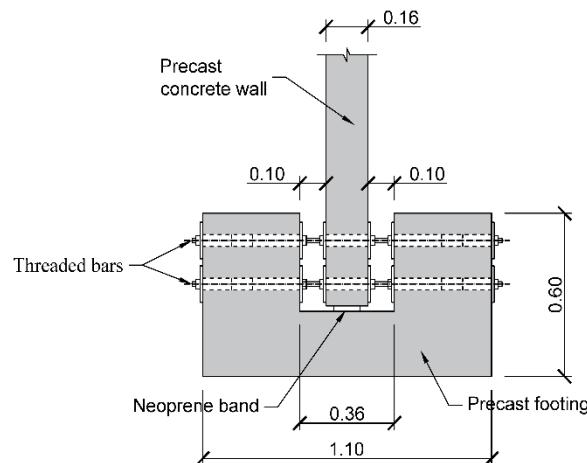
When an earthquake occurs, it is expected that most of the energy is consumed in the plastic deformation of the bars, preventing the rest of the structure from damage. The number, position, distribution, and diameter of the bars, as well as the steel quality must be specifically designed to each particular structure, depending on the dimensions of the structure and the location of the building.

Figure 4. Scheme of the low-cost energy dissipation system.

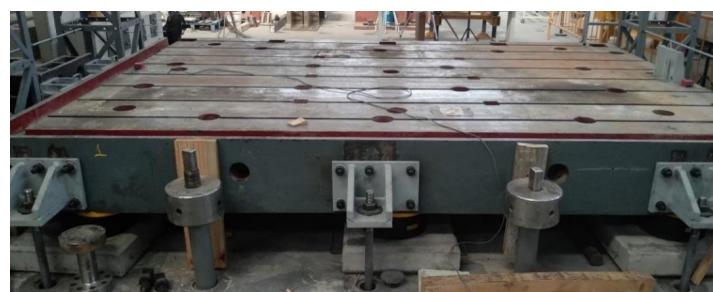
The shake table is composed of a cast steel slab 4.14 m long, 2.87 m wide, and 0.65 m high. It rests on six circular elastomeric bearing pads, reinforced with steel plates. The dimensions of the bearings are 350 mm diameter and 137 mm high.

The seismic loads are applied using a tension-compression MTS 201.70F dynamic actuator (MTS, Eden Prairie, MN, USA), with a capacity of ± 1000 kN. The actuator has a load cell MTS 661.31F-01 (MTS, Eden Prairie, MN, USA), with a range of ± 1000 kN and an error of below 1% of the range. During the testing, the actuator provided a longitudinal displacement. In order to prevent undesirable transversal movements, four stoppers were placed in both lateral sides of the steel slab (Figures 5 and 6).

Figure 5. Shake table.

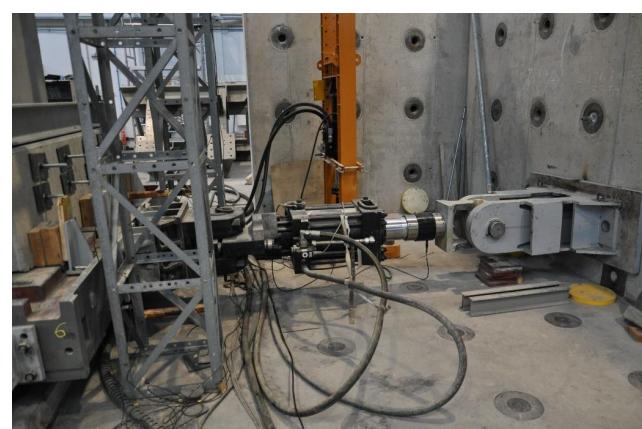
Figure 6. Detailed view of the dynamic actuator.

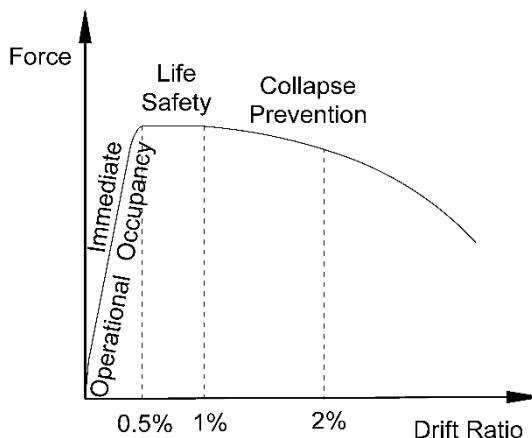
The pushover tests carried out on the isolated structural walls and the structural frames were developed according to the American standard ACI374.2R-13 [34]. According to this standard, four levels of structural performance under seismic events are defined, which are “operational”, “immediate occupancy”, “life safety”, and “collapse prevention”, moving from least to greatest lateral drift ratio (Figure 7).

Figure 7. The four levels of structural performance, according to ACI 374.2R-13 [34].

According to the goal of this research, the “immediate occupancy” level is considered for design purposes, which implies that the building can be used once the seismic event has passed. At this level, the stiffness requirements are high, the behavior of the structure must be within the elastic-linear range and, consequently, the seismic loads developed are important. The standard used does not consider other criteria apart from those concerning structural damage. That is the reason why non-structural issues, such as furniture overturning or partition damage, have not been considered in this research. However, it is worth noting that the “immediate occupancy” level implies a very low risk of life-threatening injury as a result of structural damage.

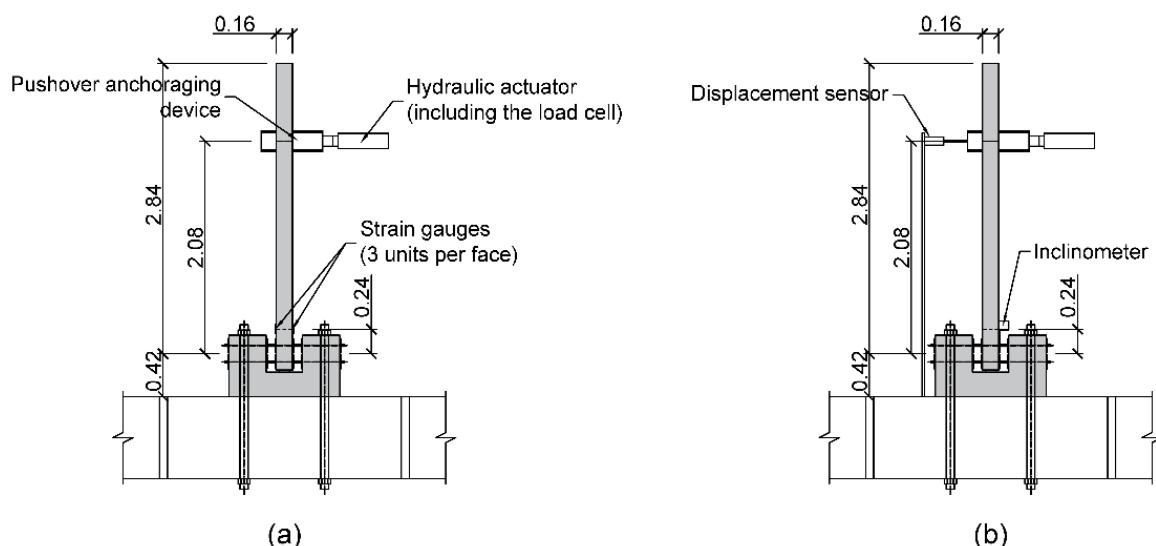
In order to analyze the structural behavior of the testing specimens, a number of sensors were used, including inclinometers (model PST300, Pewatron AG, Zurich, Switzerland), linear potentiometer displacement transducers (ranged from 50 to 500 mm, Novotechnik, Ostfildern, Germany), and uniaxial strain gauges (150 mm length, Tokyo Sokki Kenkyo Co., Ltd., Tokyo, Japan). Figures 8 and 9 show the position of the sensors in each of the two sets of testing specimens, i.e., the isolated structural walls and the structural frames.

Figure 8. (a and b) Location of the sensors in the isolated structural walls.

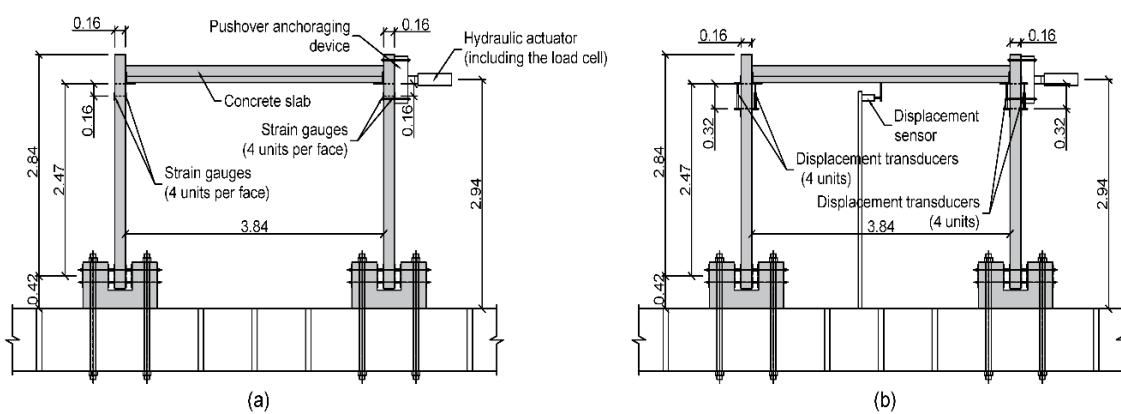
Figure 9. (a and b) Location of the sensors in the structural frames.

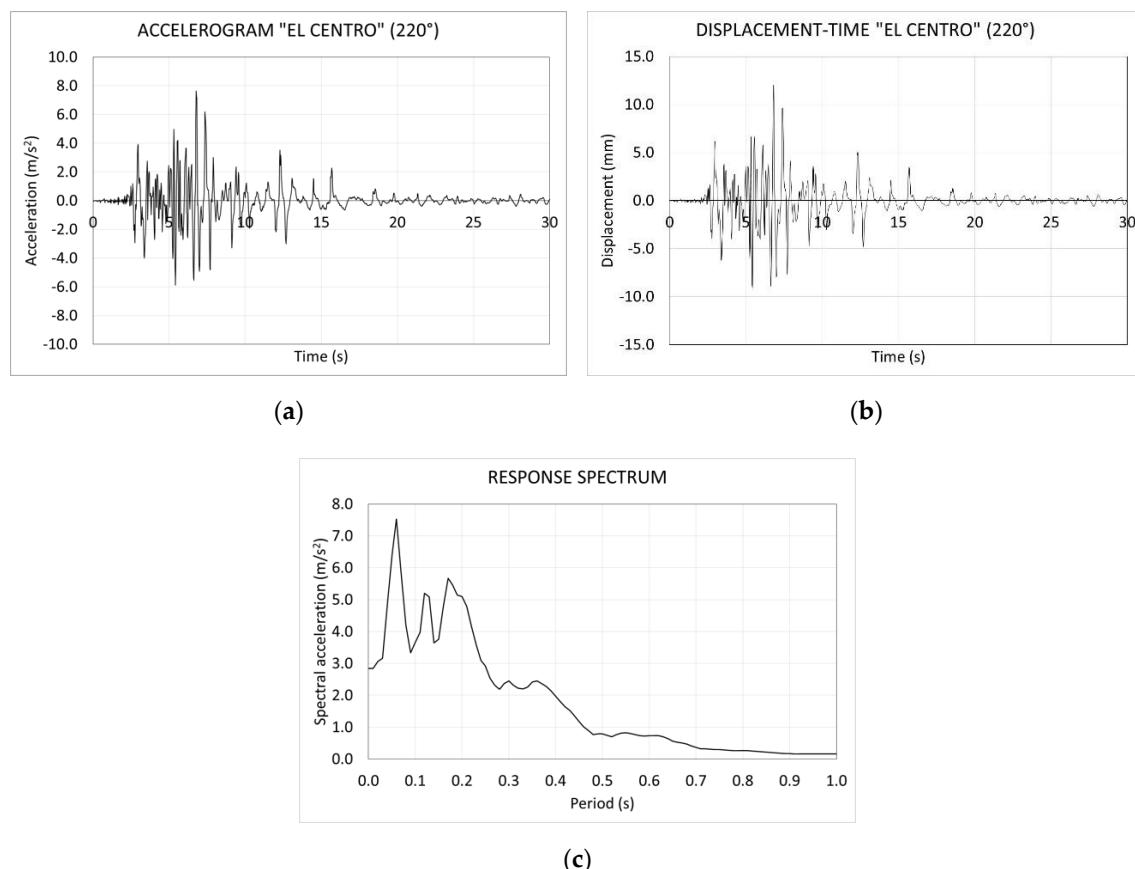
unfavourable in terms on maximum horizontal accelerations. The accelerogram was obtained from the USGS (United States Geological Survey, USA) (Figure 10a).

Figure 10. Earthquake “El Centro”. (a) Accelerogram; (b) diagram of horizontal displacement vs. time; (c) response spectrum.

The accelerogram is first transformed in a diagram of horizontal displacement verus time, which is the input signal introduced to the dynamic actuator control equipment (Figure 10b). Additionally, the response spectrum of the earthquake is shown (Figure 10c).

Figure 10c reveals that this earthquake causes the highest acceleration for structures with a natural period of 0.06 s, i.e., for structures with a natural frequency of 16.7 Hz. However, this earthquake is not only very dangerous for rigid structures, but it also provides acceleration values greater than the ground acceleration up to a period of 0.25 s, i.e., a frequency of 4 Hz.

Additionally, it is highlighted that the natural frequency of the structure is below 4 Hz before the seismic event (Figure 22b), which is the lowest threshold of the dangerous region of the “El Centro” earthquake (see Figure 10c) and no relevant accelerations are developed during the seismic events. Moreover, the loss of stiffness caused by the seismic events reduces the natural frequency (Figure 23b) of the structure and, consequently, reduces the horizontal accelerations caused by the earthquake, which prevents the structure from aftershock earthquakes.

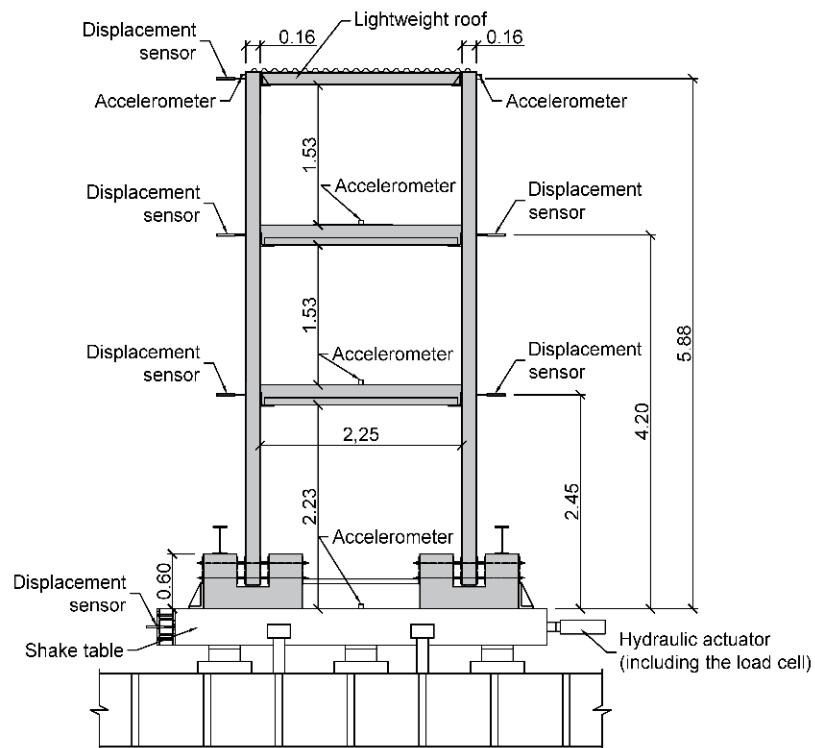
The sensors used to monitor this test were load cell, accelerometers on the shake table, the intermediate slabs at the top of the walls, and displacement transducers in several positions (Figure 11).

Figure 11. Location of the sensors in the building.

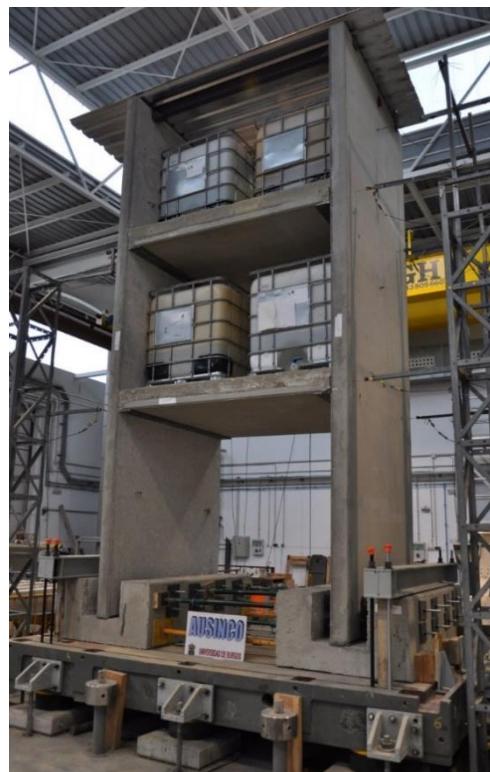
Figure 12 shows a general view of the testing. As can be observed, in addition to the self-weight of the building, a dead load of 1.50 kN/m^2 was included on the intermediate slab. This load was materialized using water tanks.

Figure 12. General view of the real-scale three-storey precast concrete building.

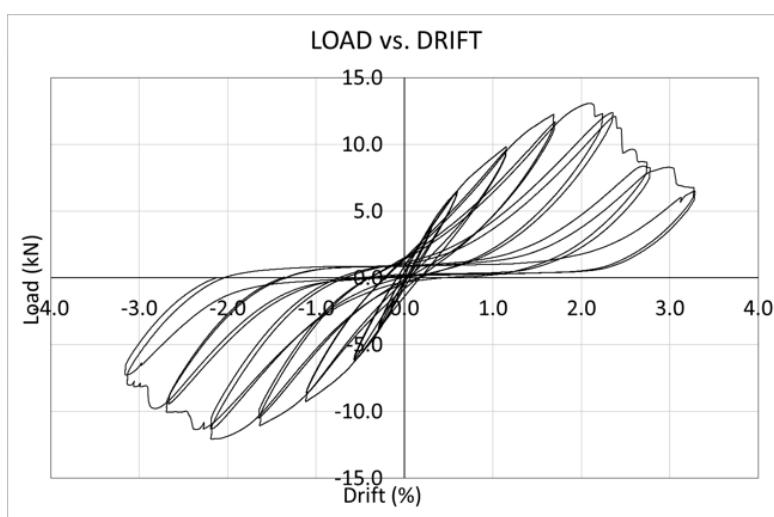
Figure 13 shows the diagram of horizontal load versus lateral drift (hysteresis loops). In this case, positive values mean push, and negative values mean pull.

Figure 13. Diagram of load vs. drift. Pushover test on isolated structural wall.

Some interesting conclusions can be obtained from Figure 13. First, a symmetric behavior under push and pull is observed, as expected. Second, it can be observed that the behavior of the specimen is linear elastic up to the critical drift φ_y (which is 0.5% according to ACI374.2R-13 [34]). In consequence, this solution agrees with one of the requirements of the American standard mentioned above.

Once the drift is greater than 0.5%, a progressive plastic behavior is observed, i.e., the specimen begins to dissipate energy at the expense of a higher deformation. The area enclosed by the hysteresis loop is proportional to the energy dissipated during the testing and represents the structural element capacity to mitigate the earthquake effect inelastically.

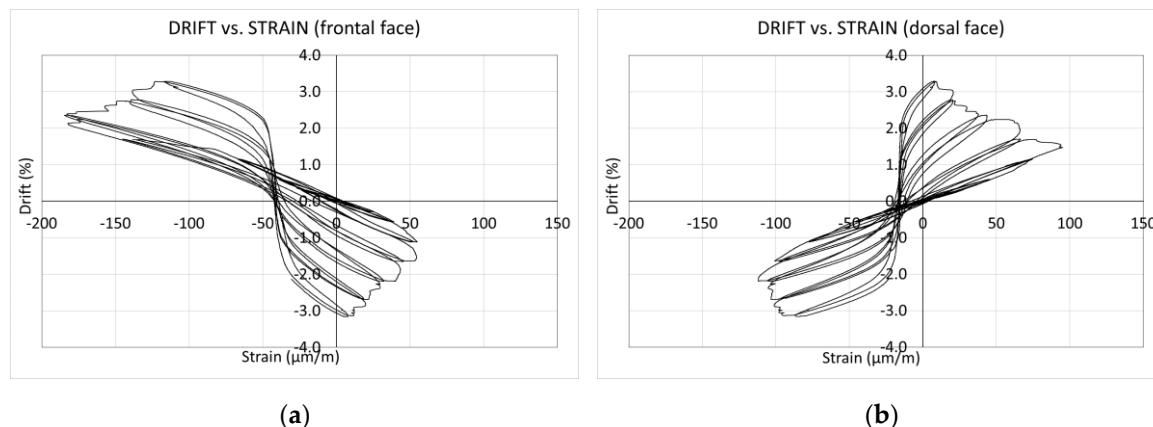
Figure 14 shows the relationship between the drift of the wall and the average vertical strain of the concrete at the base of the wall, at both the dorsal face (where the actuator is placed) and the frontal face (the opposite side). In this case, a positive value of strain denotes tension, and a negative value denotes compression.

Figure 14. Diagrams of drift vs. vertical strain. Pushover test on isolated structural wall. (a) Drift versus strain in the frontal face; (b) drift versus strain in the dorsal face.

Figure 14 shows a linear elastic behavior of concrete through the test, since the maximum measured strain is around 200 $\mu\text{m}/\text{m}$ under compression and 90 $\mu\text{m}/\text{m}$ under tension, which is smaller than maximum elastic strain of concrete (which can be estimated around 1000 $\mu\text{m}/\text{m}$ under compression and 100 $\mu\text{m}/\text{m}$ under tension). This is particularly true for the critical drift φ_y , where the maximum measured strain is significantly smaller (around 50 $\mu\text{m}/\text{m}$ under compression and 10 $\mu\text{m}/\text{m}$ under tension). The results satisfy the ACI374.2R-13 [34].

The measured vertical strain values are in accordance with the visual inspections carried out at the end of the tests, where no visible cracks in concrete wall were observed, and, of course, no concrete crushing occurred.

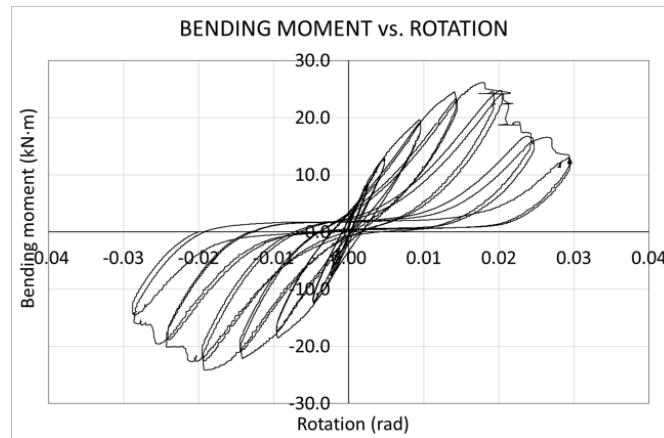
Figure 15 confirms the findings shown in previous figures. On one side, it is observed that up to the critical drift φ_y , the connection shows a linear elastic behavior. The slopes of the curves are high and quite similar under loading and unloading. The area under the hysteresis loop is small, which means that there is no energy dissipation. Additionally, no loss of stiffness is observed.

Once the structure reaches a drift of 2%, a plastic behavior starts to occur. Then, a progressive decrease of the stiffness of the connection is observed. The area under the hysteresis loop gradually increases, which reveals that there is a progressive energy dissipation. In general, a symmetric behavior of the connection is observed.

Figure 15. Diagram of bending moment vs. rotation. Pushover test on isolated structural wall.

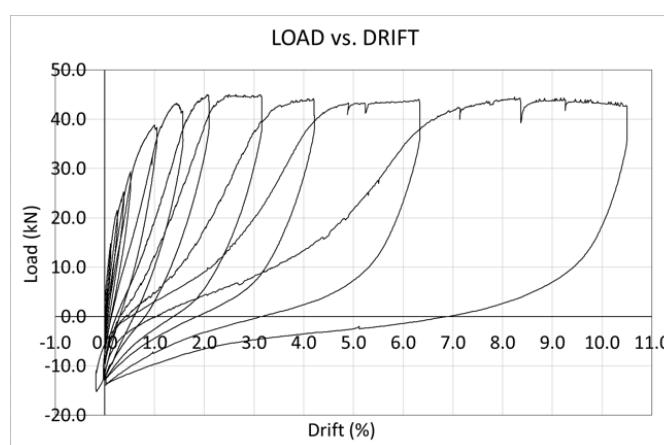
Figure 16 shows the diagram of horizontal load versus lateral drift (hysteresis loops).

Figure 16. Diagram of load vs drift. Pushover test on structural frame.

Some interesting findings can be observed from Figure 16. First, it is highlighted that a linear-elastic behavior is observed until the critical drift φ_y . This result agrees with the American standard ACI374.2R-13 [34]. Once the critical drift is reached, a progressive plastification of the structure

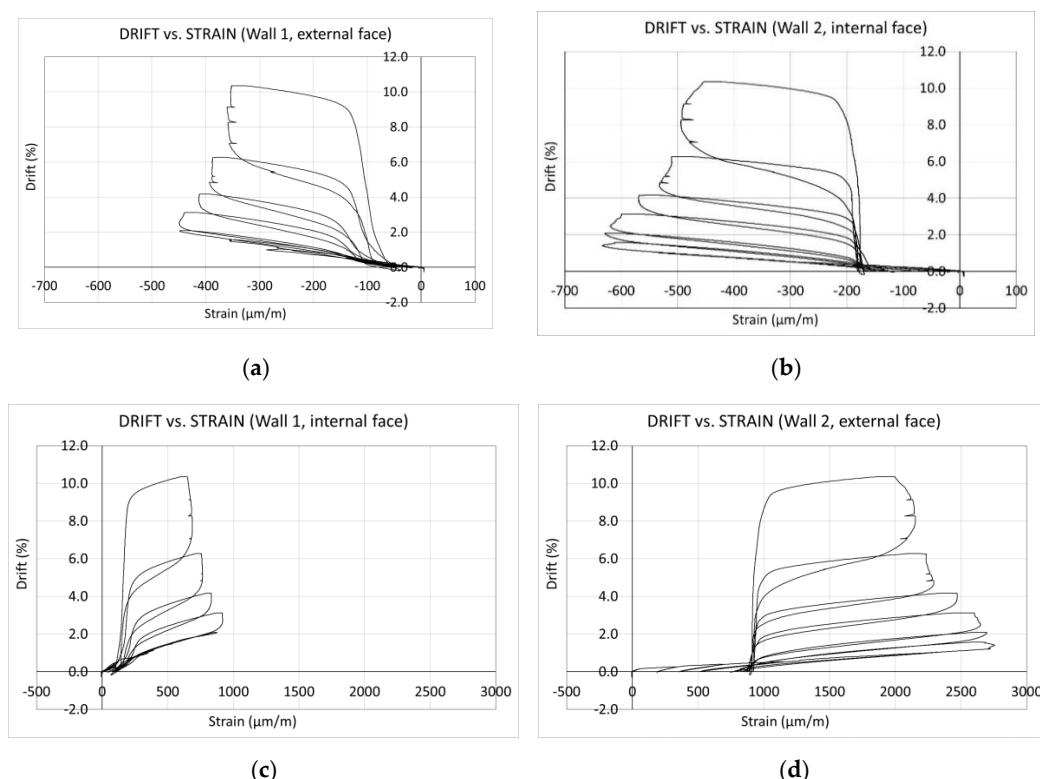
Figure 17 shows the relationship between the drift of the walls and the average vertical strain of the walls' concrete, near but below the connection with the slab, at both the internal and the external faces. In this case, a positive value of strain denotes tension, and a negative value denotes compression.

Figure 17. Diagrams of drift vs. vertical strain. Pushover test on structural frame. (a) Drift versus strain in the external face of wall 1; (b) drift versus strain in the internal face of wall 2; (c) drift versus strain in the internal face of wall 1; (d) drift versus strain in the external face of wall 2.

Figure 17 reveals the behavior of the connection between the slab and the wall. First, a linear-elastic behavior of the connection, up to a drift of 2%, is observed. In Wall 1, the one in contact with the actuator, compression strain is observed in the exterior face, as well as tension strain in the interior face. On the contrary, in Wall 2, tension strain is observed in the exterior face, as well as compression strain in the interior face. In each loading cycle, the loading and the unloading branches are almost identical and the area under the hysteresis loop is small, which denotes an absence of energy dissipation. During this first phase of the testing, the visual inspections revealed very small horizontal cracks in the walls (especially in the external face of Wall 2 where the tension strain was larger) with a crack width below 0.2 mm, i.e., clearly smaller than 1.6 mm which is the maximum allowable crack width defined by the ACI374.2R-13 [34]. No concrete crushing occurred.

Because of the type of loading cycles of the test, the connection between Wall 1 and the slab was always under positive bending while the connection between Wall 2 and the slab was always under negative bending. Wall 1 showed values of strain (both tension and compression) lower than the values observed in Wall 2. This means that the connection shows a stiffness under positive bending smaller than the one under negative bending.

Once the drift was beyond 2%, a clear plastic behavior started to be observed. In each loading cycle, the loading and the unloading branches were different and the area under the hysteresis loop increased with the cycles, which denoted an increased ability of the connection to dissipate energy. In this case, the visual inspections carried out during the testings revealed small horizontal cracks in the walls (especially in the external face of Wall 2 where the tension strain was larger). However, the crack widths were always below 1.6 mm which is the maximum allowable crack width defined by the ACI374.2R-13 [34]. No concrete crushing occurred.

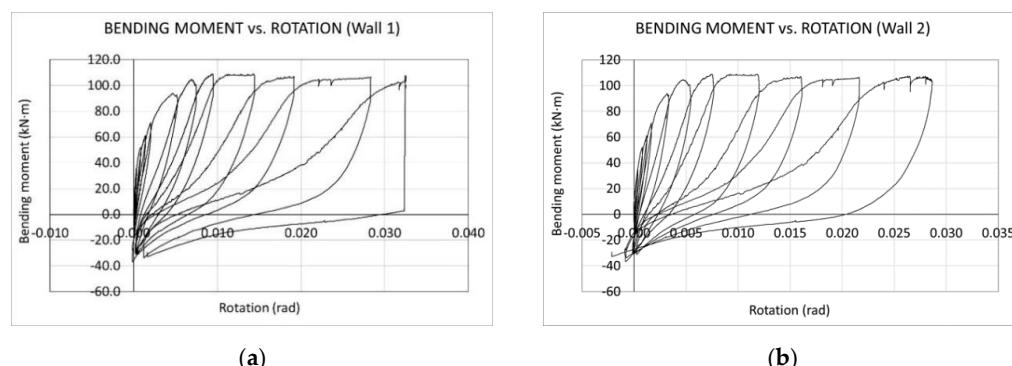
Figure 18 shows the diagrams of bending moment versus rotation of the connections between Walls 1 and 2 and the slab. The bending moment is defined as the product of the horizontal force and the vertical distance between the force and the centroid of the low-cost energy dissipation system. This is, in fact, a “global bending moment” of the frame, and not the real moment of the connection between the wall and the slab. The rotation is defined as the variation of the inner angle between the wall and the slab.

Figure 18. Diagrams of bending moment vs. rotation. Pushover test on structural frame. (a) Bending moment versus rotation of the connection between wall 1 and slab; (b) bending moment versus rotation of the connection between wall 2 and slab.

The behavior observed in Figure 18 agrees with the one shown in Figure 16. The first hysteresis cycles (up to a drift of 2%) reveal a linear-elastic behavior of the connections. The loading and the unloading branches are very similar, and the areas enclosed by the hysteresis loop are very small.

Beyond a drift of 2%, the structure begins to show a plastic behavior. In each hysteresis loop, the slope of the curve bending moment versus rotation progressively decreases, and the area enclosed by the hysteresis loop progressively increases. Consequently, the energy dissipation capacity of the connection between the wall and the slab increases. Additionally, the permanent rotation corresponding to null bending moment increases in each cycle, which denotes that the connection suffers damage in each cycle.

An unexpected behavior is observed during the last cycle in the diagram concerning Wall 1. In particular, there is an interruption of the data capture from rotations around 0.03 rad. This can be

When both connections are compared, it is observed that the one placed in Wall 1 (and consequently subjected to positive bending) shows less stiffness than the one in Wall 2 (subjected to negative bending). This finding agrees with the results of Figure 17. Moreover, the permanent rotation corresponding to null bending moment in the connection of Wall 1 is larger than the one in Wall 2.

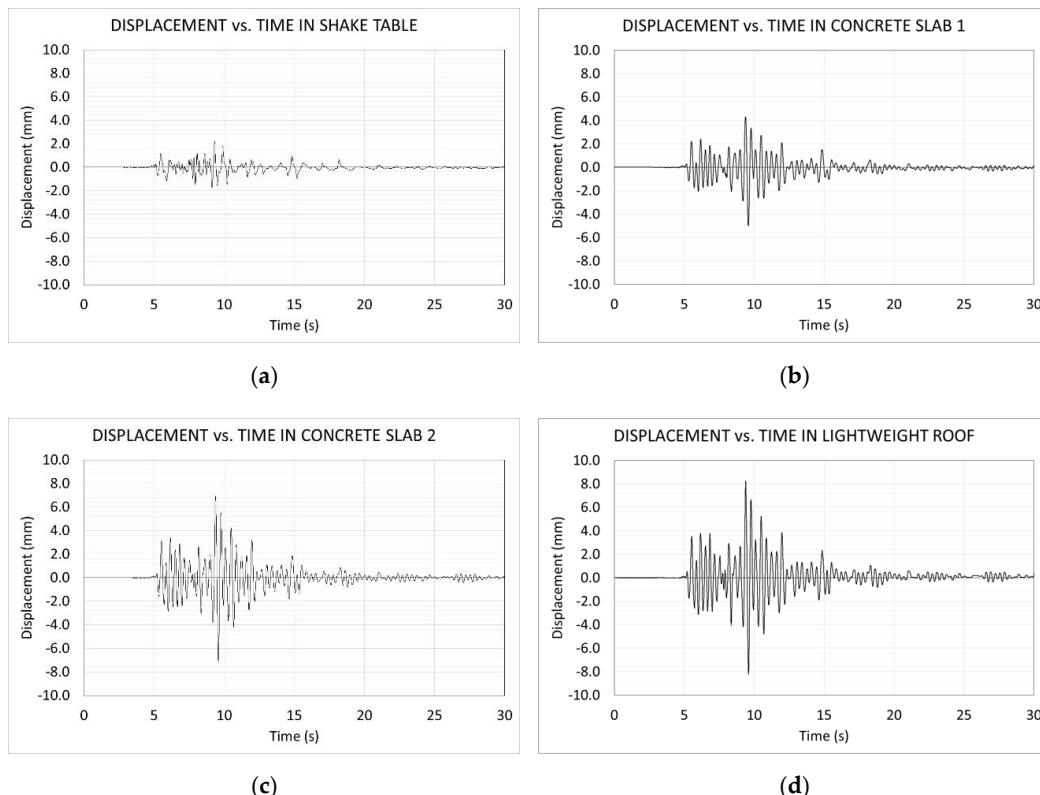
Figure 19 shows the diagrams of the longitudinal displacement versus time during the “El Centro” earthquake at the following locations: shake table, Concrete Slab 1, Concrete Slab 2 and lightweight roof.

Figure 19. Diagrams of longitudinal displacement vs. time at different locations, from shake table to lightweight roof. (a) Displacement versus time in the shake table; (b) displacement versus time in concrete slab 1; (c) displacement versus time in concrete slab 2; (d) displacement versus time in lightweight roof.

Figure 19 reveals some interesting findings. First, a progressive increase of the longitudinal displacement with the height is observed. The measured maximum longitudinal displacements values are 2.18, 4.99, 7.15, and 8.23 millimeters for shake table, Concrete Slab 1, Concrete Slab 2, and flexible roof, respectively. The displacement shows almost a linear trend from shake table to Concrete Slab 2, while the variation is much smaller from Concrete Slab 2 to flexible roof.

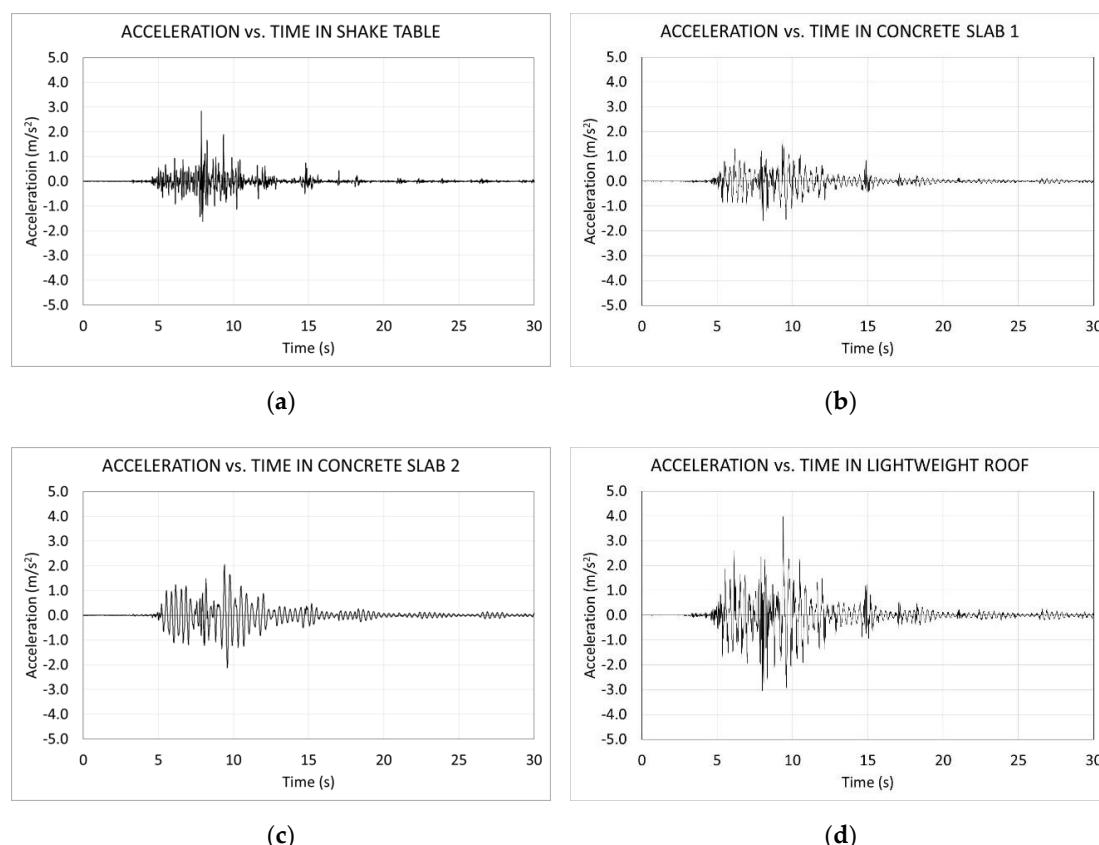
Figure 20 shows the diagrams of the longitudinal acceleration versus time during the “El Centro” earthquake at the following locations: shake table, Concrete Slab 1, Concrete Slab 2, and lightweight roof.

Figure 20. Diagrams of longitudinal acceleration vs. time at different locations, from shake table to lightweight roof. (a) Acceleration versus time in shake table; (b) acceleration versus time in concrete slab 1; (c) acceleration versus time in concrete slab 2; (d) acceleration versus time in lightweight roof.

Figure 20 reveals that this structure is especially resistant to the earthquake “El Centro”, since the maximum measured longitudinal accelerations of the concrete slabs is smaller than the one on the shake table. The maximum measured longitudinal acceleration at the lightweight roof is a bit larger than the one on the shake table. Specifically, the maximum measured longitudinal acceleration is 2.8 m/s^2 on the shake table, 1.7 m/s^2 on the first concrete slab, 2.1 m/s^2 on the second concrete slab, and 4.0 m/s^2 on the top of the building.

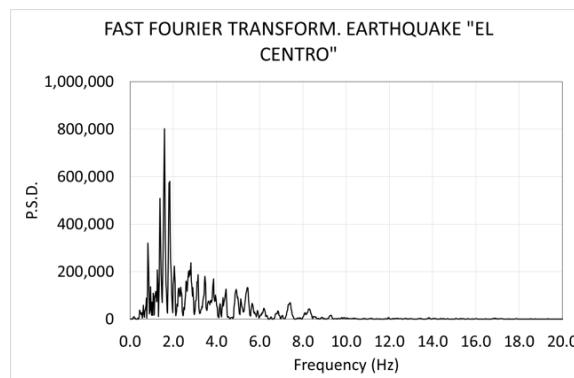
The dominant excitation frequency of the earthquake “El Centro” is around 1.6 Hz (Figure 21), and the natural frequency of the building is around 3.4 Hz before the seismic tests (Figure 22) and 2.6 Hz after them (Figure 23). This large difference between the excitation frequency and the natural frequency implies that the longitudinal accelerations that the earthquake causes in the building are small. Consequently, the horizontal inertial forces are also small, as well as the internal forces caused by the earthquake.

Figure 21. Dominant frequencies of earthquake “El Centro”.

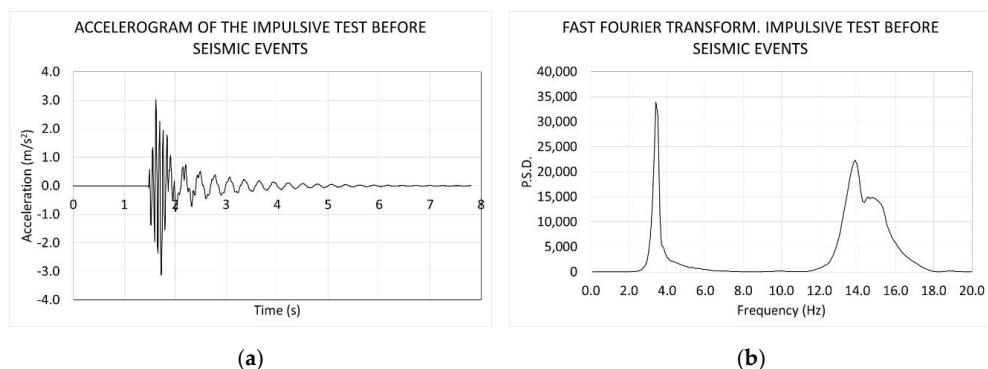
Figure 22. One-cycle impulsive test before seismic events. (a) Accelerogram; (b) fast Fourier transform.

The seismic event results in a reduction of the natural frequency of the building by 0.8 Hz, that is, 23%. Since no concrete cracks were observed, it is concluded that the damage is completely focused on the connections, both the low-cost energy dissipation system and the flexible connections between slab and walls.

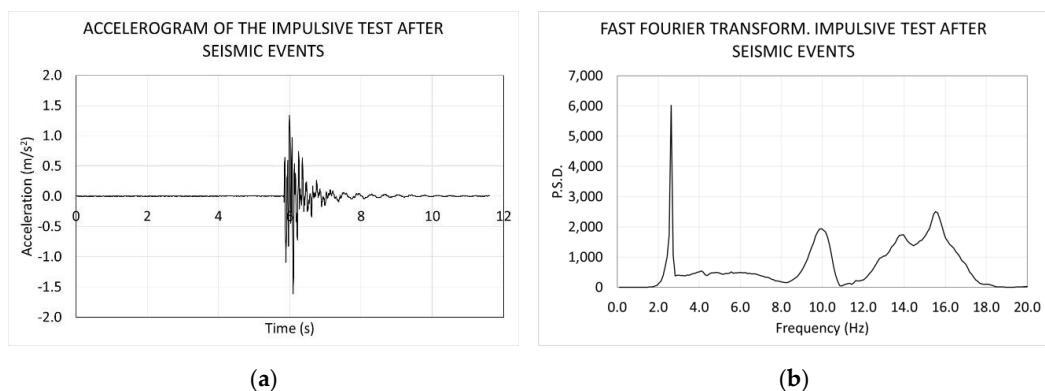
Figure 23. One-cycle impulsive test after seismic events. (a) Accelerogram; (b) fast Fourier transform.

Additionally, the measured damping factor of the building is 4.7% before the seismic tests and 6.2% after them. This increase in the damping factor is also a good indicator of the damage caused by the seismic tests.
