Stabilization Methodology in Foundation Soils by ERT-3D Application in Estepona, South Spain

Featured Application: A non-invasive solution developed to preserve damaged buildings using an injection of cement grout in the soils to stabilize it.

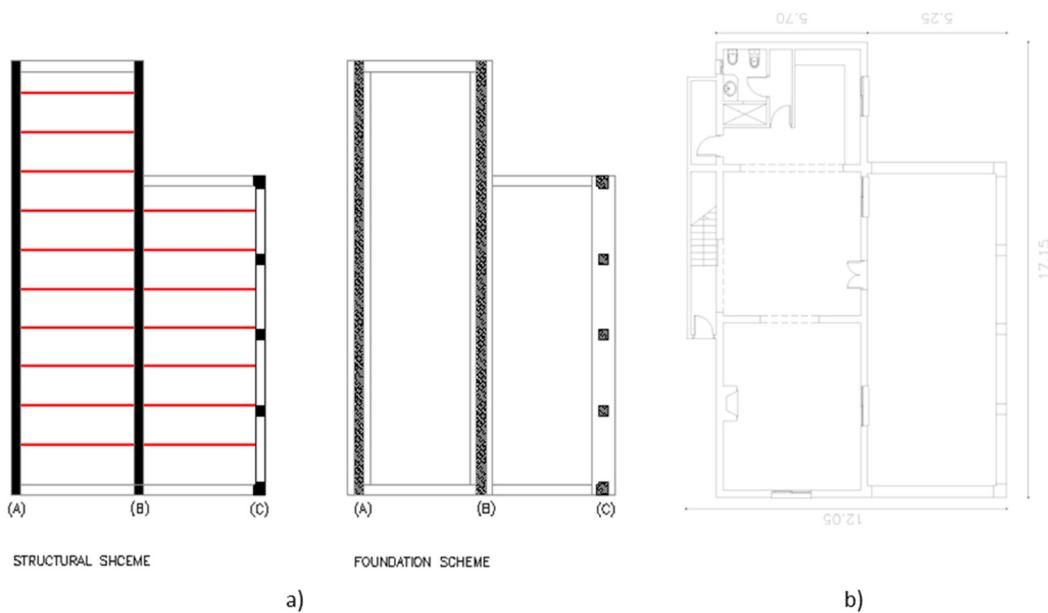
Figure 2. (a) Structural scheme of the damaged building, formed by three load-bearing walls, A, B, and C, and forged of semi-resistant joists, 24 cm thick. Building foundation scheme formed by three parallel, longitudinal shallow foundations (A, B, C), where the load-bearing walls rest and transmit the structure's weight. (b) Floor plan of the distribution of the damaged building in the slope.

According to current urban regulations, the rural house examined in this study would be difficult to demolish and rebuild. Therefore, a major challenge to this research and methodology was finding a solution to recover the building without having to demolish it. The main building in this study was a rectangular two-story building, 17.15 m long and 12.05 m wide, with a surface area of approximately 206.66 m² per floor and a total building area of 413.32 m² (Figure 2).

This was a residential building and was used as a rural house (country holiday house); hence, guest and owner safety was paramount. The distribution comprised two building components: two floors, with an open area on the ground, and an upper, noble floor (Figure 2). Both the main building and the entrance foyer were designed in the late 1980s and completed in the early 2000s. The building's structure consisted of load-bearing walls and solid brick pilasters on the façade's main porch (vertical structure); these rested on a shallow foundation base of a reinforced concrete simple wall footing, formed by three parallel simple wall footings (A, B, C) (Figure 2). The horizontal structures of the building were 24 cm thick unidirectional slabs formed of semi-resistant joists, supported in three spaces by load-bearing walls and pilasters resting on a shallow foundation composed of three longitudinal foundations in a trench.

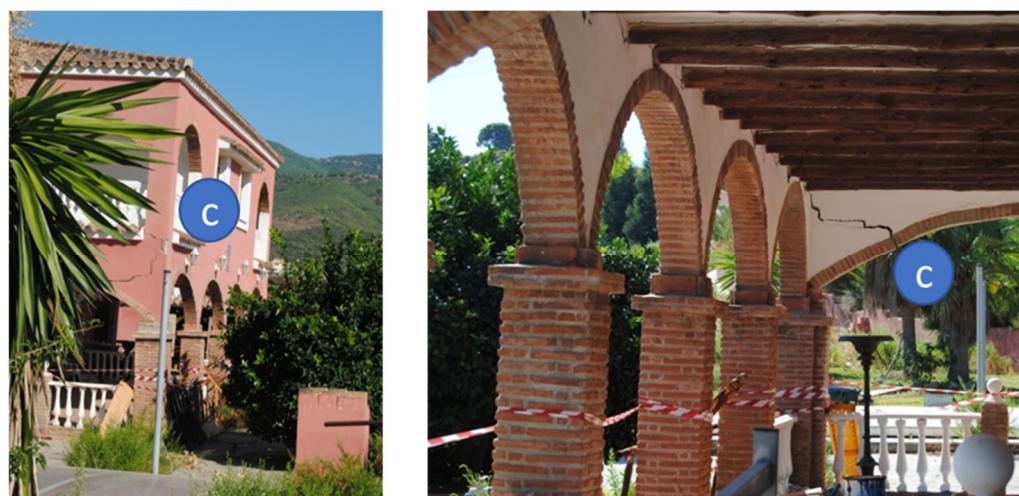
Figure 3. The building's state of conservation in April 2012, after the movement of the subsoil and its shallow foundation. (C—see Figure 2 for reference) Structure of load pilasters and semi-circular arches, a structure that has suffered a decrease in its foundation with respect to the foundations of the load-bearing walls (B) and (A) on Figure 2. This has caused the building to deform and rotate forward.

From the previous geotechnical and structural analysis of the building illustrated in Figures 2 and 3, a problem of support in the foundation for differential seats was deduced.

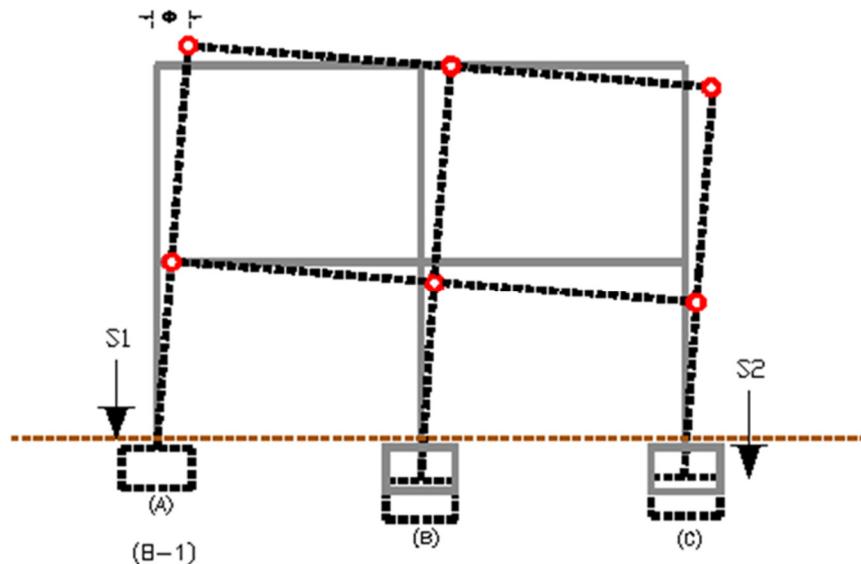
Figure 4. Cross-section scheme, presenting the likely behavior of the building's foundation and structure. There was a differential settlement of the S_1 and S_2 foundations due to a possible settlement-removal of the soil and the lack of bearing capacity of the resistant subsoil. Displacement occurred through the variable $\Phi = 95$ mm, which is the depth B and C have descended, with respect to A. The seat of the foundation for wall A (S_1) has lowered a depth of 25 mm, remaining within the admissible limit according to the Spanish Building Technical Code (CTE).

Of the A, B, and C foundations, B and C had become unstable (sunk downward) with respect to A (Figure 4). This phenomenon caused the building to swing forward, which caused serious damage to its structure, as can be seen in Figure 4. The foundation of wall A also suffered a small movement in its seat (S_1) (Figure 4).

Due to the type of movement and structural typology, displacement occurred as shown in Figure 4. When load-bearing walls deform, they collapse, and destruction of the building becomes a major threat.

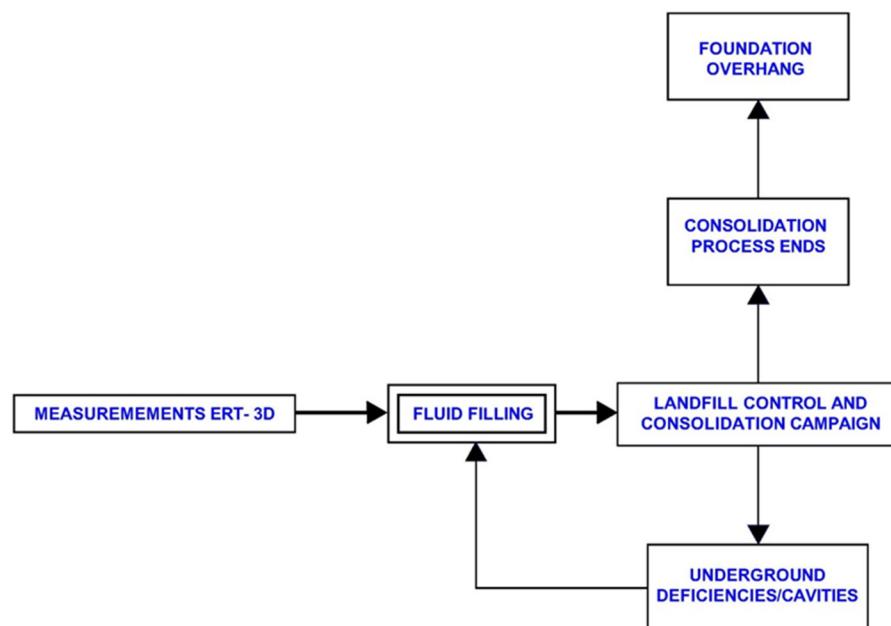
Figure 5. Block-flow diagram, showing the phases and methodology developed for intervening with the subsoil under the foundations of buildings with differential settlements.

The second phase of the proposed procedure (Figure 5) intended to obtain uniformity of chemical and physical features in the stabilized subsoil [65,70,86] until the desired goal was reached. As shown in Figure 10, the contrast tomography gave a favorable result after the cement grout injections were applied. The resistivities up to $3000 \Omega \text{ m}$ that caused distortions (cavities), affecting the stability of the building in Figure 8, were generally reduced drastically, even at values below $55 \Omega \text{ m}$. This means the anomalies and stability issues of the building were resolved. In this way, the affected building could be recovered, and demolition avoided.

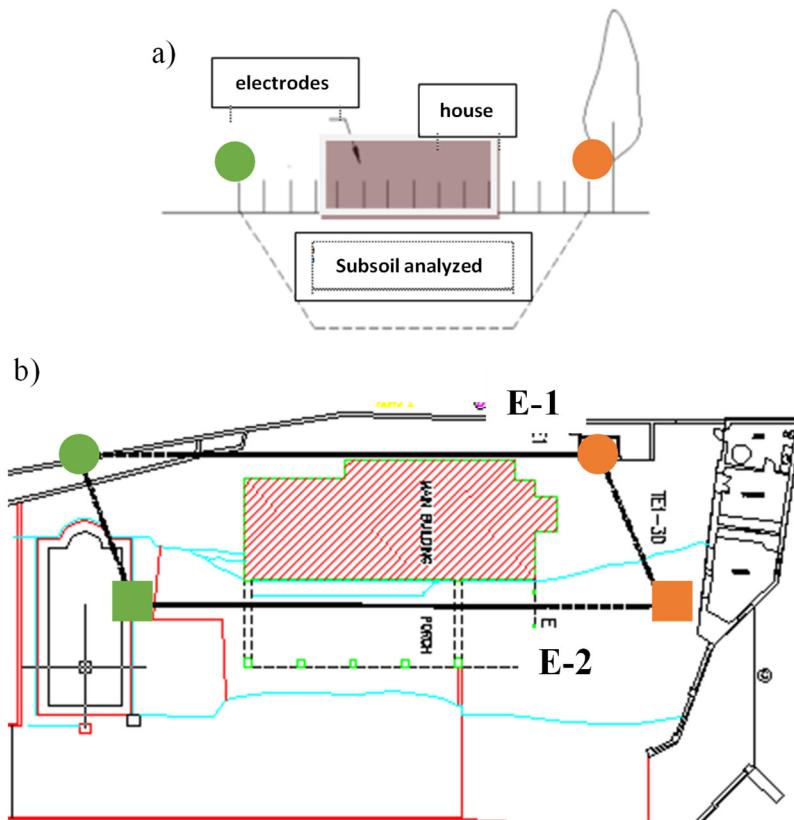
Figure 6. (a) Longitudinal scheme of the methodology and installation of the electrodes at 0.80 m in the building (house), as well as the subsoil analyzed with ERT -3D. The analyzed subsoil has a depth of 5.80 m, which corresponds to levels I and II of the geotechnical layers detected. (b) ERT -3D (TE1-3D) delimited tomography surface, covering the main building's foundation structure, within the parallel profiles proposed: E1 and E2. Circles refer to the E1 profile, while squares refer to E2; orange refers to the initial UTM coordinates, while green refers to the final ones (Table 3).

In the developed methodology, two parallel profiles (E1 and E2) were selected, covering an area of approximately 240 m², which included the main affected building area in accordance with Figure 6 and Table 3. The electrodes were placed in parallel.

In the application of our methodology, two electrical profiles were made, E1 and E2 (Figure 6), an upper part of approximately 3.90 m thick was defined for E2 (wall B) and 2.00 m for E1 (wall A) with high resistivity, ranging from 500 to up to $3000 \Omega \text{ m}$. This section corresponded to the colluvial material (porous) that covers the metamorphic rock (phyllites). Under this lithology was the rocky matrix, formed by altered phyllites with less resistivity, of the order of $55 \Omega \text{ m}$. The upper colluvial material, which was in contact with the underside of the building's footings, showed a significant degree of alteration, which means a high resistivity (from 1000 to up to $3000 \Omega \text{ m}$). However, the resistivity values were quite variable within this mass of colluvial material, and this is linked to two causes:(1) lack of compaction and (2) presence of gaps and cavities in the subsoil where the foundation of the building supported, which coincided with the levels I and II altered. These data confirm the instability results of the shallow foundation of the building. The building's final state, after the application of this methodology, is shown in Figure 11.

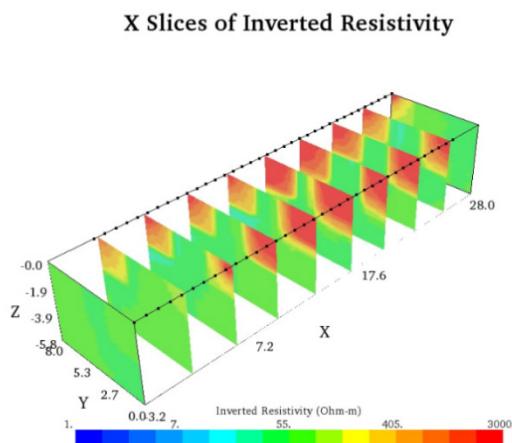
Figure 7. Advanced inversion algorithm of 3D synthetic data (RES3DINV software). Electric Ground Section ERT-3D: cross-section diagram of the ground, with the probable behavior of the soil and foundation. Cross-section scheme, with the likely behavior of the soil and foundation.

Figure 7 shows a 3D electrical resistivity model from the studied terrain and the depths reached, in this case, up to 5.80 m depth. Both profiles show resistivity values represented in a range of colors for better and easier observation of the variations in subsoil vertical and horizontal resistivities. Zones with resistivity values between 0–55 Ω m corresponded to levels of clay or colluvial material, represented in green; zones between 55–1000 Ω m, shown in orange, corresponded to fillings or colluvium removed with low compactness; and resistivity >1000 Ω m, in red, indicated anomalies due to the presence of interstitial gaps.

Figure 7 shows resistivity anomalies presented in slices of subsoil supporting the foundation of the damaged building. The red color shows a higher resistivity value, up to 3000 Ω m, which suggests that there are cavities causing the resistivity to rise. From the obtained resistivities, combined with the geotechnical data (SPT standards) [85,86], the physicochemical properties of geological materials can be determined.

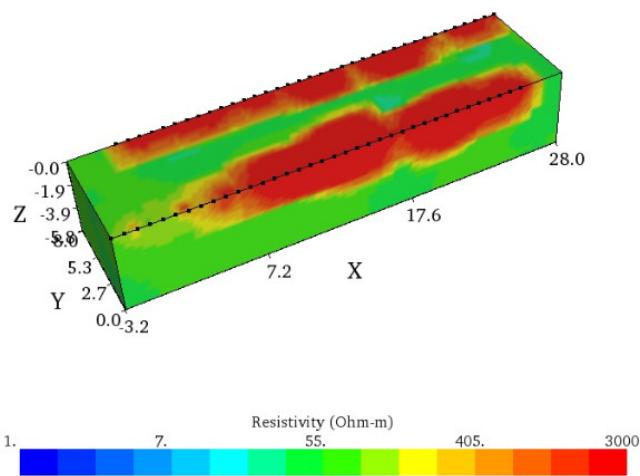
Inverted Resistivity Image

Figure 8. Volume plot rendered for the subsoil model of the building analyzed with topography included results of 3D inversion of electrical resistivity tomography over the whole survey area. On the left, view from the south, and on the right, view from the north.

mary, according to the algorithm developed in Figure 6, the first phase of the tomographical campaign was carried out, by analyzing the resistivities of the subsoil supporting the building and considering previous data, including the initial geotechnical data. Anomalies and areas with low compaction and/or gaps were identified and isolated in ERT-3D for the building's main load-bearing walls (Figure 8), so this knowledge might be acted on in the future.

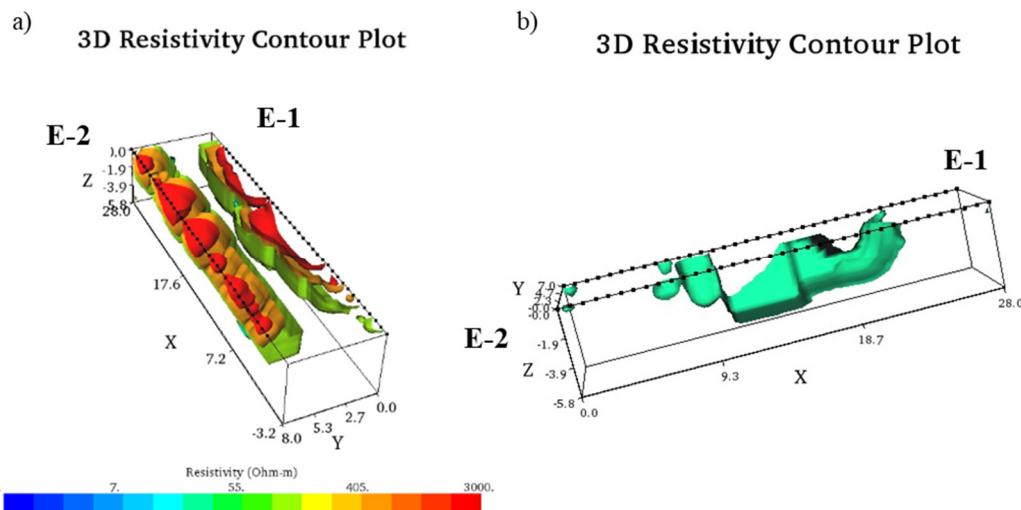
Figure 9. Example of a 3D survey using the offset dipole-dipole: (a) resistivity contour plot by anomalies. Scheme obtained through ERT-3D. (b) Resistivity contour plot by anomalies. Isolation of areas to be treated with soil consolidation grout using RES3DINV software.

Given the powerful information about the subsoil under the building's main load-bearing walls, the second phase of this methodology was proposed: consolidation injections into the subsoil for those detected anomalies (flow diagram, Figure 5). Figure 9 isolates the areas to be treated with injections via the RES3DINV investment program.

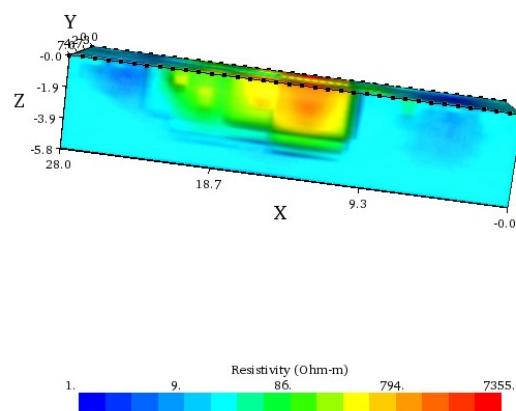
Inverted Resistivity Image

Figure 10. Results of 3D inversion of electrical resistivity tomography over the whole survey area. On the left, view from the south, and, on the right, view from the north. Contrast tomography after the consolidation injections in the subsoil.

The proposed intervention methodology is, therefore, highly effective in buildings damaged by settlements in shallow foundations, due to a deficient stress capacity of the subsoil, in this case by a removed anthropic fill. In this case study, a building on the verge of collapse, was recovered. Figure 10, showing the tomography performed after consolidation injections, indicates that up to $3000 \Omega \text{ m}$ resistivity anomaly areas have disappeared and left the building's subsoil consolidated and stabilized.

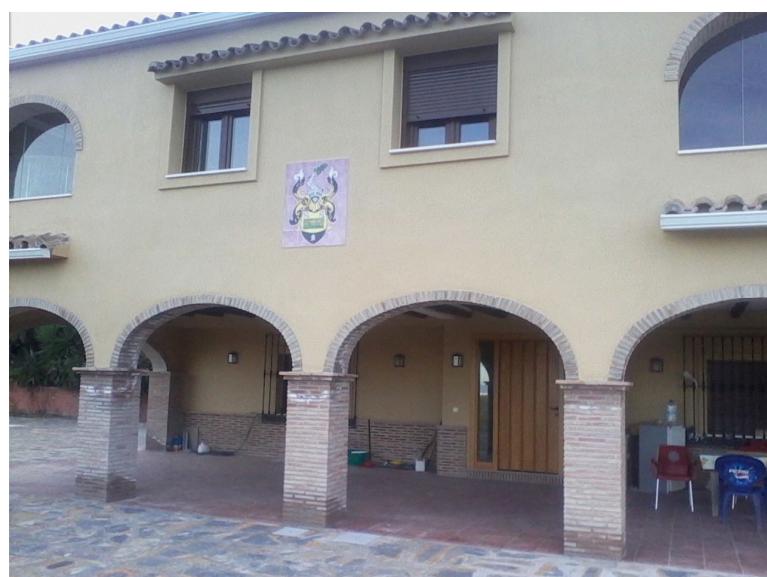
Figure 11. Current state of the main building. Image taken after the intervention and application of the methodology. Had this methodology not been used, the only solution would have been demolition of the building.
