# A Conceptual Design Approach for Archaeological Structures, a Challenging Issue between Innovation and Conservation: A Studied Case in Ancient Pompeii

Vincenzo Calvanese and Alessandra Zambrano \*

Ministry of Culture, Pompeii Archaeological Park, 80045 Pompeii, Italy; vincenzo.calvanese@beniculturali.it

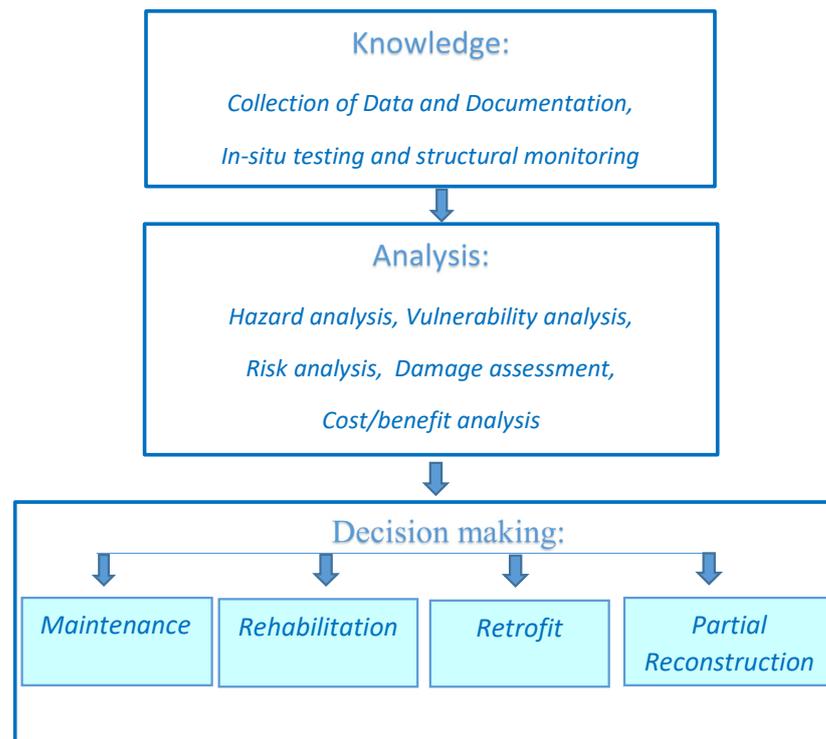
**Figure 1.** Design process on a historical building.

The structural design of cultural heritage artifacts is conditioned by several constraints: the need to preserve the authenticity of the historical fabric, the presence of decorative surfaces that need to be protected, the existing damage level, the expected benefits and improvement in the structural behavior due to the rehabilitation works, the planned building use, and the time period between two planned consecutive maintenance interventions. The decision making process is clearly articulated, and can be summarized as shown in Figure 1.

Preliminarily, information regarding the material fabric and the construction technique and dimensions of the structures is needed. A measurement survey, experimental testing, studies of previous restoration work documentation, and a hazard analysis to understand the hazards associated with the potential actions are fundamental steps. Then, a structural model permits reliable vulnerability and damage analyses to be performed. The design involves a decision making process, where each possible design solution implies a certain level of intervention, and consequently a corresponding level of safety. Herein, four levels of intervention for archaeological structures have been identified: maintenance, rehabilitation, retrofit, dismantling and reconstruction (generally partial reconstruction).

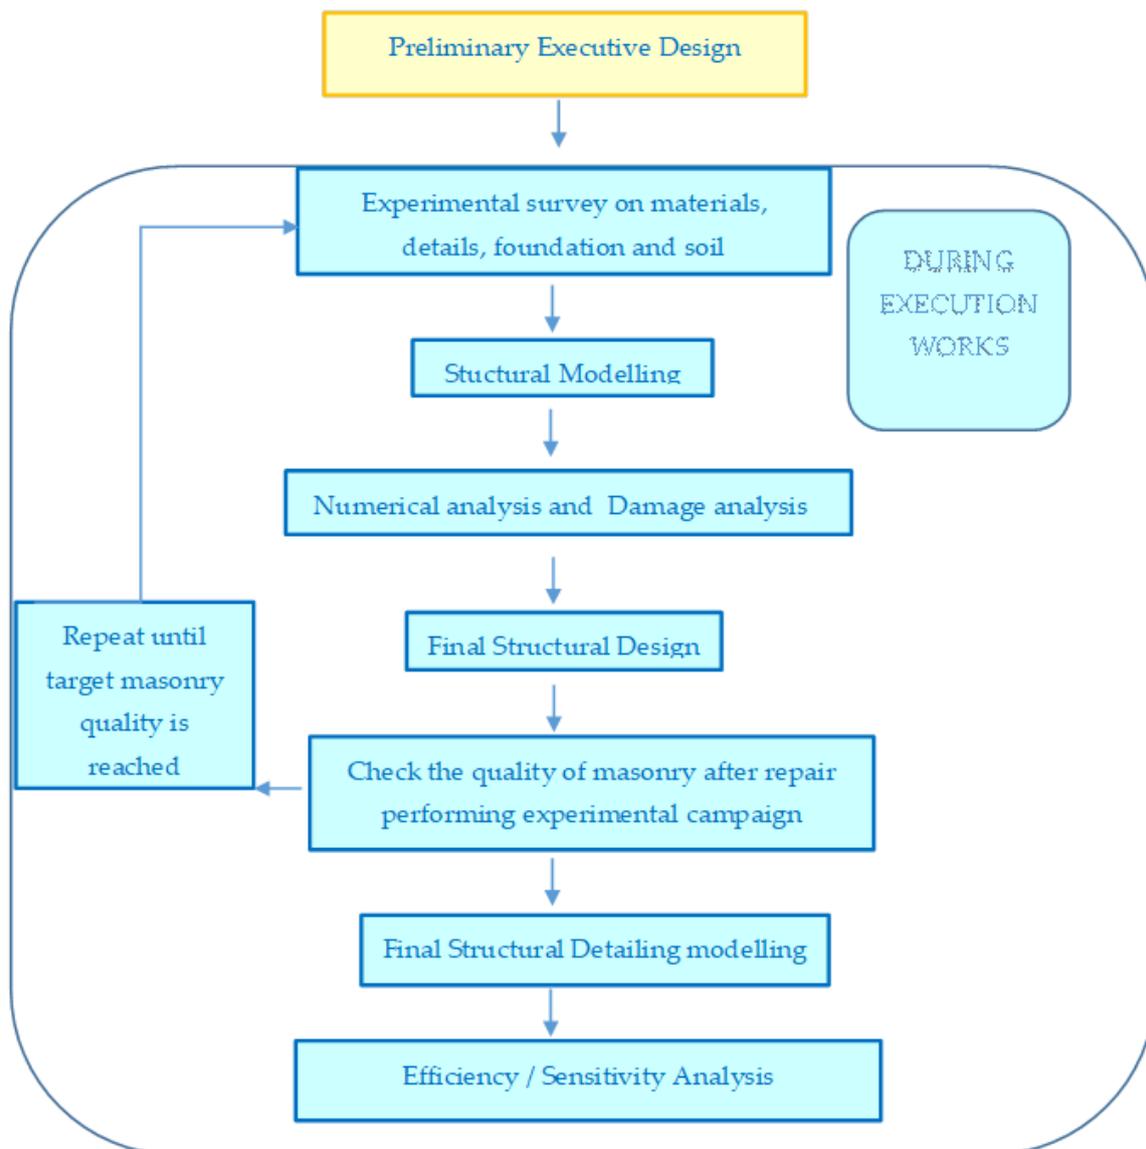
**Figure 2.** Design procedure on masonry structures at archaeological sites.

In the flow chart in Figure 2, as a first step, a preliminary campaign, a literature review and documentation studies yield a preliminary executive design. Then, after rehabilitation works, but still under construction, a second experimental campaign permits the weak points of the structure to be shown and the design of localized repairs where the rehabilitation works have been less effective. This is an interactive process until the target rehabilitation level is reached. Consequently, the final structural details are defined as soon as a target quality of the masonry is obtained, and the efficiency of the connections is proven with experimental testing. The final structural model then allows for a sensitivity analysis to be performed and to check the efficiency of the repairs and of the proposed solutions.

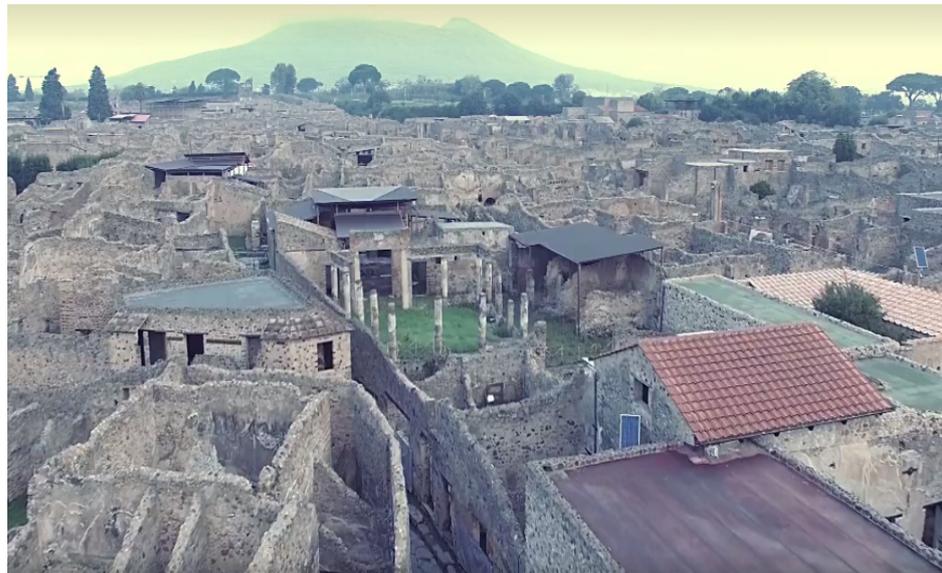
**Figure 3.** The aggregate of Championnet houses before restoration.

The proposed design approach was applied in the rehabilitation project design of the aggregate of Championnet houses, in the ancient city of Pompeii, Italy. This part of the city of Pompeii was subjected to extensive rehabilitation works in the period 2015–2017 inside the project *Grande Progetto Pompei*. Figure 3 presents the area before the restoration and rehabilitation works.

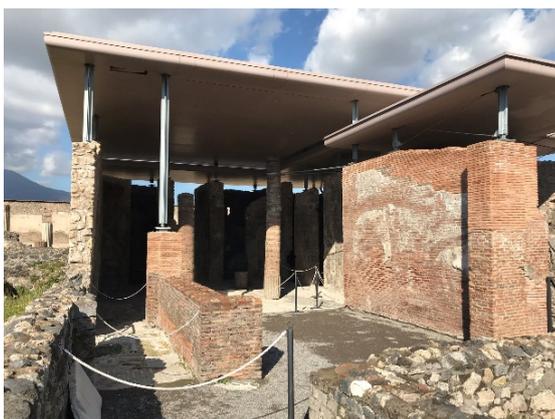
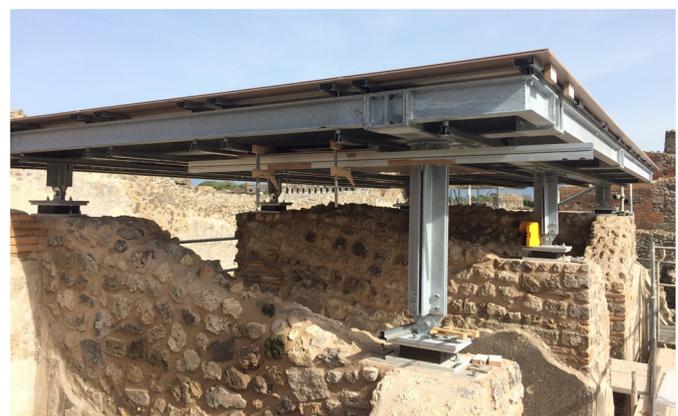
**Figure 4.** The new roof in the Championnet area. (a) View of the new roof. (b) Steel structures before coating.

In order to preserve the ancient decorative surfaces, a new roof, characterized by a steel structure and Corian slabs, was built over the ancient masonry walls as shown in Figure 4. These design decisions were conditioned by the presence of some precious mosaic decorated floors that needed protection, and their extensions did not allow for the design of a roof standing on a separate structure, which would be too invasive in the archaeological space. The extensive damage level and the limited thickness of the walls have gained great attention in the design of the rehabilitation works. Following the proposed design approach in Figure 2, the final design was reached after four extensive testing campaigns, before and during the execution phase. In the following, the experimental campaigns, the model, the performed analysis, and the design solutions are discussed.

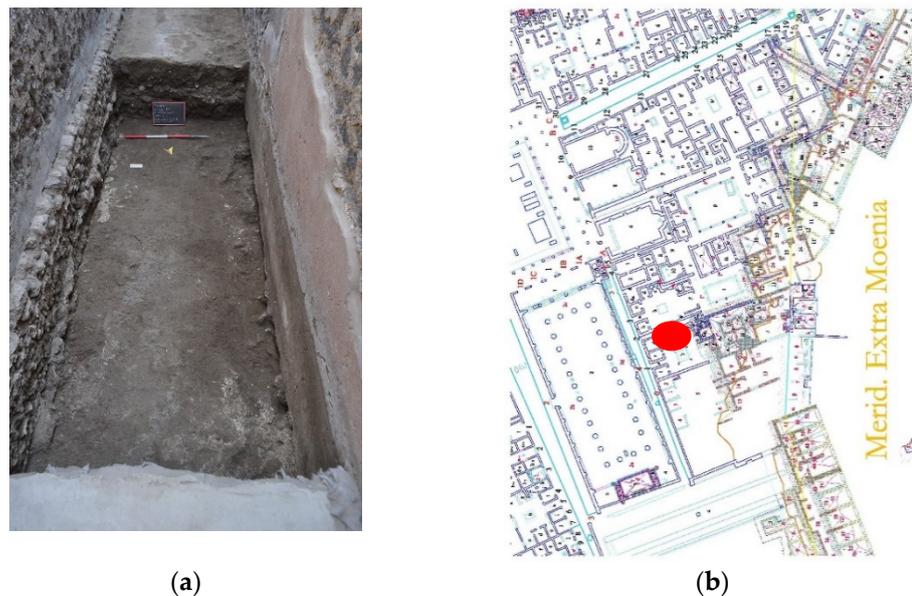
**Figure 5.** Foundation. (a) Excavation at *Regio VIII*. (b) The localization of the excavation (reported in red).

foundations had underground walls that were thicker 0.30–0.40 m more than the ones in the upper part, and with a more intact and less degraded structure. The excavations revealed that the foundation was not deeper than one meter from the soil surface. The dimensions and depth of these foundations make the structures vulnerable to static and seismic load. For these reasons, the structural skeleton of the new roofs placed on the ancient masonry walls was made of light materials in order to do not overload the thin foundations and the bearing soil of these ancient structures. Figure 5 shows an excavation to reveal the foundation.

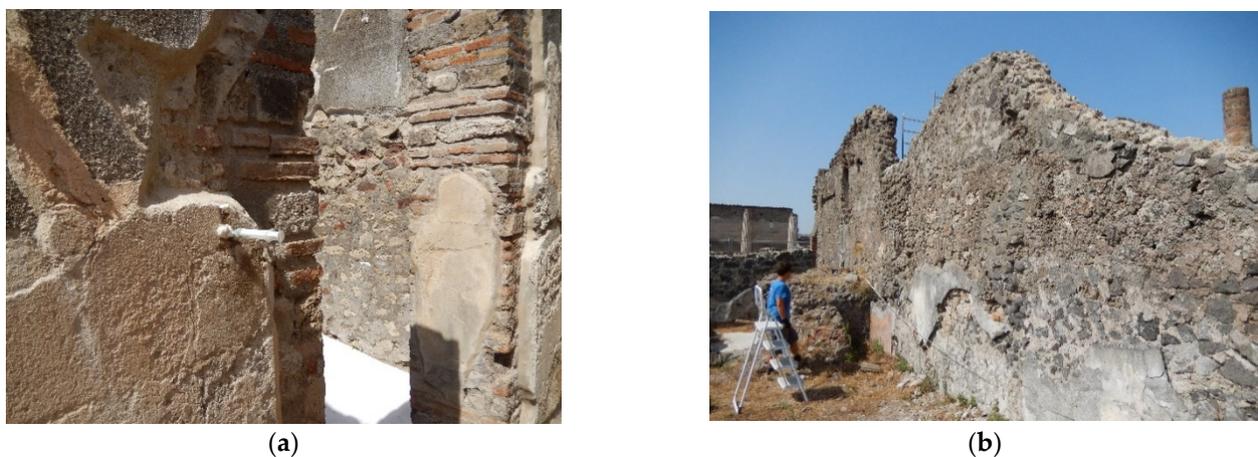
**Figure 6.** The masonry walls in the Championnet area. (a) A sample of the variety of masonry walls. (b) A long structural masonry wall before rehabilitation, with evidence of the alveolation and damage.

Most masonry walls are of the type “*opus incertum*”, made of irregularly shaped stones with a more or less flat face. The stones used in the masonry were bound together with mortar. The smaller pieces were added between one stone and another. The whole wall was then sprinkled with a pouring of liquid mortar that was able to expand throughout the masonry. In some walls, the masonry structure is of the type “*opus vittatum*”, which constitutes bricks and small blocks (called “*tufelli*”). Sometimes, bricks are located in the edges and corners.

The chemical-physical characteristics and damage are extensively varied in the masonry walls, affecting stone elements and mortars. The masonry deterioration concentrated, especially in the first meter in height, even with the loss of elements (ashlar and mortar). In general, rain water and wind erosion have caused the most loss of material. The damage processes are related to the absorption, flow, and stagnation of rain water. In particular, the tops of the walls are subjected to degradation due to the erosion and the breakup of large tracts. Damage is often determined by the nature of the mortar; whenever the mortar is made up of a volcanic aggregate with a variable size of 3–4 cm lithic clasts and fine sands mixed with a low lime component or other binder, this composition made the mortar very vulnerable. The volcanic nature of the aggregate involves the absorption of rain water and the rapid saturation of the top of the walls. This imbibition process leads, over time, to consistent loss and erosion, especially at the top of the walls. In particular, the water absorption of the stones/bricks and the mortar of the walls yield desegregation, with consequent swelling, fracturing, and breaking of the masonry.

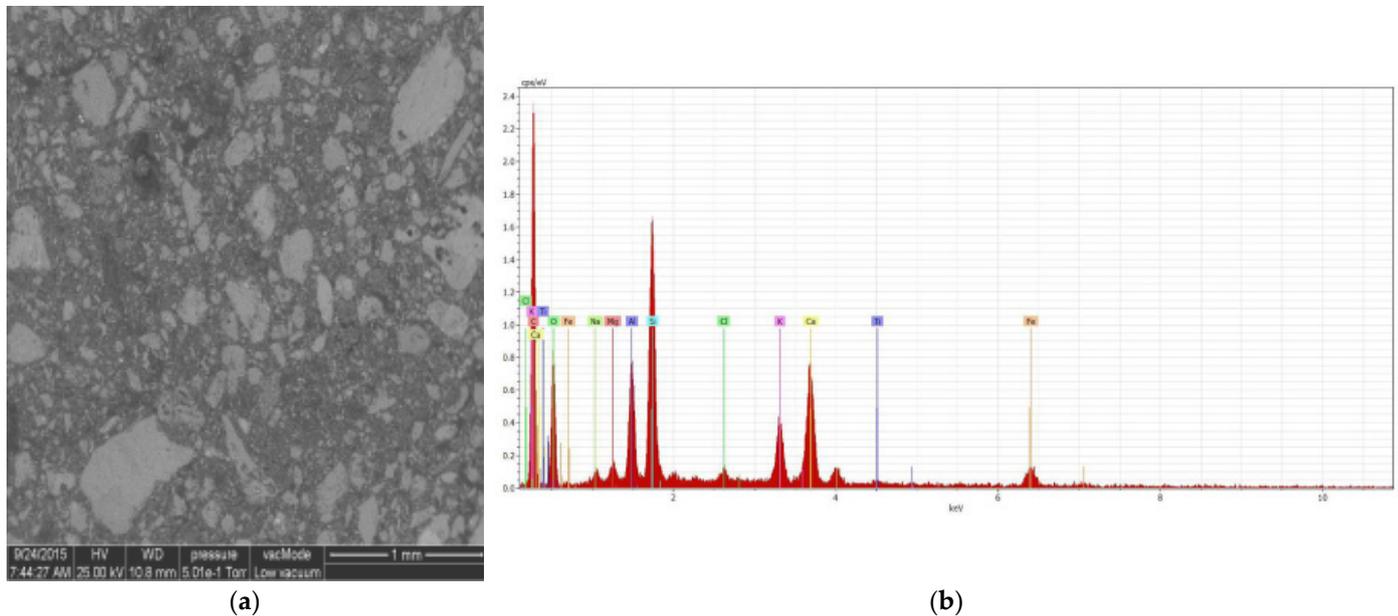
**Figure 7.** (a) Mortar image with Environmental scanning electron microscope (ESEM) modality low vacuum (LV); (b) energy dispersive spectroscopy (EDS) analysis on the mortar.

(25%), the aggregates were mainly vulcanites (brown and reddish *pozzolane*) (92%), feldspar (3.8%), pyroxenes (3.2%), mono and polycrystalline calcite (0.7%), and micas (0.3%). The porosity of the binder was about 15% due to the presence of micro-cracking. This proves the vulnerability of the mortar to rain water, which yields desegregation and fracture.

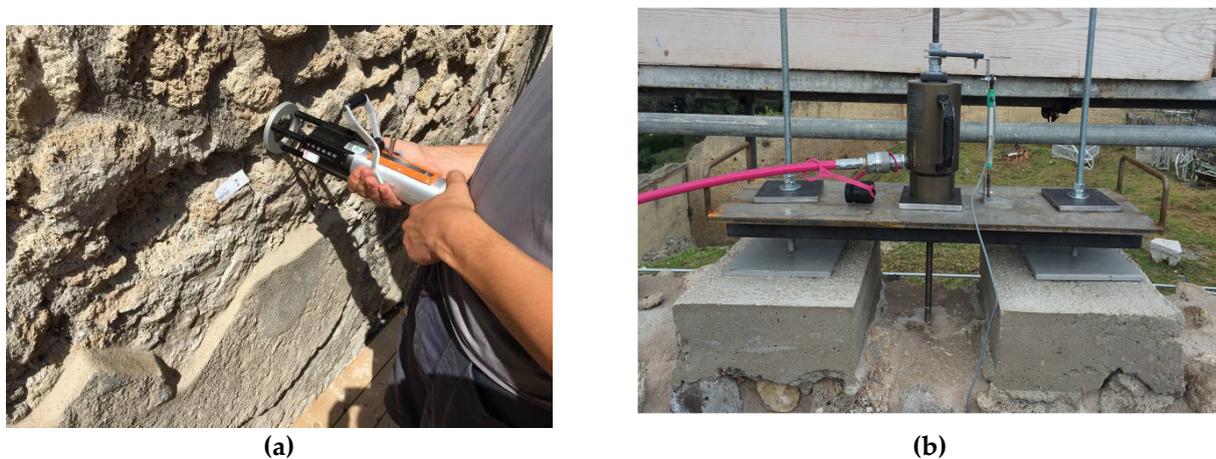
**Figure 8.** Tests. (a) Penetration test on mortar; (b) Pull-out test on a steel bar, connection the roof on the masonry walls.

A penetrometer test was also performed. The test measures the depth of penetration by inserting a steel needle into the mortar joint. Figure 8a shows the equipment that was used. The test, performed at fifteen points on ancient mortars, measures the penetration of the test needle and the results were interpreted by using correlation analysis in terms of the conservation state of the mortar and then in terms of the mechanical properties. The obtained penetration test results are reported in Table 3. Most values are often less than  $0.4 \text{ N/mm}^2$ , which demonstrates the low resistance of the mortar joint.

In order to assess the efficiency of the steel bar and connection of the steel roof skeleton to the underneath walls, three pull-out tests were conducted during the construction phase. During the tests, a maximum load of 2600 daN was reached. This proved the efficiency of the grout injection technique that was used to lock the bar of the steel roof-skeleton inside the masonry walls. Figure 8b shows the pull-out test setup.

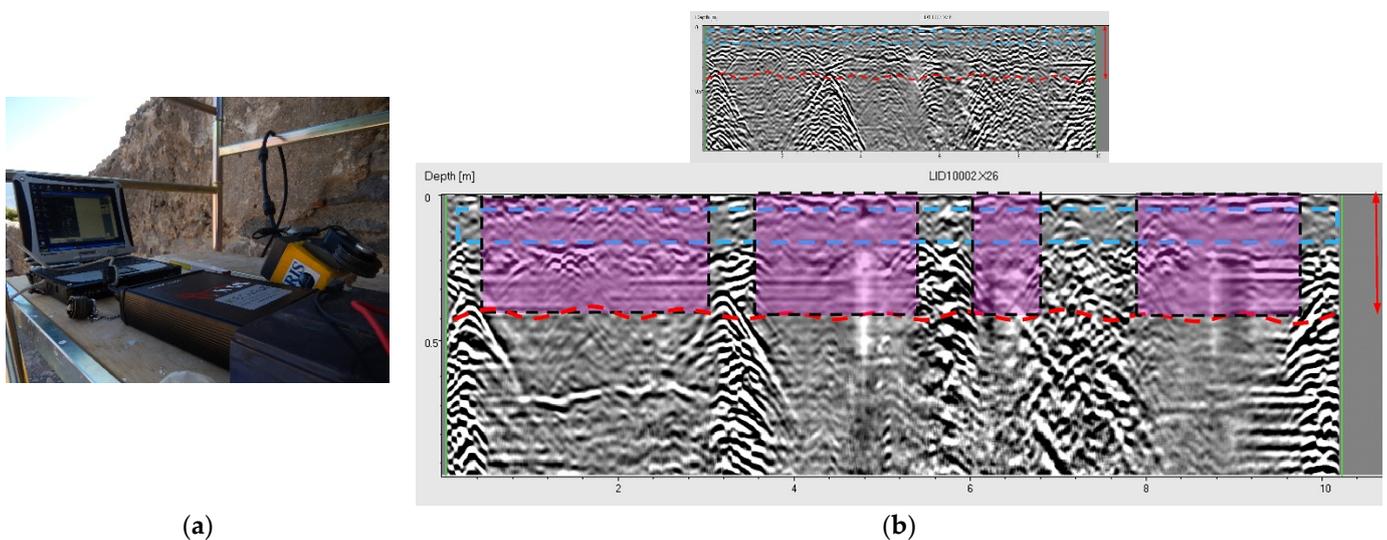
**Figure 9.** (a) Radar test on a structural wall: the equipment. (b) Comparison test before and after rehabilitation.

Figure 9 shows the radar test on the masonry walls, in particular, Figure 9a shows the equipment and Figure 9b the diagram results. This test has been used to check the efficiency of masonry consolidation through the grout injection technique and the insertion of basalt fibers inside the mortar joints, which is discussed in the next paragraph. The comparison of the radar diagrams showed evidence of the area of wall where the rehabilitation technique had been less effective, as a consequence, new consolidation work has been planned during the execution works in order to have homogenous structural density in the masonry wall.

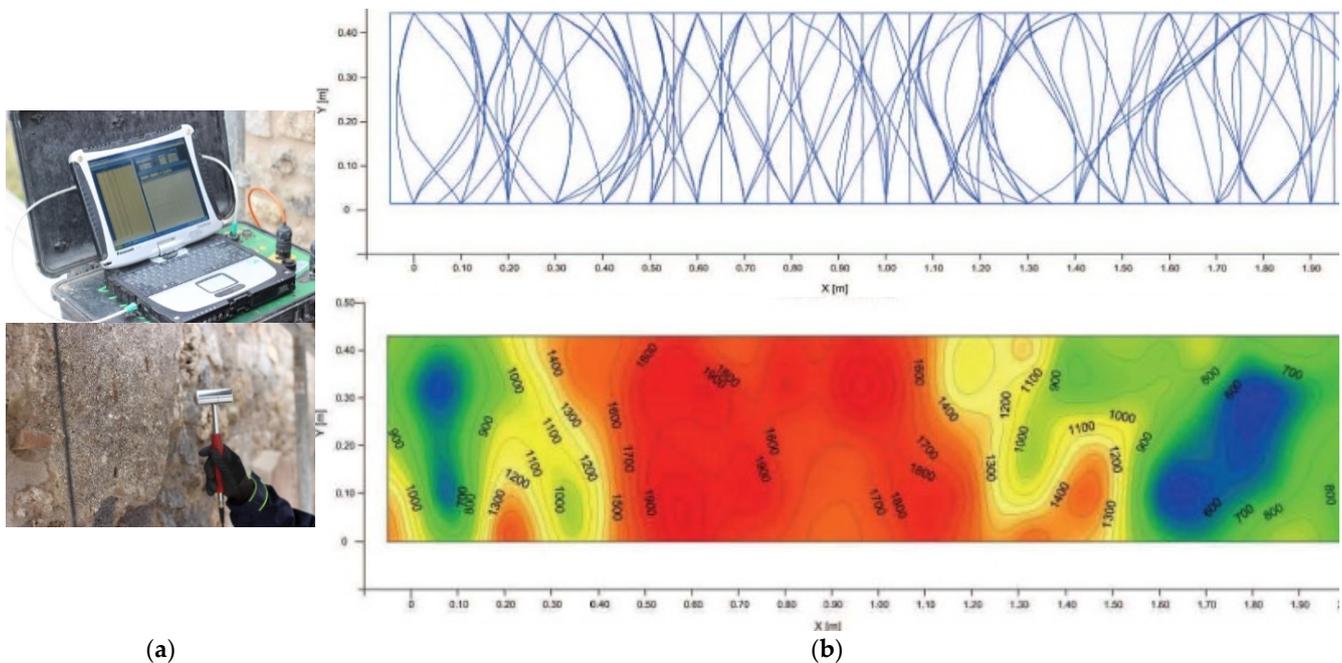
**Figure 10.** (a) Equipment for tomography tests. (b) Tomography test results on a plan section of an ancient wall.

Tomography images, obtained from the sonic test equipment composed of a hammer as exciter and a receiver of the generated waves (in Figure 10a the sonic test equipment), were obtained of selected sections of the walls. The elaboration of signals also allowed us to check the homogeneity of the inner part of the masonry walls and the efficiency of the rehabilitation works. Figure 10b shows the test results of a section of the wall, where both the trajectories of the signal and the tomographic image show the velocities of the waves.

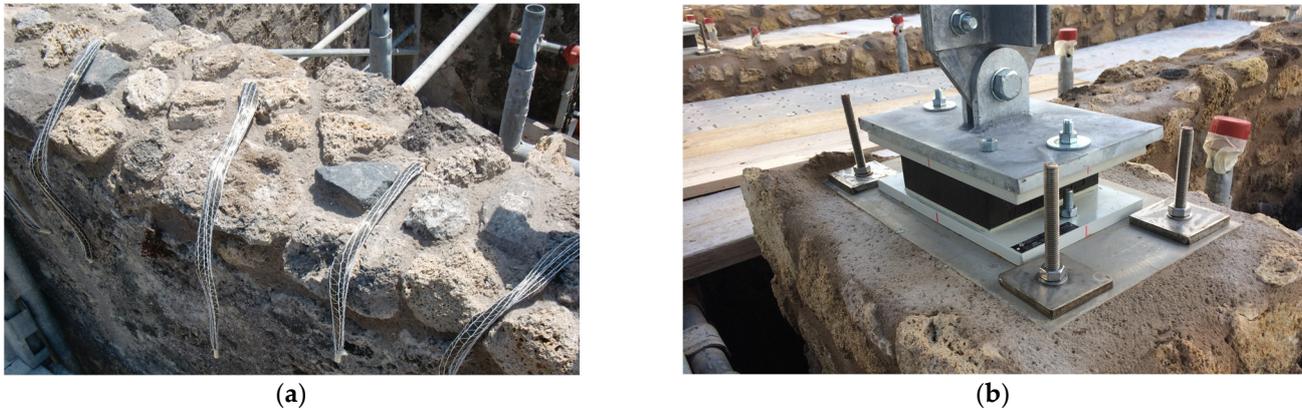
**Figure 11.** (a) Basalt fiber ropes in the masonry top wall. (b) The rubber support device.

The masonry damage state is characterized by deteriorated mortars and the presence of holes and alveolation. For these reasons, the ancient walls have been consolidated by grout injection as well as the insertion of basalt fiber nets and ropes [31–33]. The choice of natural fibers (Figure 11a) such as basalt in structural rehabilitation is currently a new technique, particularly suited to cultural heritage, as soon as basalt is a natural material with a high level of compatibility with the historical fabric. The use of these fibers, as a connection between the existing masonry and the reconstructed portion, is particularly effective for these ancient walls, as even when burdened by roofing, they increase the structural continuity. Basalt fiber ropes have been also introduced inside the mortar joints in the wall facades in order to increase the resistance of all systems made of stones and mortar. The connectors in basalt fibers are characterized by 54 fibers, a warp thickness of

6.48 mm, warp density of  $2.6\text{g}/\text{cm}^3$ , and warp elastic modulus of 87 GPa. The fibers were inserted in the joint using a structural mortar with a compression strength after 28 days greater than 1.5 MPa, with rheoplastic characteristics made of natural hydraulic lime and selected aggregates.

The characteristics of the Elastofip 1.5EF 7.2 device produced by Fip Industriale (Figure 11b) are described in Table 4. The device is a rectangular block of rubber with the insertion of a number of horizontal steel laminated plates, vulcanized to the rubber, which increases the vertical stiffness and improves the stability under horizontal load. The bearings were designed according to European standard EN 1337-3 in which they are classified as type C bearings. The elastomer that forms the core was made of natural rubber of reinforcing plates class S355, while the anchoring counter plates were made of class S275.

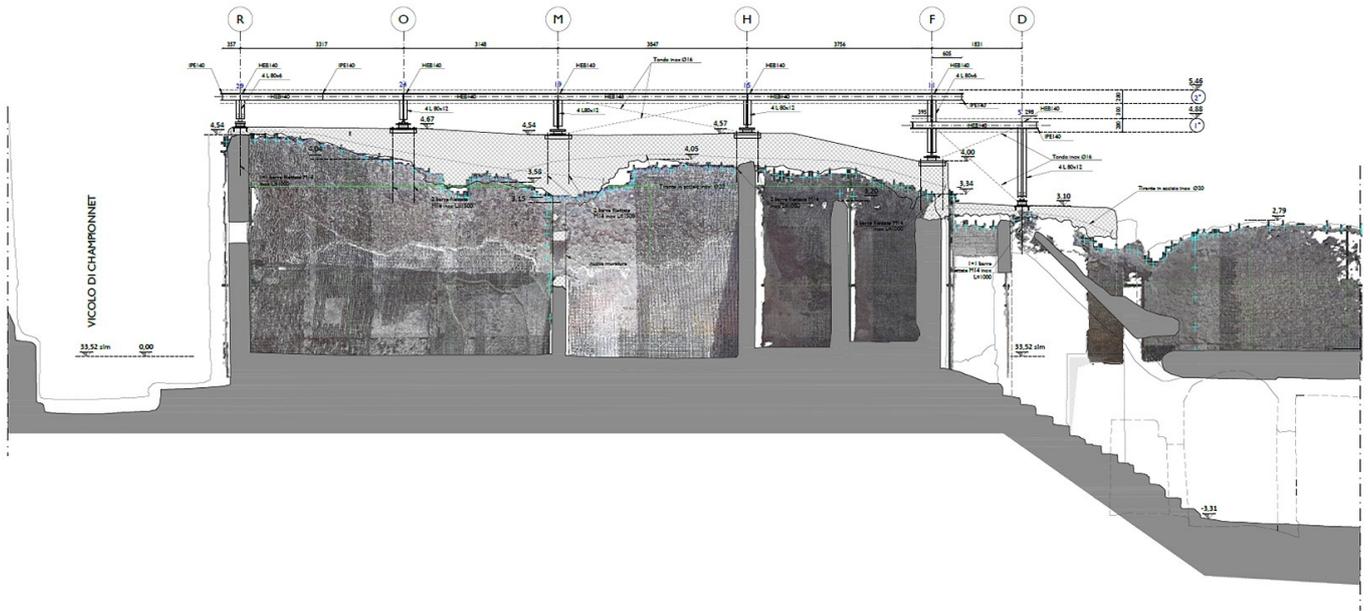
Figure 12. Executive section with cover, supports, and walls.

A steel skeleton and Corian slabs for the roof were chosen in order to limit the structural overweight (Figure 12) on the underneath walls. The atrium of the principal house (at numbers 1 and 2 Championnet Street) is about nine-meters-wide; for this reason, beams of considerable length had to be put in place (Figures 13–15), but the Corian surfaces, characterized by a limit weight compared to other materials on the steel skeleton limit of the roof load on the ancient walls, avoiding high compression stresses in the masonry.

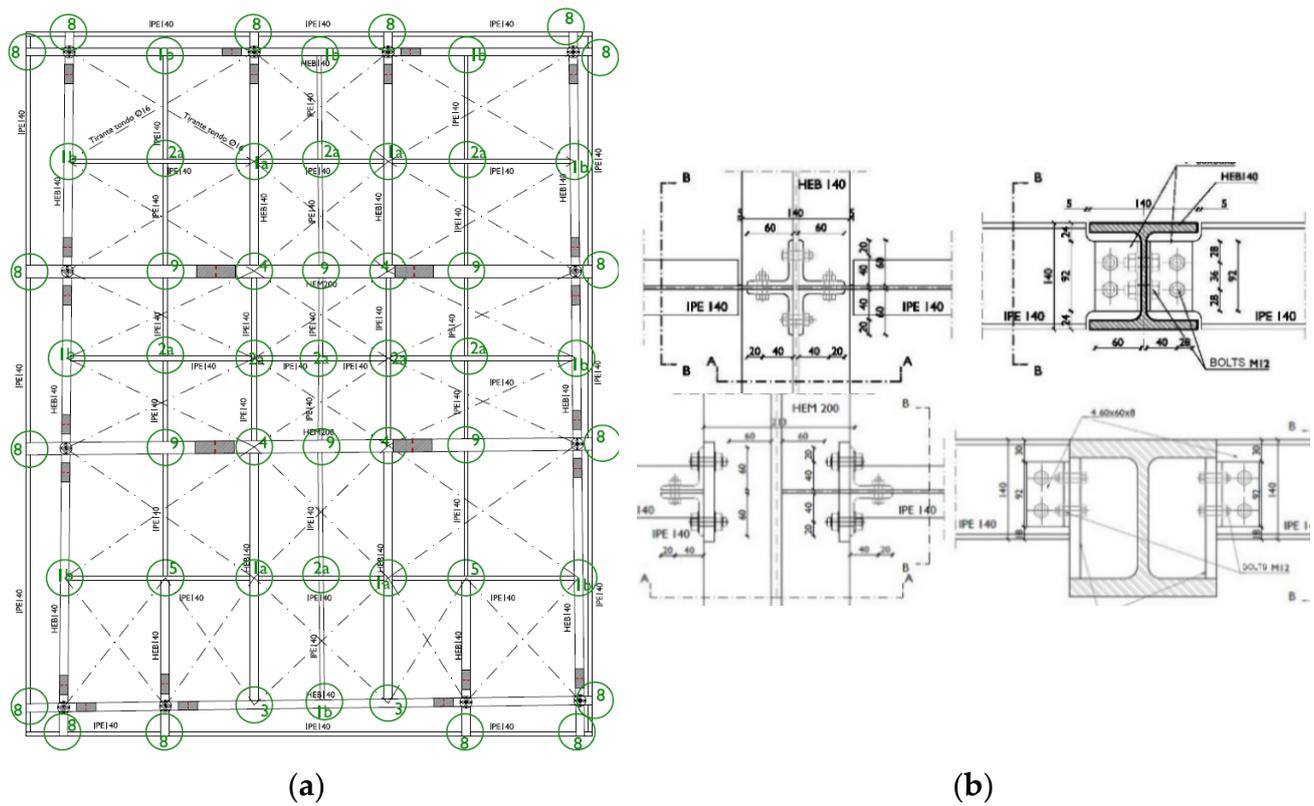
Figure 13. Structural design. (a) Detail of the roofs in plane. (b) Joint detail.

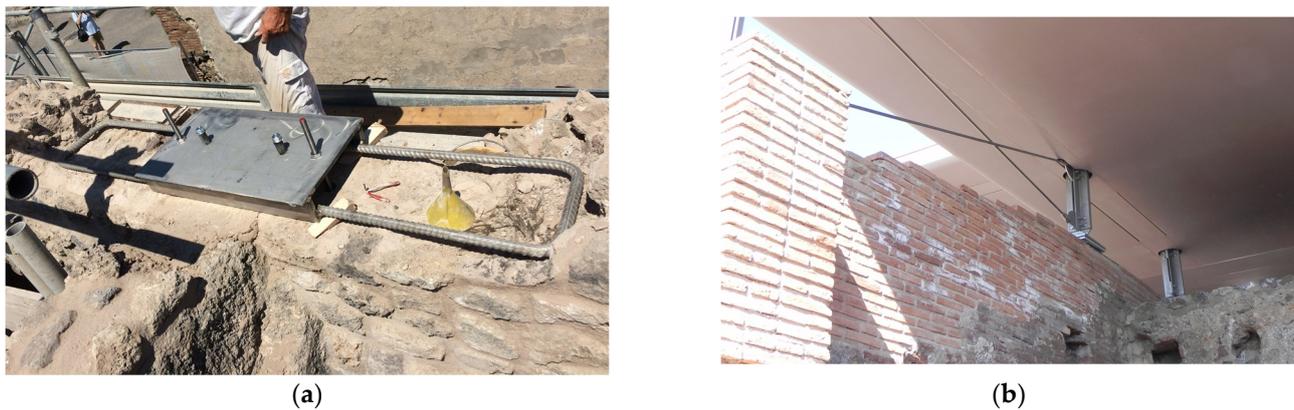
**Figure 14.** (a) Steel slab detail. (b) Steel rob detail.

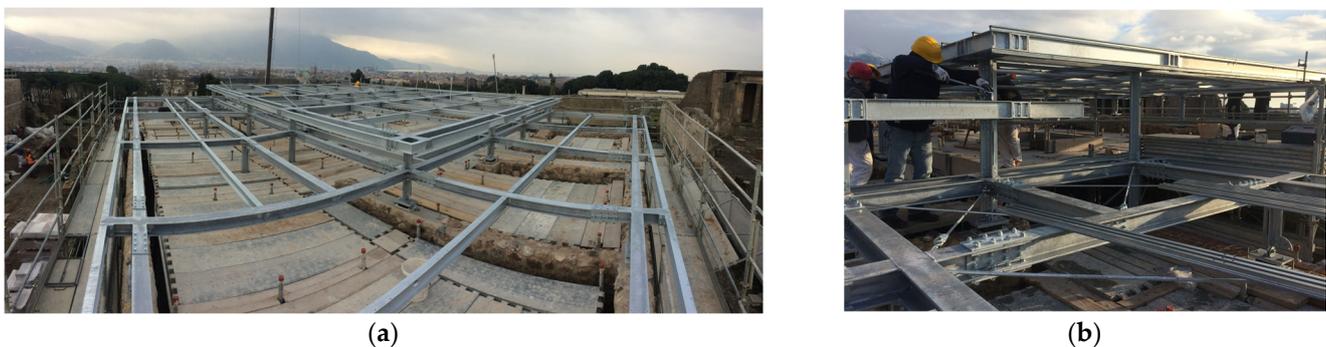
**Figure 15.** (a) Steel beams during structural work. (b) Details under construction.

At the base of the columns, the bearing device was modeled with elements having the stiffness of the Elastofip 1.5 EF 7.2. The structural detail was designed according to Italian seismic code NTC2008 [12]. The local bearing capacity of the masonry walls were verified according to Eurocodes and the possible overturning mechanisms were assessed according the limit analysis [16]. Figure 13 shows the structural design of the details, while Figures 14 and 15 show the structural elements on place during construction.

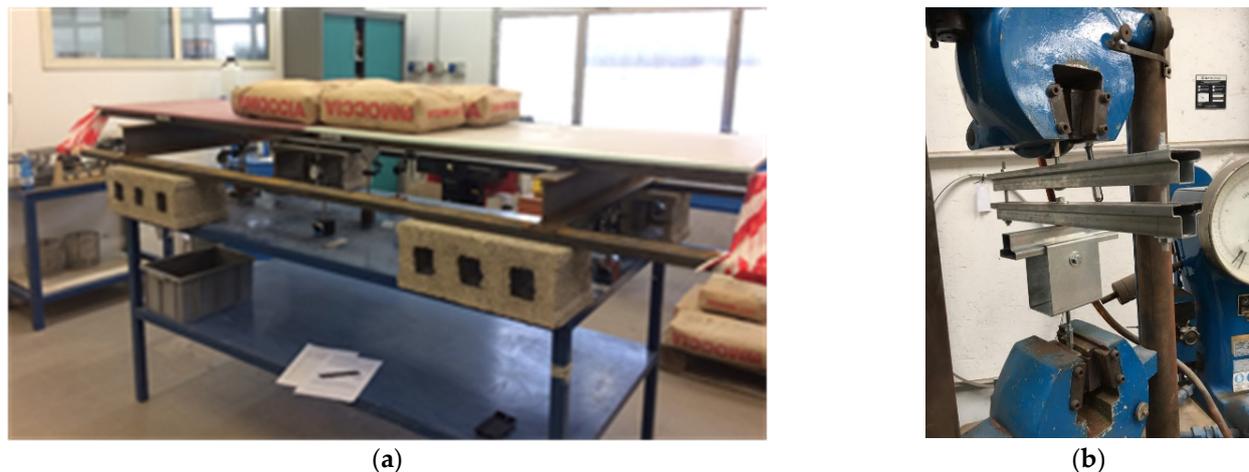
**Figure 16.** The laboratory testing on the upper and bottom surface of the Corian slabs (a). The flexural test in laboratory (b).

The slabs have been the object of laboratory tests, the structural resistance to flexural actions has been proven, moreover, the connection of the covering layer (the extrados and the intrados of the metallic carpentry) has been the object of test investigations to verify their resistance during the operating phase and in rare load conditions such as the future maintenance phases. Figure 16 shows the test design and the execution of the laboratory test on Corian slabs, in particular, the flexural test in Figure 16a and the tensile test on the connection between the steel skeleton and the slab in Figure 16b.

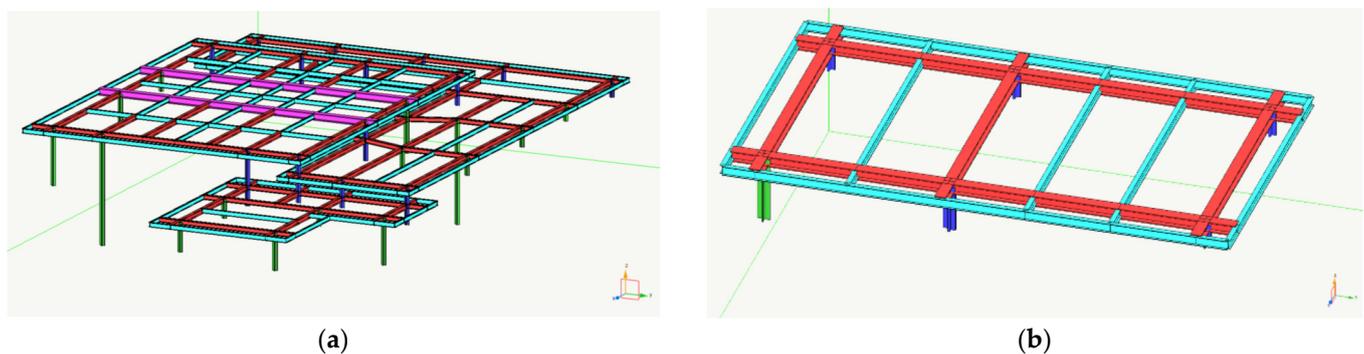
**Figure 17.** The structural models of the roofs. (a) Championnet n.1-2; (b) Championnet house at n.3.

The model of the new roof was upgraded on the basis of the structural experimental results. The spatial model of the two roofs at civic number 1, 2, and 3 is shown in Figure 17.

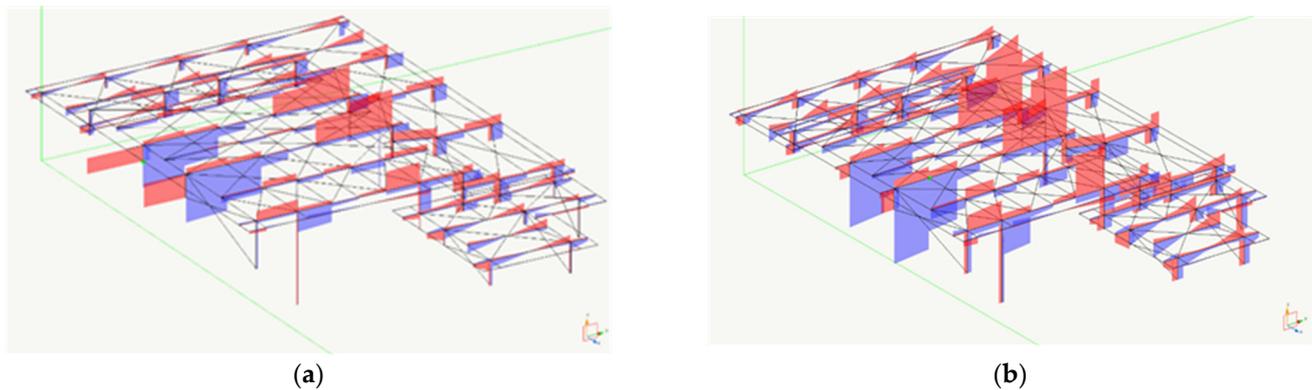
**Figure 18.** Comparison in terms of shear. (a) Base isolated structure. (b) Fixed base structure.

The efficiency of the structural designed was performed. In the following, a comparison between the isolated structure at the base and a fixed base structure (the same structure modeled with interlocking constraints at the base) is presented, in order to show the benefits induced by the rubber bearing device installation, in terms of shear stresses at the base of the column and at the top of the underlying walls. First, introducing the bearing devices registered a shift in the first natural period of the structure. The result comparison showed a 424% reduction in shear in the base isolated structure (see Figure 18 and Table 5).
