Thermal Imaging Study to Determine the Operational Condition of a Conveyor Belt Drive System Structure

Abstract: The paper discusses the results of a study carried out to determine the thermal condition of a conveyor power unit using a thermal imaging camera. The tests covered conveyors in the main haulage system carrying coal from a longwall. The measurements were taken with a thermal imaging diagnostic method which measures infrared radiation emitted by an object. This technology provides a means of assessing the imminence and severity of a possible failure or damage. The method is a non-contact measuring technique and offers great advantages in an underground mine. The thermograms were analysed by comparing the temperature distribution. An analysis of the operating time of the conveyors was also carried out and the causes of the thermal condition were determined. The main purpose of the research was to detect changes in thermal state during the operation of a belt conveyor that could indicate failure and permit early maintenance and eliminate the chance of a fire. The article also discusses the construction and principle of operation of a thermal imaging camera. The findings ob

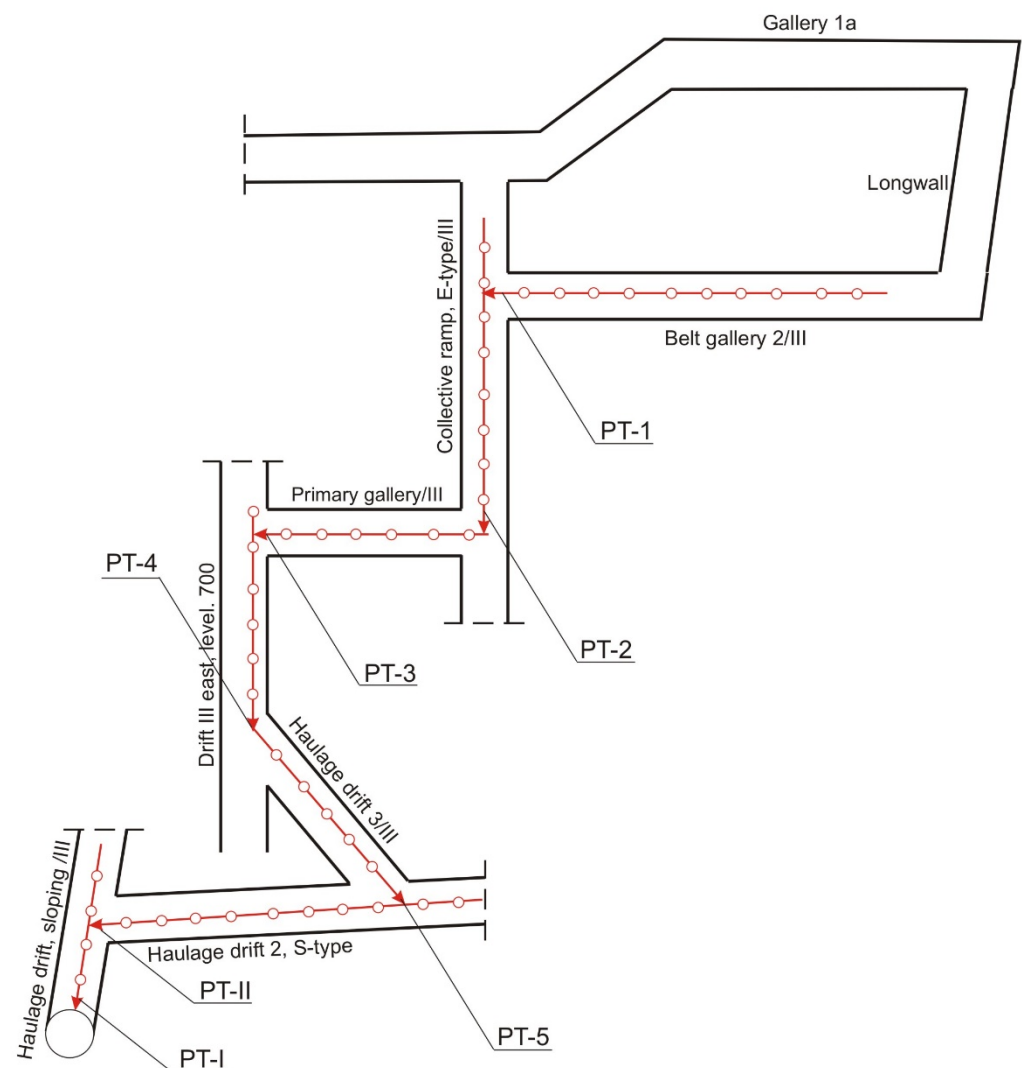
**Figure 1.** Layout of the conveyors of the main haulage system, (PT—a belt conveyor).

The main haulage belt conveyors used in the study transported the excavated coal from the longwall. The longwall mining was carried out conventionally with roof caving. The longwall was equipped with a powered roof support, a double-drum shearer and a scraper conveyor. The length of the longwall is 238 m and the panel length is 480 m. The thickness of the seam is between 2.5 and 3.1 m, with a slope between 23° and 25°. The main haulage system from the longwall transports the excavated material to a 1000 m³ silo located in the mining shaft area. The analysed haulage system consists of six belt conveyors with a total length of 1846 m. The parameters of the analysed main haulage are presented in Table 1 and their location in Figure 1.

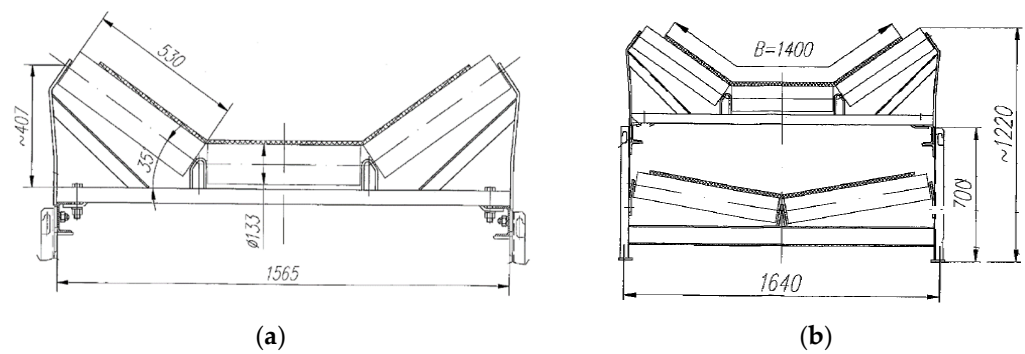
Figure 2. Support structure of the conveyor route: (a) The upper belt forms a trough with an angle of 35°; (b) View of the upper and lower belt routing.

The conveyor routes are made of coils supported on lower trestles, which are spaced every 3 m and each has two \varnothing 133 mm pulleys (Figure 2b), they serve to guide the lower belt in a V arrangement with a constant inclination angle of 10° and variable advance (-2° , 0° , 2°). The upper band is guided along the triangular supports to form a trough with an angle of 35° (Figure 2a). Each of the side pulleys of the top support has an oblique 2° lead-in in the belt direction and a belt distance of 1.2 m.

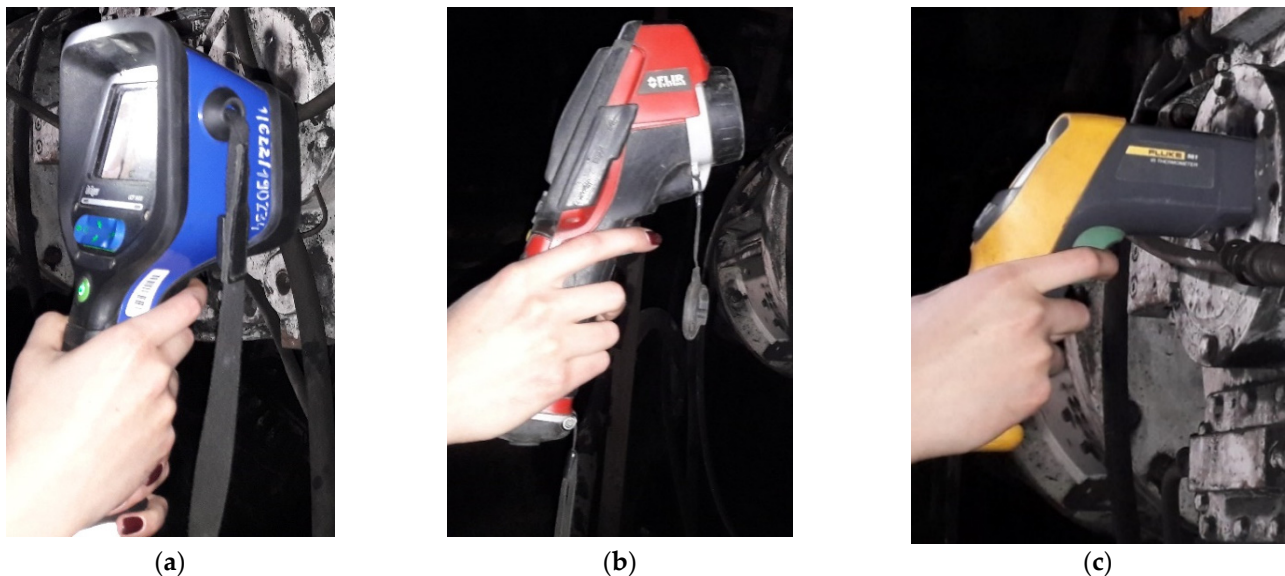
Figure 3. The measuring equipment used in the study of the thermal condition of the belt conveyor drive unit: (a) Dräger UFC 9000 thermal imaging camera; (b) FLIR i60 thermal imaging camera; (c) FLUKE 561 pyrometer.

A thermal imaging camera (shown in Figure 3a,b) works by processing infrared radiation that is emitted or reflected by objects. The resulting electrical signal is transformed into an image viewed on a monitor. The camera is built of an optical system, an infrared detector, a visualisation circuit and electronic amplification. The camera reads the measurement of any object with a temperature above zero without relative 0 °C, which is a source of infrared radiation, and its intensity depends on the temperature and surface features of a given object. The range of detection (sensing), recognition and observation identification depends mainly on three parameters: the viewing angle of the camera, thermal resolution and number of detectors in the array [91]. The devices shown in Figure 3 are equipped with a laser pointer that allows the temperature to be recorded at a specific point during the measurement from the object or location. A pyrometer (Figure 3c) is used for non-contact temperature measurement. It works by analysing the thermal radiation emitted by the objects as a whole.

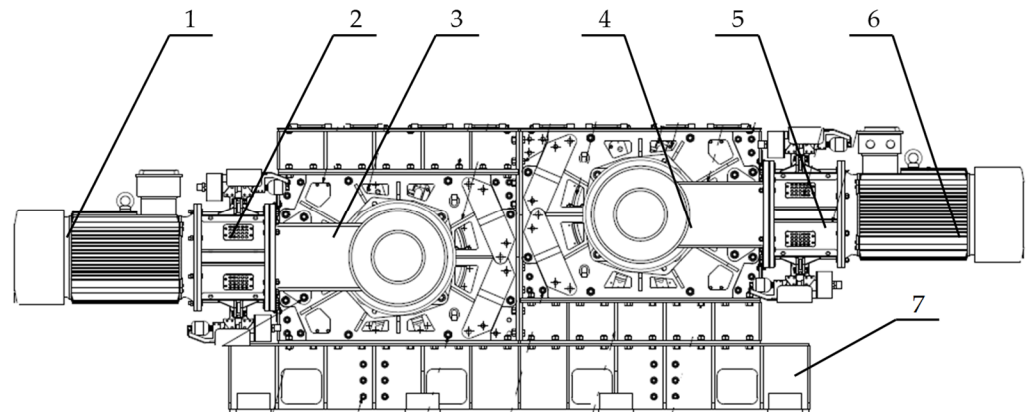
Figure 4. Conveyor drive unit, where; 1—engine, 2—left brake system (I), 3—left gearbox (I), 4—right gearbox (II), 5—right brake system (II), 6—engine, 7—foundation.

The drive unit consists of a gearbox, clutch and motor connected via the coupling case. The conveyor drive drums are driven by drive units. The transmission of the take-off torque from the gearbox to the drums is affected by means of couplings. The drive unit is built on

a drive drum module. The gearbox is attached to the drive body via an intermediate plate. Drive units consisting of motors and gearboxes require water cooling. Figure 4 shows an example of the construction of the drive unit.

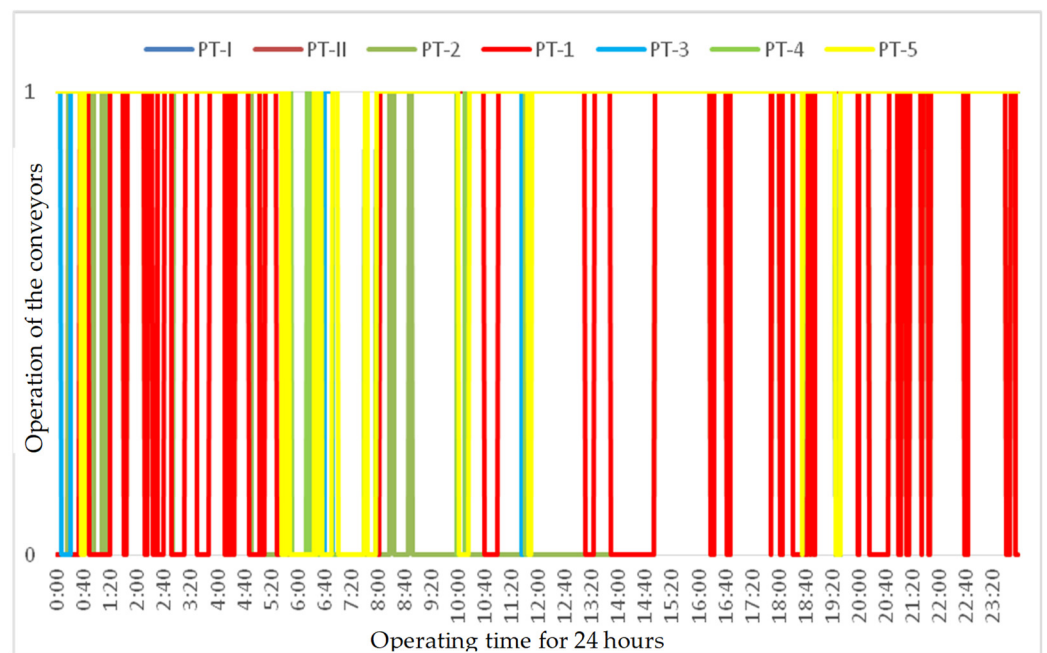
Figure 5. Graph for the operating time of the main haulage belt conveyors, where: 1—the operating time (it is in motion) of the conveyor belt, 0—the idle time (the machine is halted).

The diagram (Figure 5) illustrates the operation of the main haulage belt conveyors on a daily basis. It allows us to view the stoppages that have occurred during its daily operation. The belt conveyors whose running time measurement is shown in the above diagram are explained in Table 2.

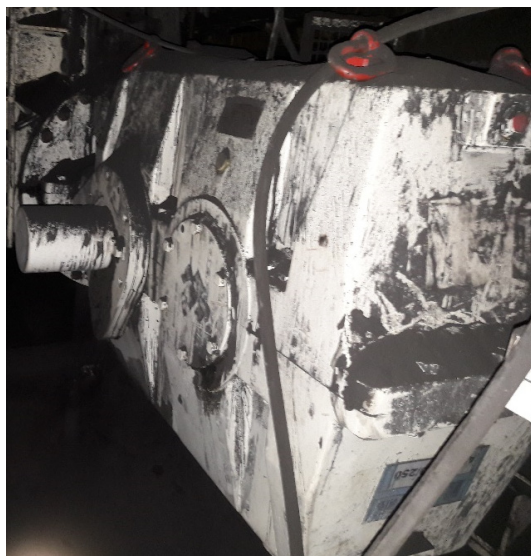
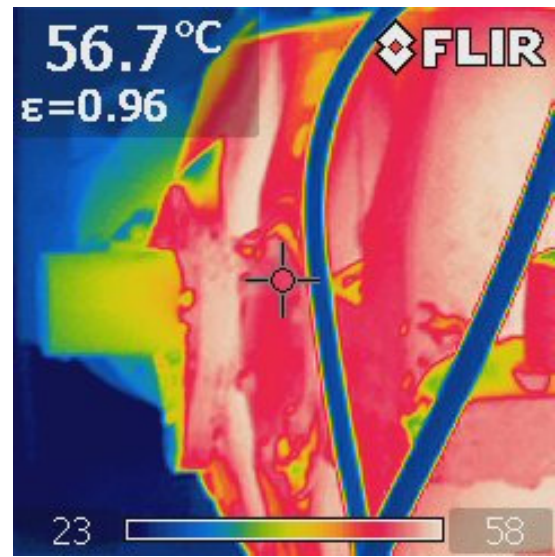
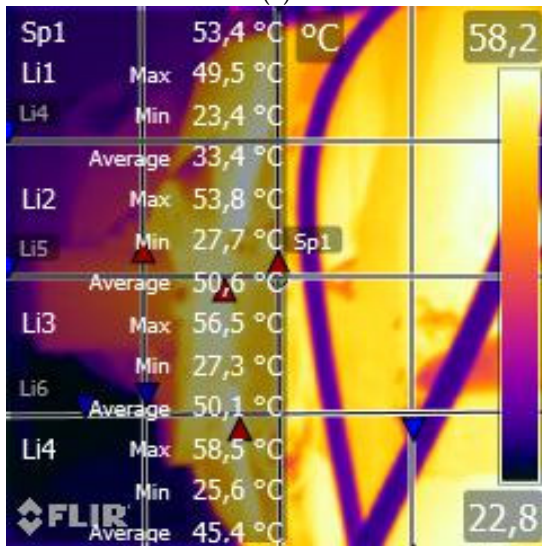
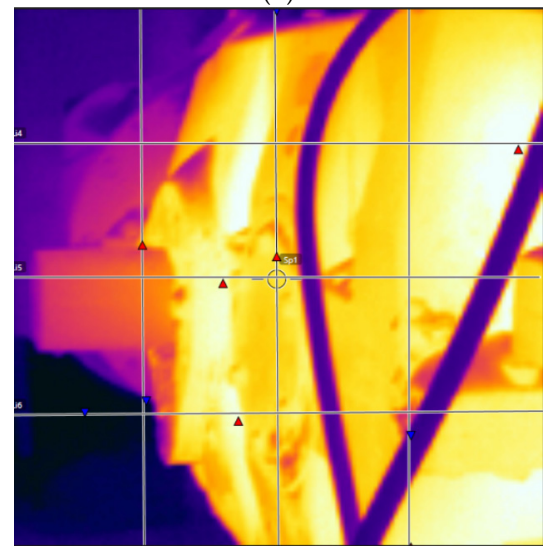
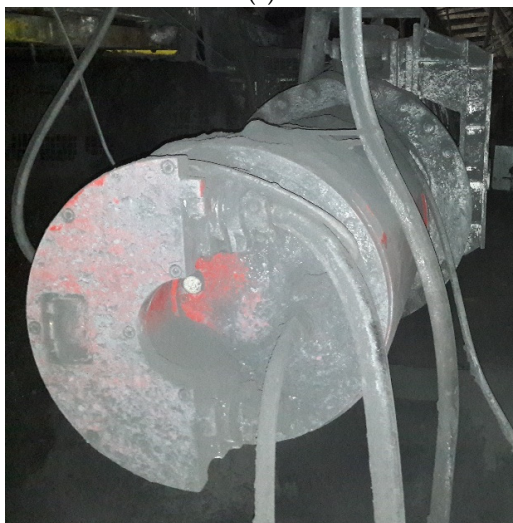
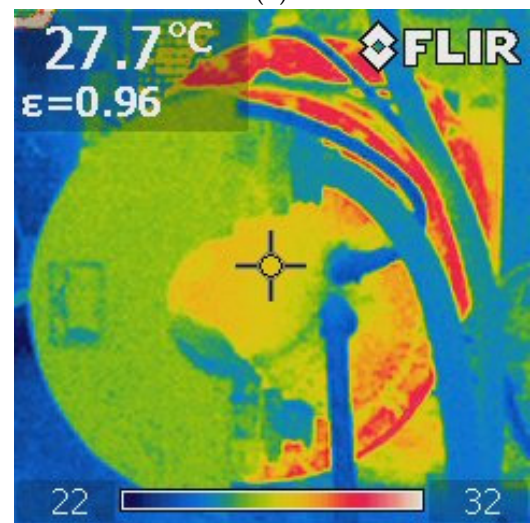
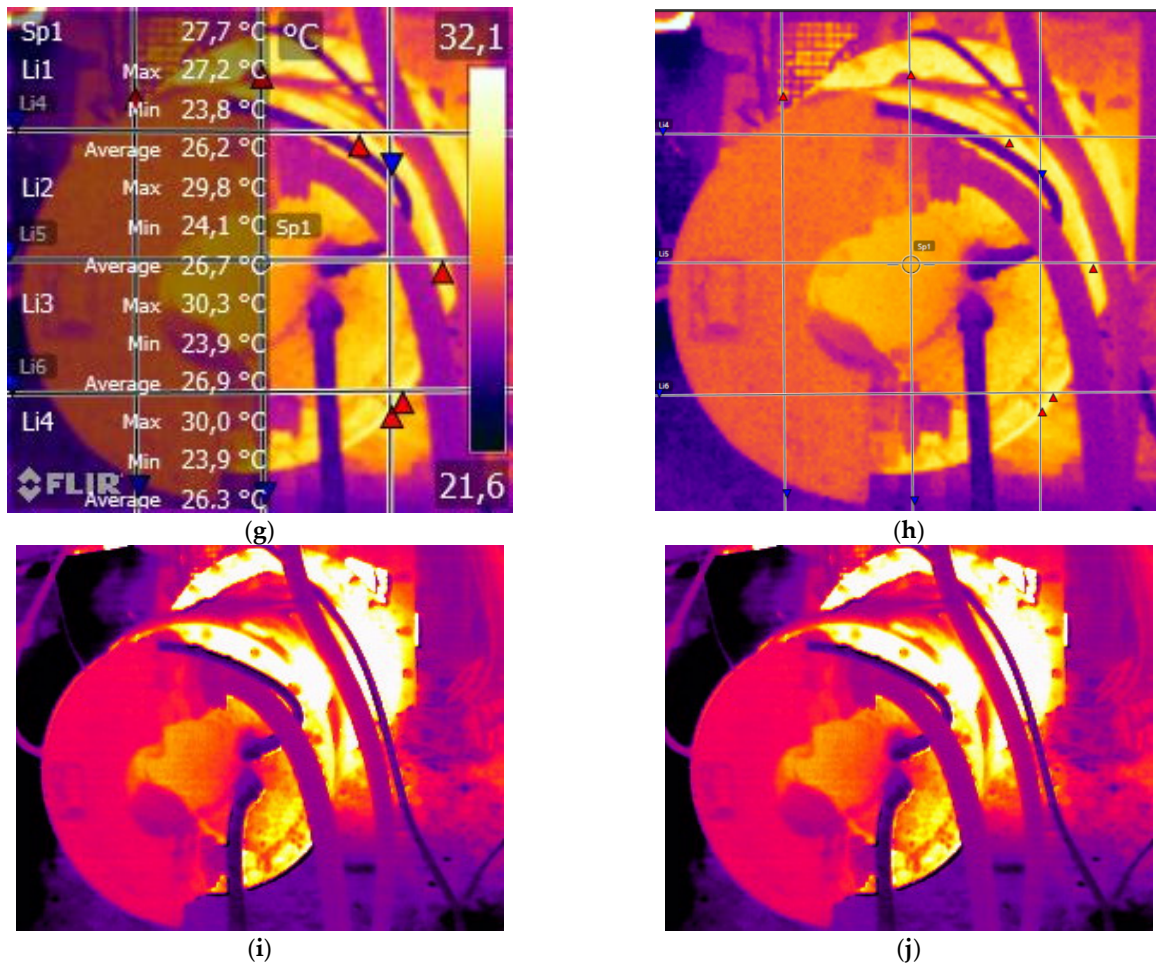
Figure 6. A view from a measurement session made with a thermal imaging camera together with processing in the software FLIR Tools for (II) drive unit of belt conveyor PT-4 from the analysed main haulage, where heat distribution is presented for: (a) photo of the tested right gearbox (II); (b) thermogram with visible thermal effect for the right gearbox (II); (c,d) thermogram showing the heat distribution for the right gearbox (II); (e) photo of the tested right engine (II), (f) thermogram with visible thermal effect for the right engine (II); (g,h) thermogram showing the heat distribution for the right engine (II); (i,j) thermogram showing the heat distribution taken with the Dräger UFC 9000 camera.

The test results obtained (Figure 6) were analysed using a process based on special software FLIR Tools in order to determine the temperature distribution within the test object. The software FLIR Tools uses the function of creating a line to catch points for which a black triangle is used to mark maximum temperatures (Figures 6c,g and 7c,g,k,l). The blue triangles indicate the minimum temperatures. A series of temperature points for the gearbox and motor were thus obtained. This function greatly simplifies and shortens measurement times, as a single image provides information on the complete temperature distribution. On this basis, the average highest and lowest temperatures of the gearboxes, motors and braking systems of the belt conveyors studied were determined, which were used in the analysis of the thermal condition of the main haulage conveyor drive units.

The obtained characteristic curves of heat distribution in the form of thermograms (Figure 6) and graphs (Figures 7 and 8) constitute an evaluation of the thermal condition of the individual elements of the tested driving unit of the main haulage belt conveyor. The measurements made refer to stable (constant) operation. For all tested main haulage conveyors (Figure 1), the highest temperatures were recorded for gearbox II and had a significant effect on the maximum temperature of the entire drive. For the PT-2 conveyor drive unit located in the collective ramp on E/III, the lowest of the maximum temperatures at around 29.9–34.2 °C. was recorded. Higher temperatures (50.1–54.6 °C) obtained from the measurements were characteristic of the PT-1 conveyor drive located in the belt gallery. In contrast, the same type of conveyor PT-3 achieved temperatures of 42.8–47.6 °C. In further measurements, temperatures remained between 47.2 and 52.6 °C for the drive unit of the PT-4 conveyor located in the eastern drift III. The presented comparison of temperatures obtained for the conveyor drive unit (Figure 9) shows that the PT-5 conveyor drive has the highest temperatures, remaining at 62.7 °C, which means it exceeded the critical value of 60 °C. This may indicate intensive use of the conveyor. The analysed measurements for the PT-II conveyor drive were at a level of 48.3–51.0 °C, which indicates correct operation. For the PT-I conveyor, temperatures ranging from 38.0 to 43.3 °C were recorded.

Thermal imaging technology makes it possible to solve many diagnostic problems easily and inexpensively by using a thermal imaging camera. The thermograms obtained (Figures 6 and 7) depict the surface of the object under investigation, i.e., the areas with the highest or lowest temperature.

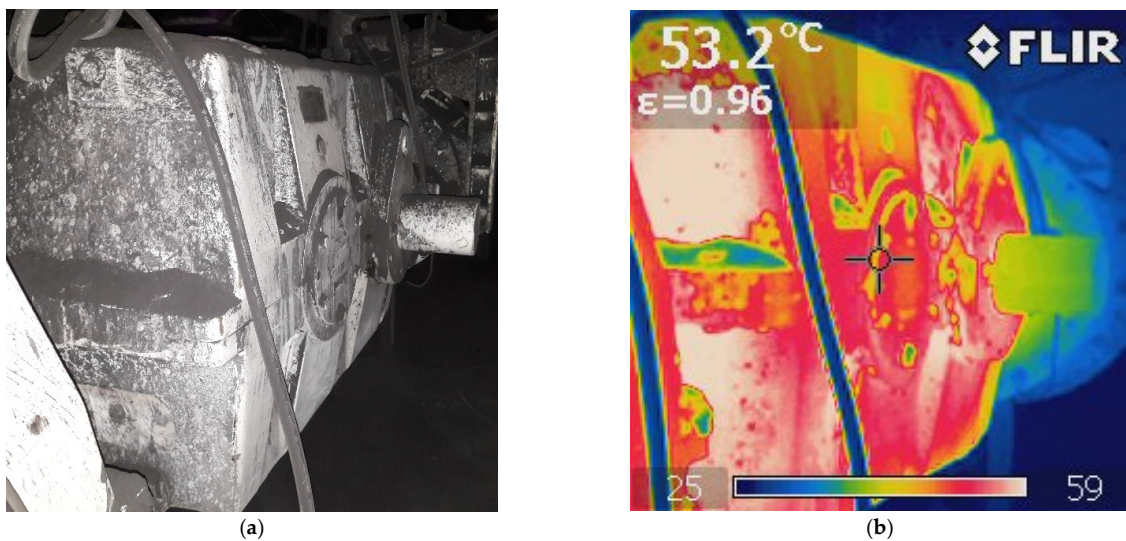
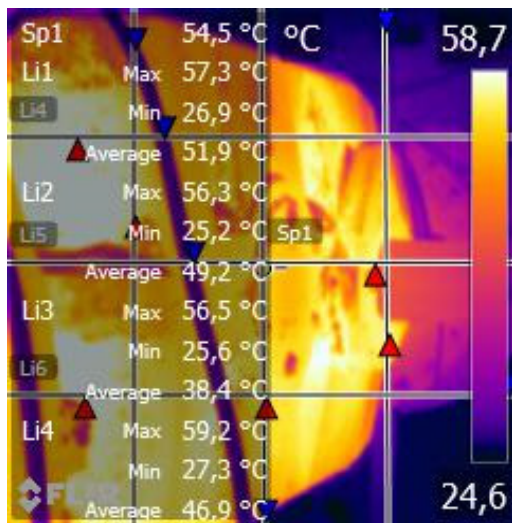
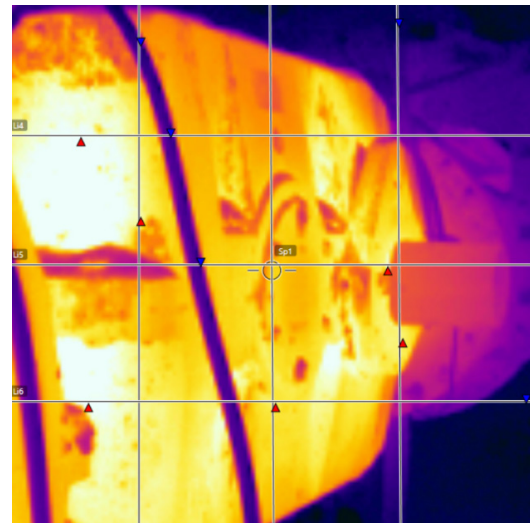
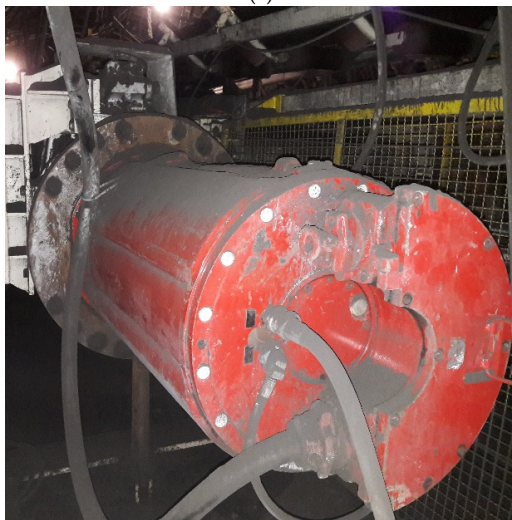
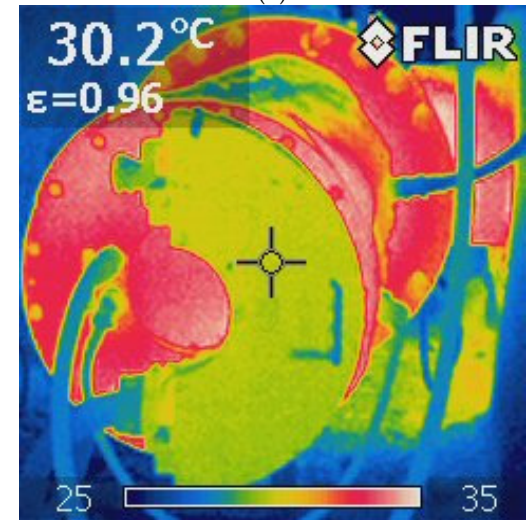
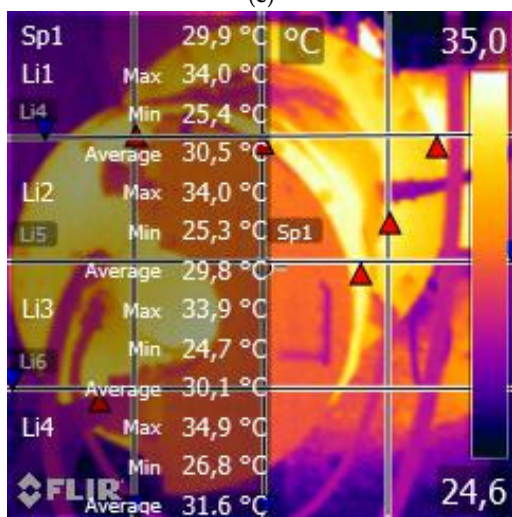
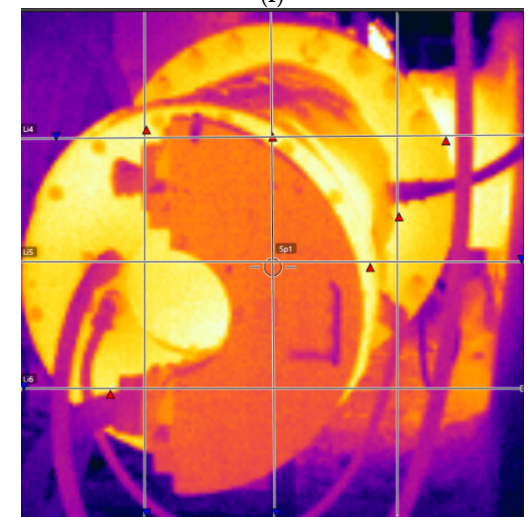
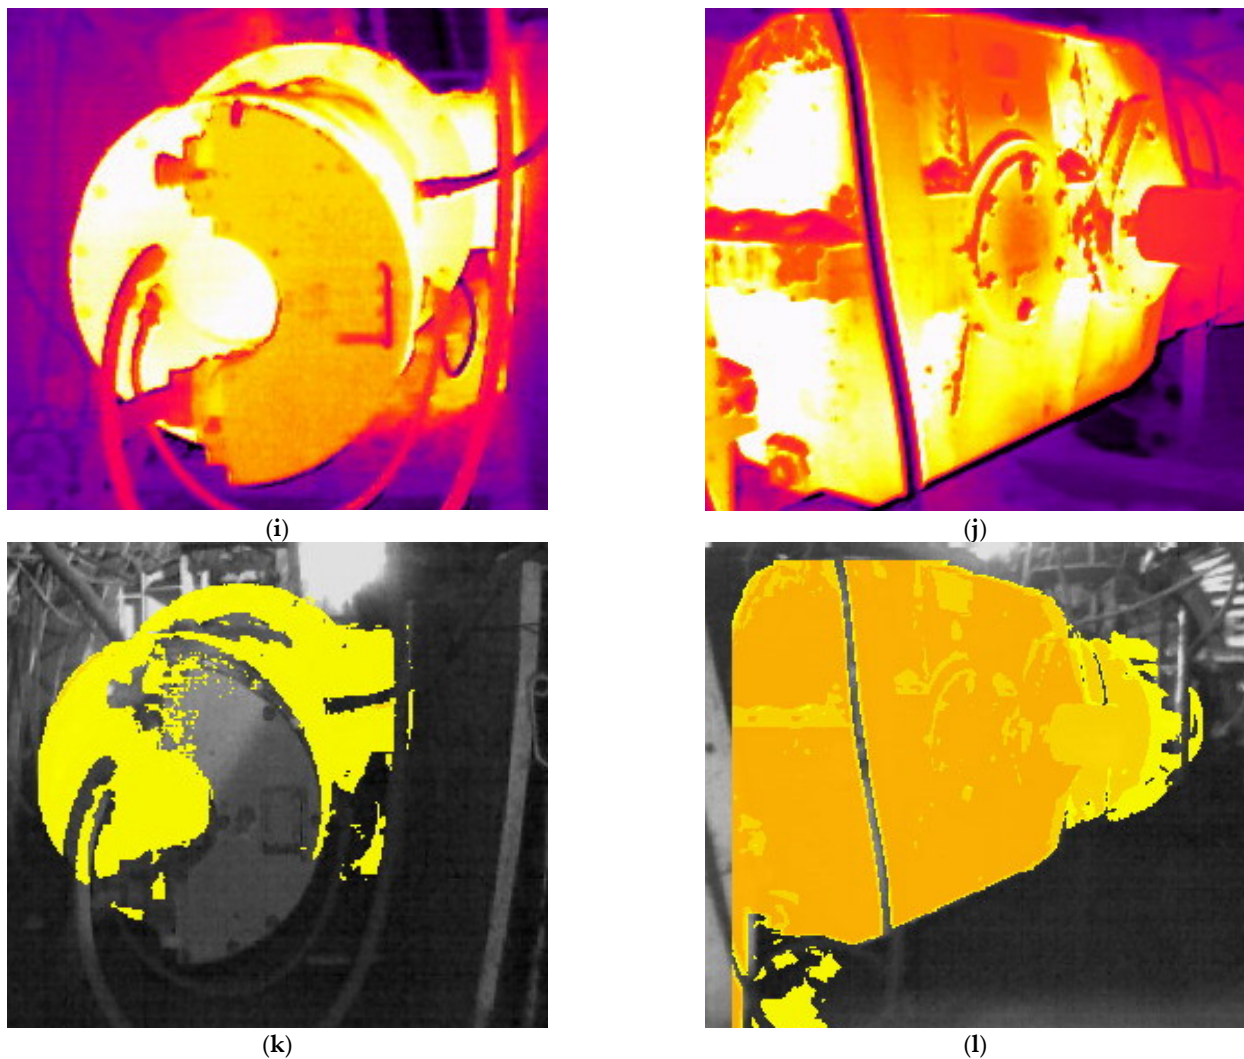
Figure 7. A view from a measurement session made with a thermal imaging camera together with processing in the software FLIR Tools for (I) a drive unit of a belt conveyor PT-4 from the main haulage analysed, where the heat distribution is presented for: (a) photo of the tested left gearbox (I); (b) thermogram with visible thermal effect for the left gearbox (I); (c,d) thermogram showing heat distribution for the left gearbox (I); (e) photo of the tested left motor (I); (f) thermogram showing heat distribution for the left motor (I); (g,h) thermogram showing the thermal effect for the left motor (I); (i,j) thermogram showing the heat distribution with the Dräger UFC 9000 camera; (k) temperature distribution for the motor in the excavation environment; (l) temperature distribution for the gearbox in the excavation environment.

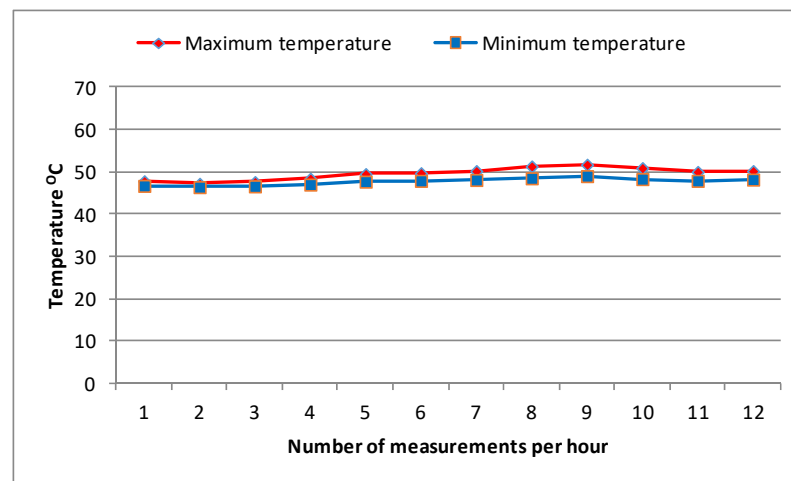
Figure 8. Temperature variation over 60 min for gear I of conveyor PT-4.

In the 60 min test interval, the graphs show minor decreases and increases in the minimum and maximum temperatures. There were no interruptions to the operation of

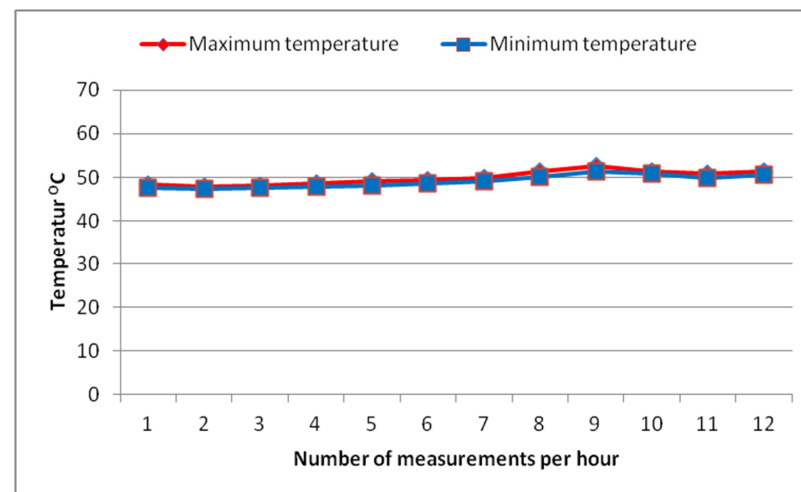
Figure 9. Temperature variation over 60 min for gear II of conveyor PT-4.

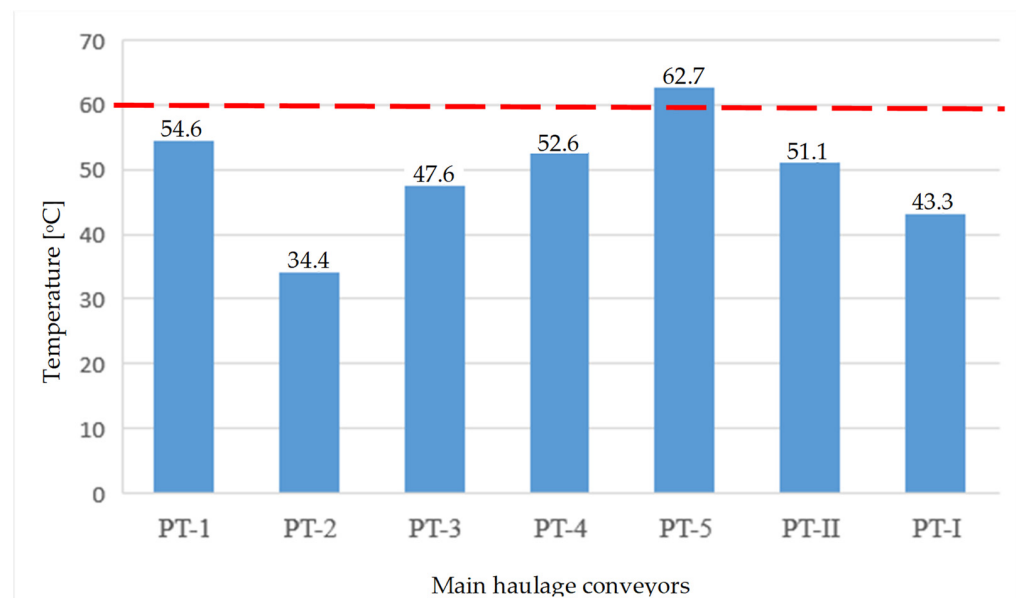
A key element in the overall test procedure is to determine the values at which alarm states associated with temperatures exceeding 60 °C can be identified. The determination of these values is based on a statistical analysis of the results obtained for the main substitution tested. A summary of the measurements obtained (Figure 10) for the main drive units are shown, with the temperature warning levels marked by a red dashed line.

Figure 10. Summary of test results obtained for the drive units.

The summary of obtained measurements for the presented Figure 9, which illustrates all tested main haulage conveyors, can be the basis for searching for diagnostic changes related to improper operation. In the following discussion, based on the results obtained, the average temperature rise in relation to the ambient was determined [92]:
