Failures of the Cast-Iron Columns of Historic Buildings—Case Studies [†]

Abstract: Selected technical problems related to the rehabilitation of cast-iron columns in structures from the turn of the 19th and 20th century are discussed in the paper. Lack of contemporary standard regulations related to the design of cast-iron structures is a significant problem in the design works and experimental investigations on cast-iron columns are frequently required. The paper presents results of the tests concerning principal properties of cast-iron—strength and deformability. The historical design principles are discussed in the light of the results of experimental investigations. As it was demonstrated, the actual load-carrying capacities of cast-iron columns may exceed by several times the values resulting from the 20th century design rules. The conservatism of the design principles resulted, however, from the material uncertainties—lack of homogeneity and hidden defects of the cast-iron. Selected examples of failures of cast-iron columns from 19th-century structures such as post-industrial buildings and engineering structures are discussed. They resulted from errors made during adaptation

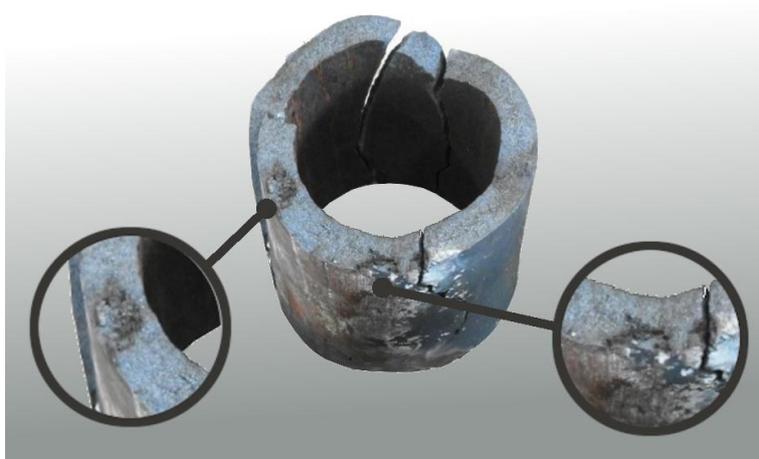
Figure 1. Example of the imperfections in the structure of cast-iron.

(1.1 ÷ 1.7%); and sulfur (0.05 ÷ 0.07%). Initially, it was mainly produced with the *Bessemer* process. Due to the imperfections of the casting technology of that time, cast-iron was characterized by very differentiated properties, which were not regulated by any standard provisions. Cast-iron products were often characterized by defects, which were manifested by the occurrence of various types of voids (bubbles, nitrogen blowholes), microcracks (as a result of shrinkage), and impurities in the form of inclusions (e.g., furnace slag, sand; see Figure 1). Due to the high uncertainty regarding the mechanical properties of cast-iron, before proceeding to the design works it is necessary to undertake material tests. Cast-iron has a compressive strength that significantly exceeds its tensile strength, and is therefore a brittle material.

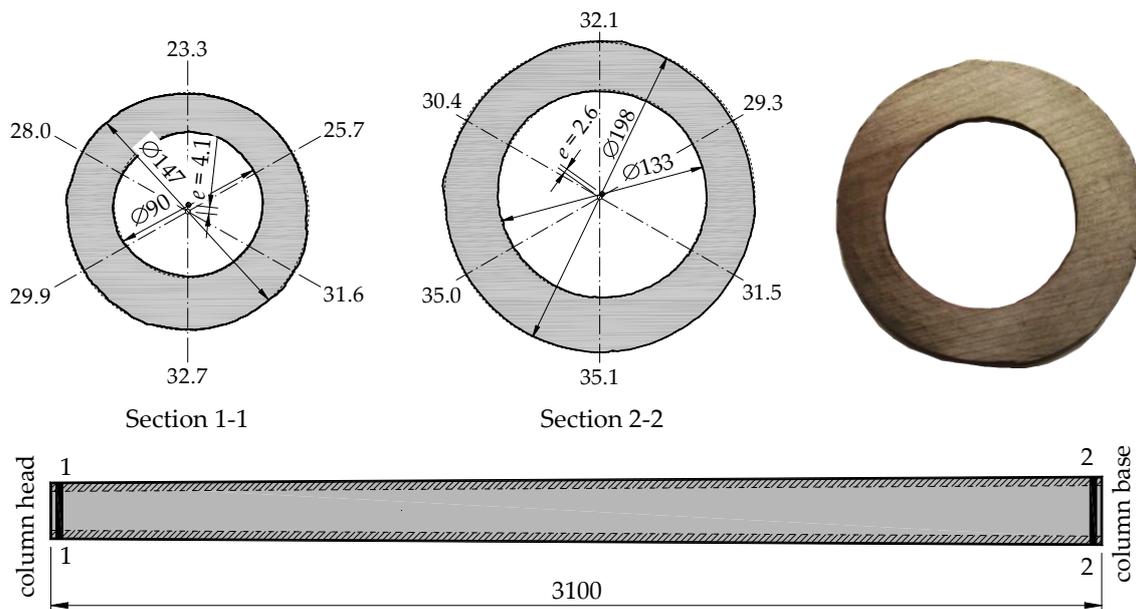
Figure 2. Cross-sections at different locations on the column length.

Very important practical information on average geometric imperfections of cast-iron columns is provided by the work of Salmon [12]. Based on the statistical analysis, he found that the mean crookedness is $\delta = L/1500$, while the geometric eccentricity is on average $e_i = D/40 \div D/30$ (where L denotes the length and D is the outer diameter of the column). In Figure 2, examples of cross-sections of columns from the post-industrial buildings in Łódź were presented. Based on the measurements, it was found that the geometrical eccentricity was not constant along the column length and on average varied in the range of $e_i = 2 \div 4$ mm ($1/75 \div 1/35D$). This feature, which should be remembered by defining the load-carrying capacity of the structural elements, resulted from the process of manufacturing [6,13,14]. Cast-iron columns were casted horizontally in molds with an inner core that shaped the tubular cross section. After filling the mold with liquid cast-iron, the core of the mold was subjected to buoyancy force and moved upwards, resulting in the differentiated wall thickness along the column. As a consequence an additional geometrical eccentricity arose, which reduced the load-carrying capacity of the column.

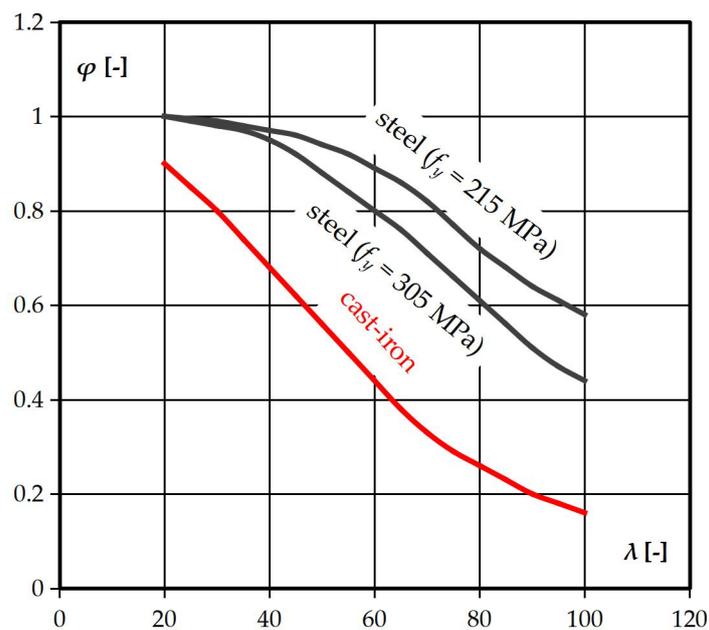
Figure 3 shows the relation between the overall instability coefficient and the slenderness of the column, plotted according to [17,18]. One can notice a clear difference between the values characterizing cast-iron and steel—depending on the slenderness, the coefficient is from 10% to more than 70% lower, which proves the high carefulness by designing of cast-iron columns.

Figure 3. Overall instability coefficient ϕ as a function of column slenderness λ .

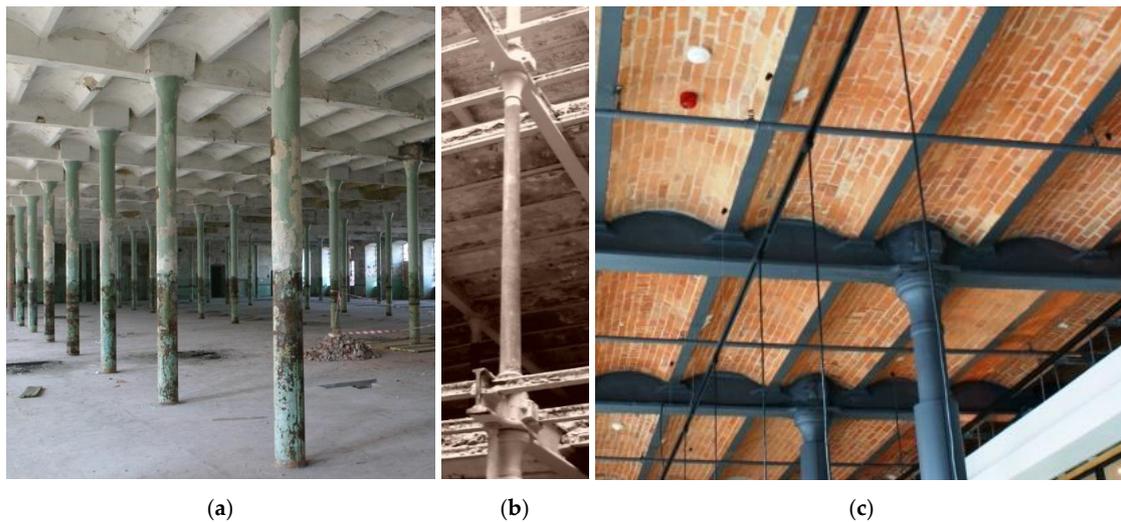
Figure 4. Structure of the former I. Posański's spinning mill: (a) before, (b) during, and (c) after reconstruction.

In the years 2002–2006 a large-scale revitalization project in the former Izrael Poznański's industrial complex, in which the textile cotton factory operated, was implemented in Łódź. The reconstruction of existing buildings has been performed in a way to partially preserve the former atmosphere of this place. This was also in case of the former spinning mill, which was transformed into a hotel. The designers decided to leave the existing structural elements, visible in Figure 4. For this purpose, a detailed stocktaking of the existing cast-iron elements was made, including measurements in several places. In the case of selected columns, the thickness of the section walls was measured using an ultrasonic thickness gauge. Thickness was measured at approximately 100 locations on each of the columns. It was found that the outer column diameter ranged from 148.3 to 150.3 mm, while the inner diameter from 90.5 to 93.5 mm, indicating a non-prismatic cross-section of the columns (convergence of about 2.5%). The thickness of the walls varied between 23.5 mm and 33 mm along the column perimeter.

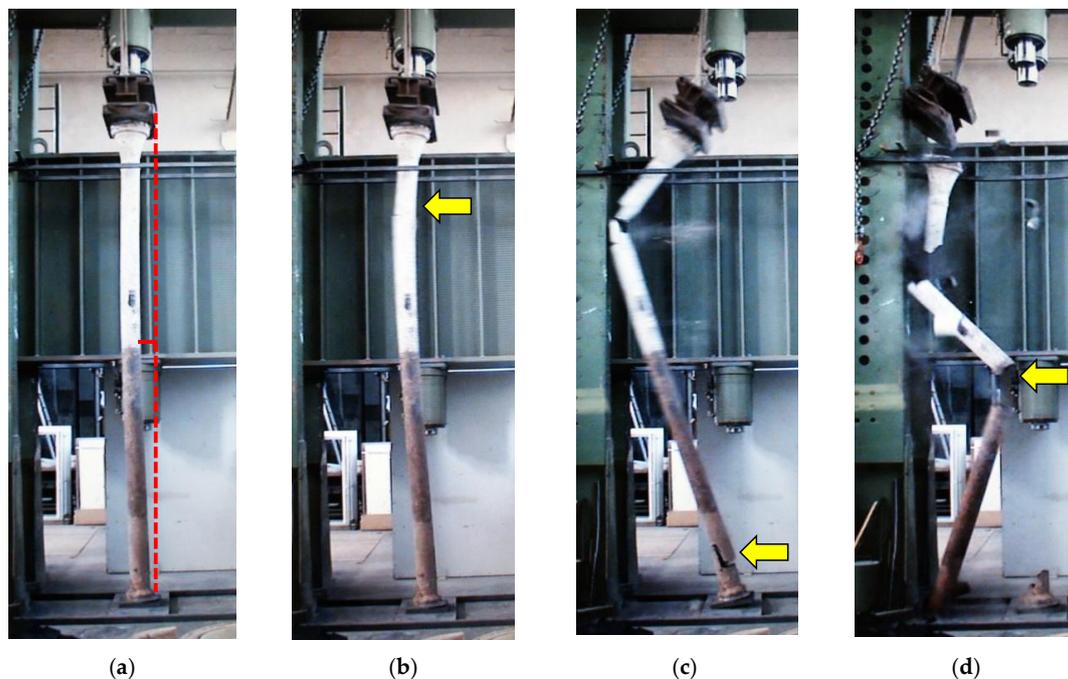
Due to uncertainty regarding the actual load-carrying capacity of cast-iron columns, it was decided to carry out destructive tests. For this purpose, four cast-iron columns from the demolished part of the building were used. The tests were carried out in the laboratory in Vienna [19]. Figure 5 shows the course of the final phase of the test of the selected column. Buckling of the column can be clearly seen. Then the fracture of the element was observed in $\frac{3}{4}$ of its height and close to the base. It is worth noting that the first crack did not occur in the mid-height, where the horizontal displacement was the highest. The reason can be found in the variable cross-section as well as the inhomogeneity of the cast-iron, which was confirmed by the subsequent inspections. In the cross sections where the failure was initiated, casting imperfections in the form of air bubbles were found. All of the failure phases, shown in Figure 5, occurred within a time interval of about 0.1 s.

Figure 5. Course of the final stage of the test [19]: (a) buckling of the column, (b) occurrence of the first crack, (c) occurrence of the second crack at the column base, (d) fracture at the mid-height (with the red line primary axis of the column has been marked, while the yellow arrows indicate the locations of the cracks).

The results of the tests on four columns demonstrated that the experimental load-carrying capacities were several times ($13 \div 15$) higher than the ultimate loads determined according to the DIN 1051 [16] procedure. The safety factor predicted at level 6 turned out to be more than twice as high.

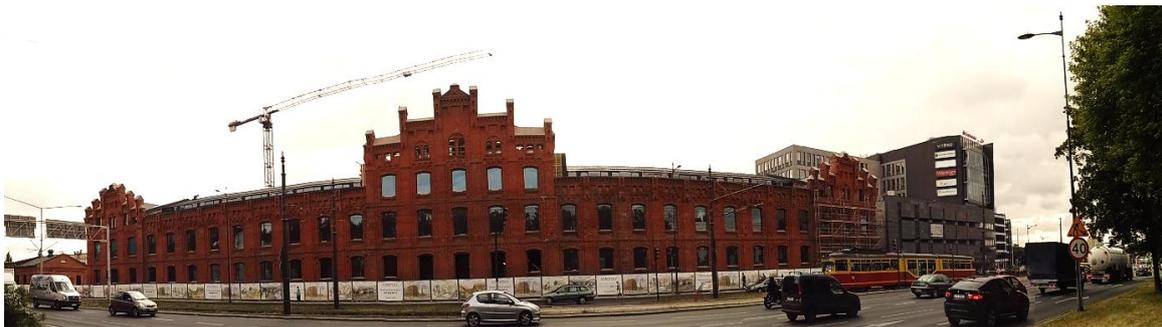
Figure 6. Main building of the former Vodka Monopoly in Łódź during construction works.

At present, the third of the large industrial complexes is being revitalized in Łódź. These are the facilities of the former Vodka Monopoly built in 1902. In these plants the production of quality spirits occurred almost continuously until the beginning of the 21st century. In 2013, as a result of ownership changes, a new era for one of the most valuable monuments in Łódź, currently known as “Monopolis”, began. In Figure 6 the main building of the complex during reconstruction is presented.

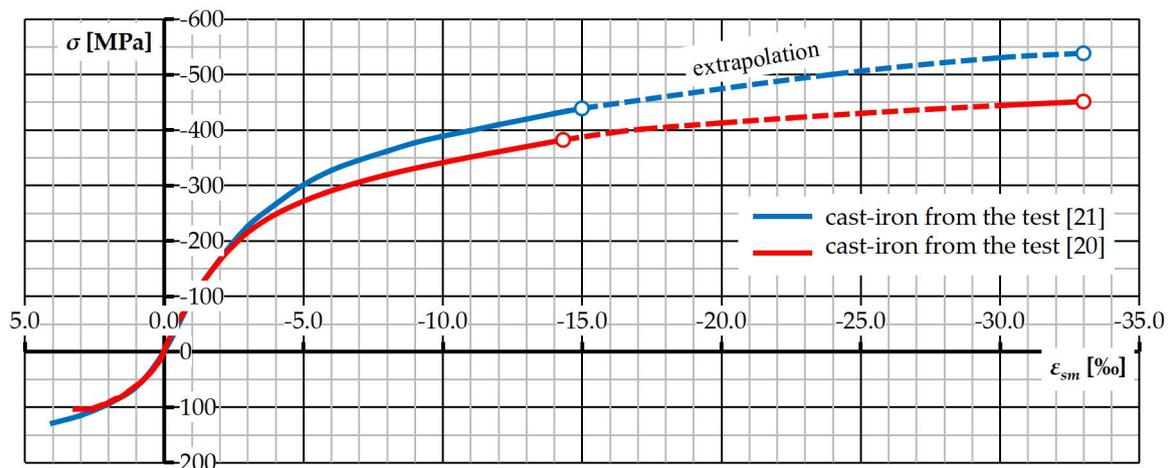
On the basis of the strain measurements secant modulus of elasticity of about $100 \div 115 \text{ GPa}$ was also determined. Very high deformability of cast-iron turned out to be surprising—the ultimate shortening of the tested samples reached over 30%, which can be seen in Figure 7.

Figure 7. Stress-strain relationship characterizing cast-iron from structural elements.

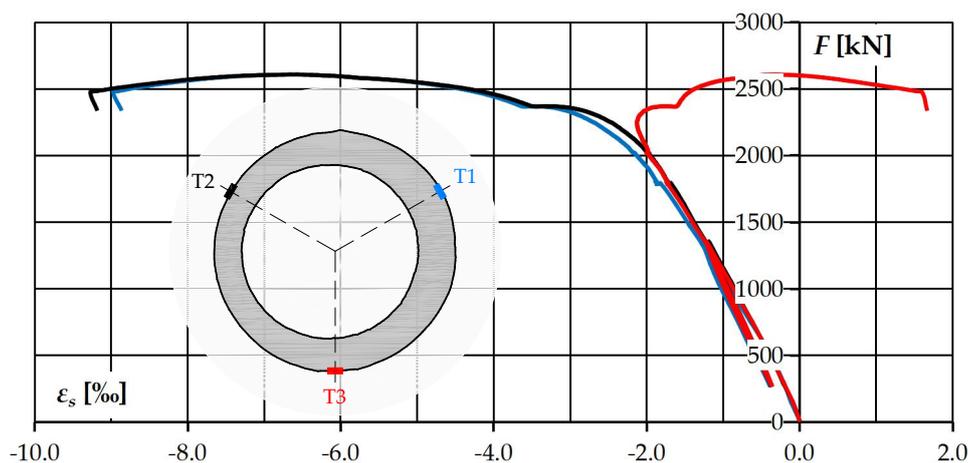
The test of the column was carried out in the hydraulic press with a maximum pressure of 6000 kN. The specimen was loaded axially under load control. A test specimen with a length of $l = 3100$ mm was made from the column selected for destructive test. Before starting the test, the element was stocktaken by measuring the thickness of the section walls at the base and at the head at 6 points around the perimeter. Measurements were made using a calliper with an accuracy of 0.05 mm. During the test, longitudinal strains were measured in the mid-height of the column in three bases around its perimeter. Strains were measured with resistive strain gauges with an accuracy of $\pm 0.5\%$ and recorded using a data acquisition system. The results of the measurement were shown in Figure 8. In the initial phase of the test, uniform shortening of the column was recorded. At about 80% of the ultimate force, a gradual decrease in strains was observed in one of the measuring bases (T3). At the maximum load these strains were close to zero. Considering the results of the measurements registered just before the failure, the maximum strains in the cross-section equal to $\epsilon_t = 1.66\text{‰}$ (on the tensioned side) and $\epsilon_c = -12.55\text{‰}$ (on the compressed side), were estimated.

Figure 8. The results of measurements at the mid-height of the column (the colors correspond to the measuring points presented in the cross section).

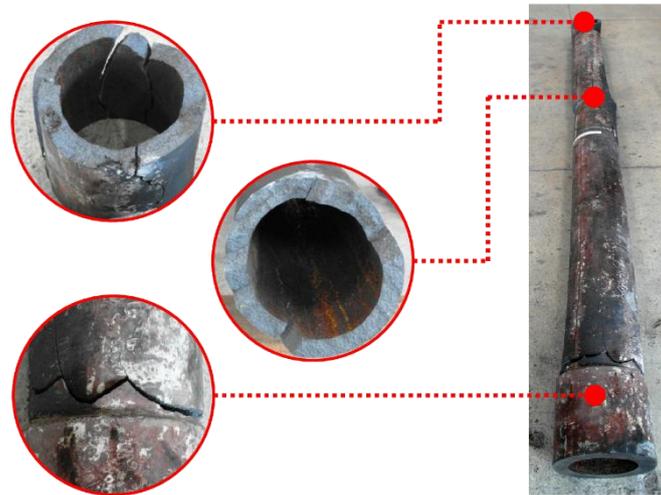
The failure of the column was extremely violent and occurred within fractions of a second at a load of about $F_{max} = 2605$ kN. In the final phase of the test at the load of about 90% of the destructive force, gradual cambering of the column began to be observed, which allowed us to conclude that the failure was a consequence of the loss of stability (buckling). It was initiated by a crack in the upper part of the column, at 2/3 of its height. Immediately after the first crack occurred, the next one was

observed in the vicinity of the column base. The column was broken into 3 parts, which were forcefully ejected from the test setup. In Figure 9, the tested column after failure was presented. Casting defects in the form of furnace slag inclusions and blow-holes were visible in all of the three sections where the failure was initiated.

Figure 9. View of the column after end of the test (the column composed of parts).

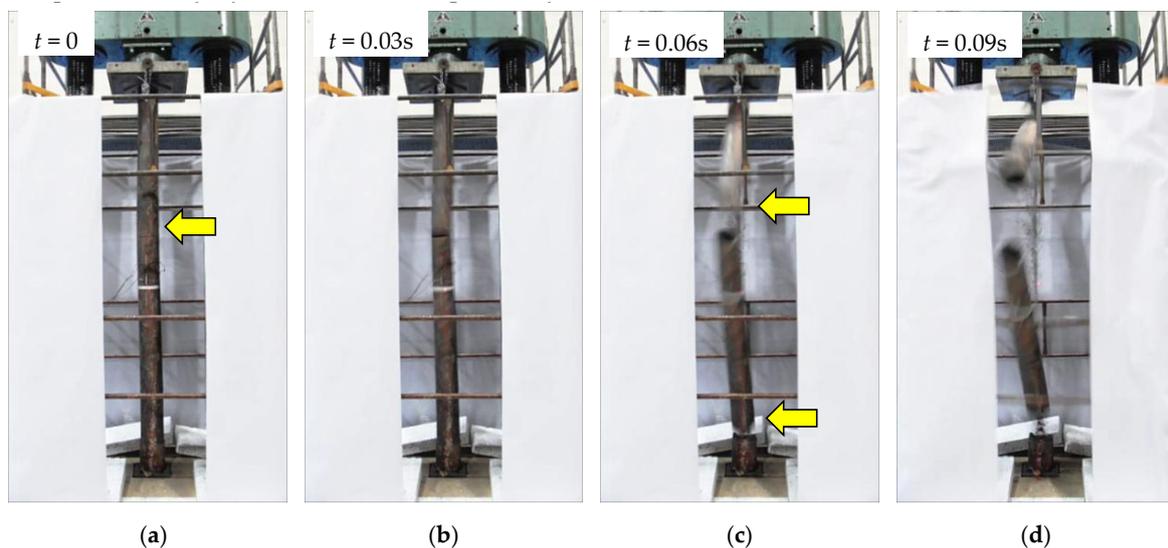
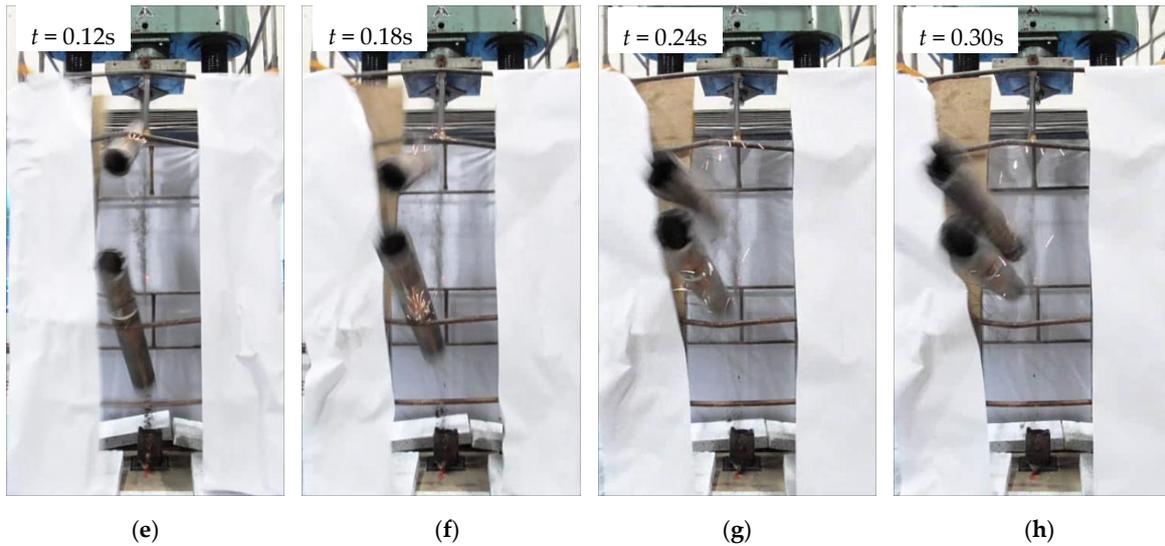
Figure 10. Cont.

In Figure 10 the course of the final phase of the test was demonstrated. The course of the failure was very similar to that observed during previous investigations [19]; compare with Figure 5. Sections, where failure was initiated, were marked with a yellow arrow. It is worth noting that the column failed within fractions of a second, and indication of the subsequent phases of destruction was possible only by means of time-lapse analysis.

Figure 10. Course of the final stage of the test: (a) 0, (b) 0.03 s, (c) 0.06 s, (d) 0.09 s, (e) 0.12 s, (f) 0.18 s, (g) 0.24 s, (h) 0.30 s. after occurrence of the first crack (with yellow arrows locations of the subsequent cracks have been marked).

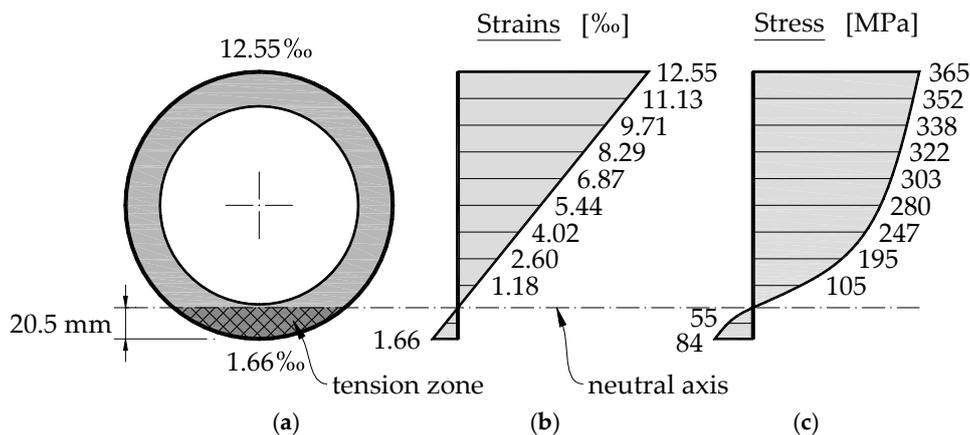
Assuming Euler–Bernoulli theory the strain distribution in the cross-section just before failure was plotted; see Figure 11. The recorded values indicated a transgression beyond the elastic range of the material. On the basis of the stress-strain relationship (see Figure 7), the stress in the cross-section were determined. The maximum stress was equal to 84 MPa (on the tensioned side) and 365 MPa (on the compressed side). These stresses accounted for 80.9% and 81.0% of the tensile and compressive strength of cast-iron, respectively. The maximum strains on the compressed side were significantly lower than the ultimate strain $\epsilon_{cu} = -33.0\%$; therefore, it can be concluded that the failure of the column was the result of exhausting the material capacity on the tensioned side due to deformation associated with buckling.

Figure 11. Strains and corresponding stress in the column cross-section: (a) location of the neutral axis, (b) strain distribution, (c) stress distribution.

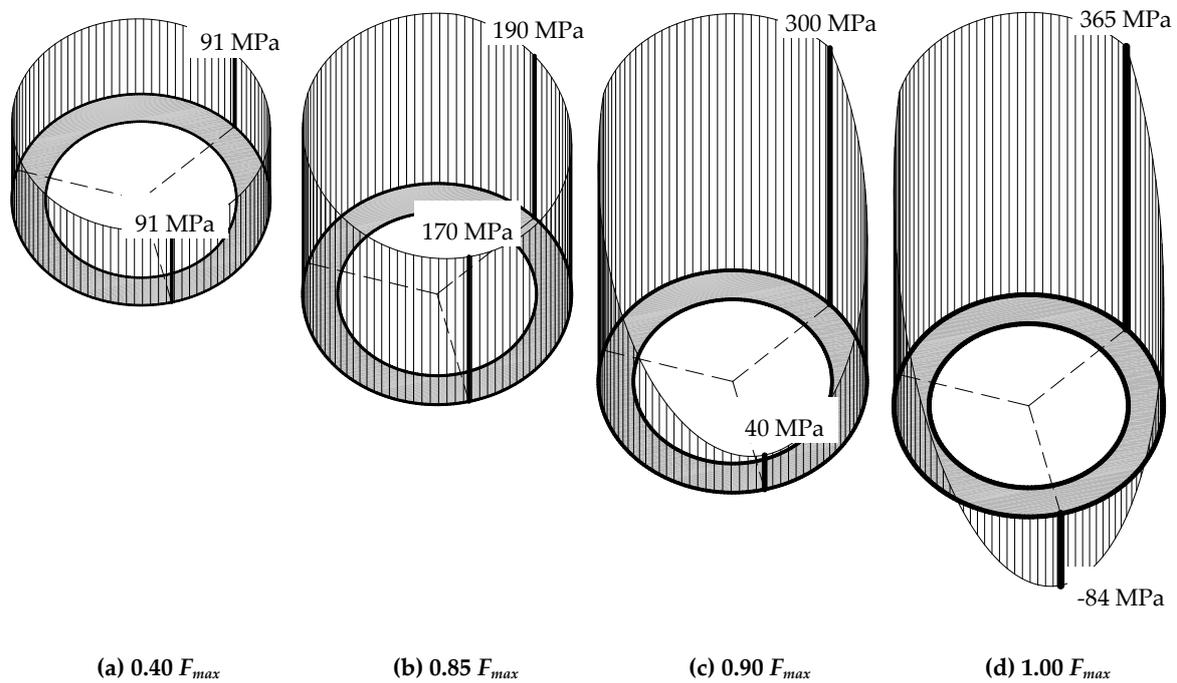
In Figure 12 the development of stress in the column cross-section in the subsequent stages of the test is presented. The stress was determined on the basis of the strain measurements and the nonlinear stress-strain relationship (see Figure 7, “-” denotes tensile stress). Up to about 80% of the ultimate force, the stresses in the cross-section were of a similar value and nature. By further increase in load, a decrease in stress, and then the change of its character into tensile, was observed. At the ultimate

load F_{max} , the maximum tensile stress was about 7.5 times lower than the maximum compressive stress in the cross-section.

Figure 12. Stress distribution corresponding to the subsequent load levels: (a) at 40%, (b) at 85%, (c) at 90% of the experimental load F_{max} , (d) at failure.

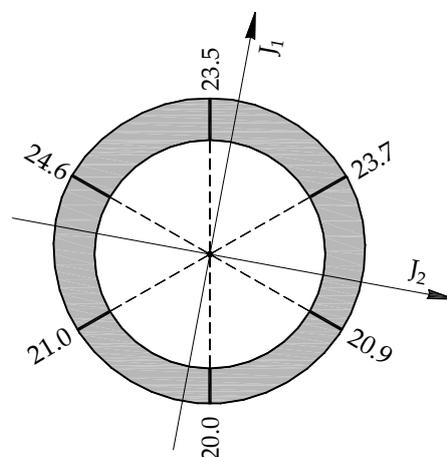
- cross-sectional area: $A = 10,526 \text{ mm}^2$,
- lowest moment of inertia: $J_2 = 29,995,276 \text{ mm}^4$.

Figure 13. Column cross-section at the point of failure initiation and the layout of the main central axes of inertia.

Taking into account the length of the tested column ($l = 3100$ mm) and the adopted static scheme (*Eulerian* pin-ended bar), the slenderness of the element was calculated as:

$$\lambda = \frac{l_0}{i_2} = \frac{l_0}{\sqrt{\frac{I_2}{A}}} = \frac{3100}{\sqrt{\frac{29995276}{10526}}} \approx 58,$$

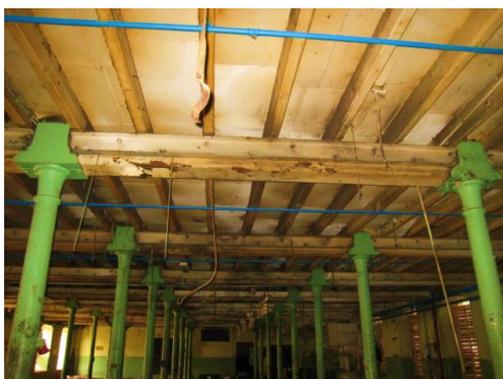
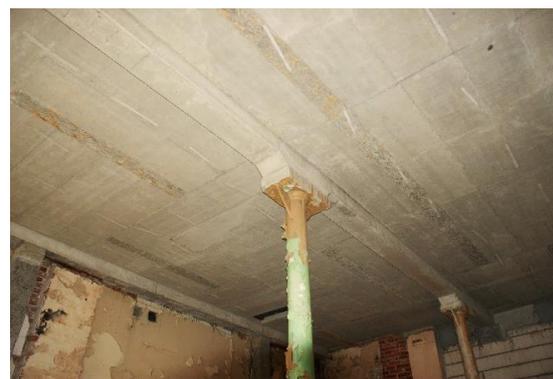
In the building of the former wool products factory, wooden ceilings were supported by external masonry walls and internal cast-iron columns. Due to the technical condition of the ceilings, it was decided to replace them with monolithic reinforced concrete ribbed slab, maintaining the original shape of the ceiling; see Figure 15. As a result of the change in the original use of the building from industrial to residential, the live load decreased, so the increase of permanent loads, resulting mainly from the self-weight of the reinforced concrete slabs, did not significantly affect the total load.

Figure 15. View of the ceilings in the factory building: (a) before the commencement of works, (b) during reconstruction.

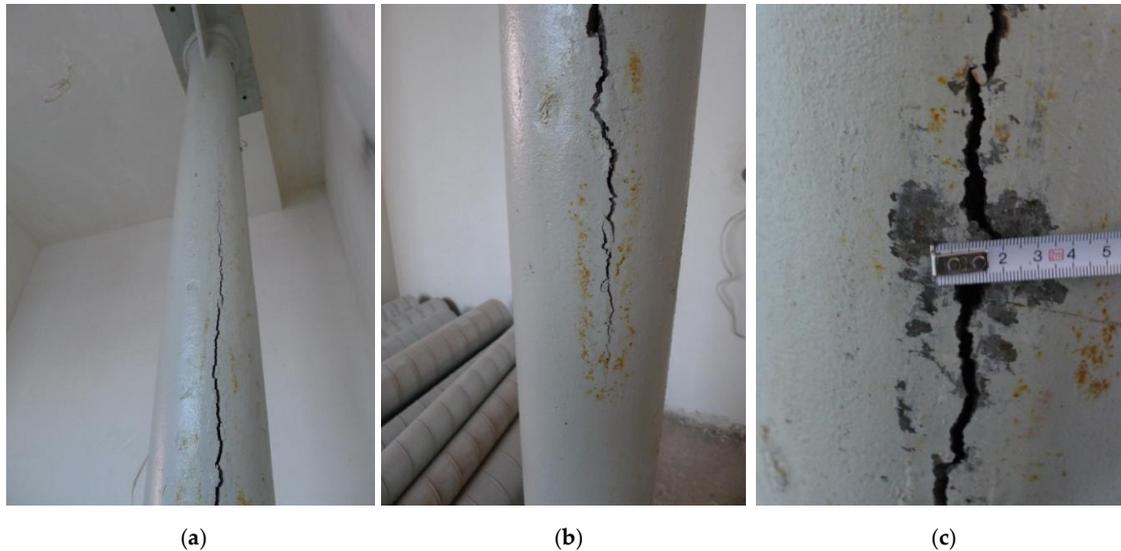
During the construction works that were carried out in winter, vertical cracks in the ground-floor columns were found. The width of these cracks was significant and in some cases reached a few millimeters; see Figure 16. Based on the inspections performed, it was found that their source was a frozen mixture of water, oil, and cement paste trapped inside the columns cross-section. The oil was

a remnant from the period of the facility’s operation as a spinning mill, while the water got inside the columns probably during the execution of concrete works. The tight cast-iron coat prevented the evaporation of water, which resulted in bursting of columns at temperatures of $-20\text{ }^{\circ}\text{C}$, which were noted in the winter of 2013.

Figure 16. View of the damaged cast-iron columns (visible cracks of a width of few millimeters): (a) room no. 1, (b) room no. 2, (c) detail of the crack.

The initial method of repair proved to be ineffective. The contractor for the reconstruction works tried to solve the problem on his own by welding the cracks. However, new cracks appeared soon in the vicinity of the weld joints, because water was not removed from the inside. As an alternative method of repair, steel rings along the cracks were proposed. An independent expert proposed the solution shown in Figure 17. It consisted of placing steel rings in the places where the cracks appeared [22]. The rings consisted of two halves joined by a single V-weld. In order to ensure the correct fit of the clamps to the column during the execution of the weld-joints, special pressure clamps with an elastic washer were used. The clamps were dismantled after the completion of welding. The number of rings was selected individually for each column, depending on the length of the crack.

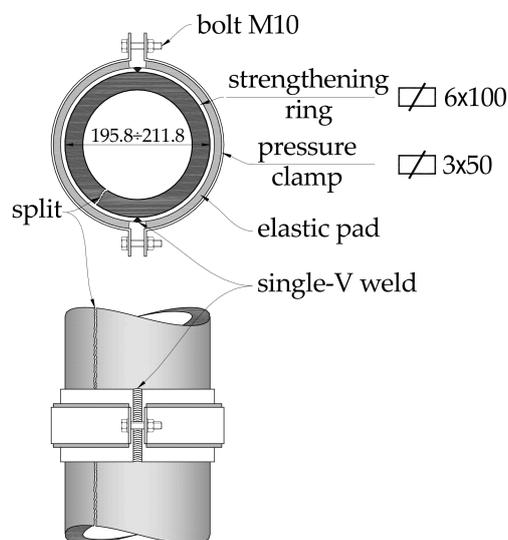
Figure 17. Detail of the strengthening of the broken cast-iron columns according to the idea of dr inż. J. Kozicki [22].

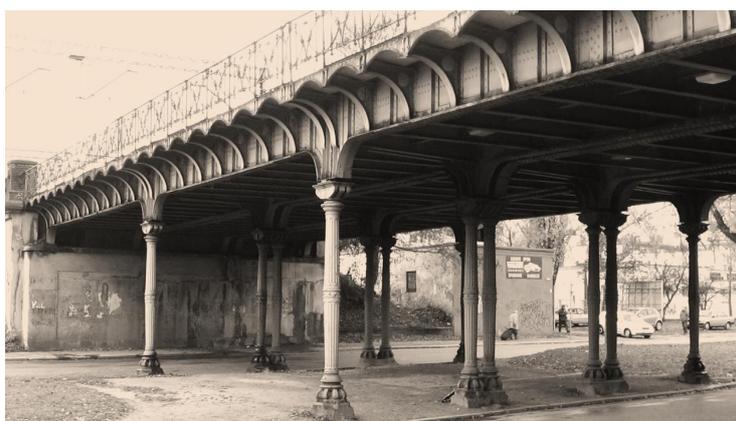
Figure 18. View of the rail overpass over Zaporoska Street in Wrocław.

Another spectacular example of a serious failure of cast-iron columns took place at the end of 2009 in Wrocław. As part of the works related to the modernization of the railway line, it was necessary to strengthen the supports of existing overpasses—pinned-pinned columns, so called Hartung's columns (*Hartungsche Säule*); see Figure 18. The project provided for increasing the load-carrying capacity of the cast-iron columns by filling them with a coarse-grained concrete mix. It was not an innovative solution. This method of strengthening was previously used successfully in Germany for over 300 columns [23]. The effectiveness of this method has also been proved by research conducted at the Berlin University of Technology [9]. Filling of cast-iron section with concrete enabled to increase the load-carrying capacity from 16% to 19%, with simultaneous reduction of deformations by 15 ÷ 35%.

The attempt to strengthen the columns in Wrocław, however, ended in failure. During the construction works carried out in December, the appearance of vertical cracks was found in several columns. The analysis of the causes of failure [23] showed that it was most likely the consequence of unconsidered changes in the original design. It assumed the use of a concrete mix with coarse aggregate, while any voids and cavities were planned to be filled with epoxy resin. Finally, a fine-grained mix (mortar) was used, with polyurethane resin as a filler, which required a lot of water for wetting the substrate, has been applied. Due to significant temperature drop during construction works, the water trapped inside the section froze and, as a result of the increase in volume, led to bursting of the columns; see Figure 19. Due to the risk of a structural failure, it was decided to immediately exclude the overpasses from use, which was associated with significant impediments in railway traffic.

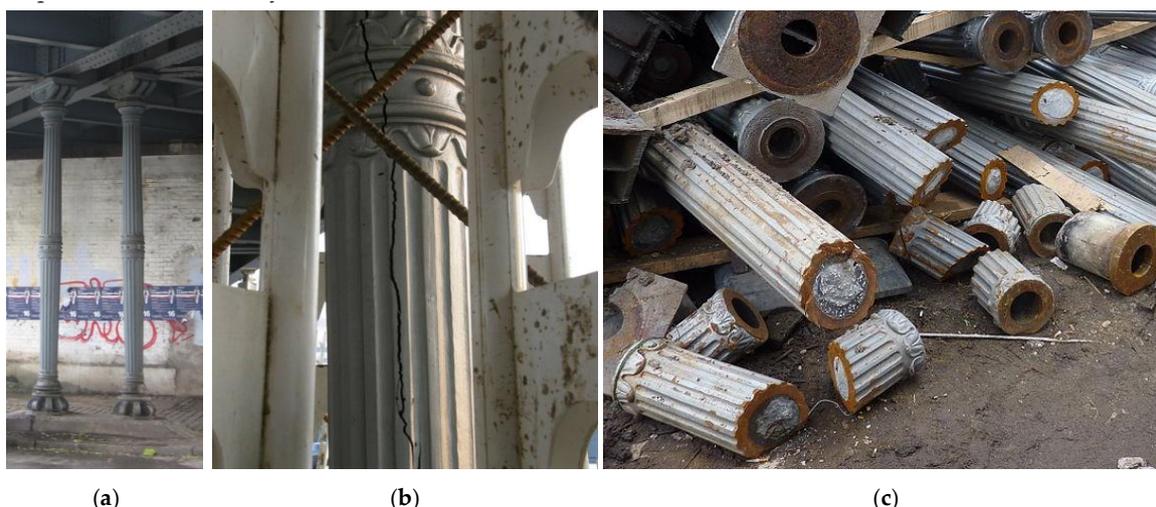
Figure 19. Hartung’s columns supporting the railway overpass at Stysia st. in Wrocław: (a) original elements, (b) view of the damaged column, (c) disassembled columns in the landfill.

Different methods of repair were considered, including strengthening the columns with carbon fiber mats and fabrics in the form of external coating (the effectiveness of such types of reinforcement was demonstrated, among others, in [11]). Finally, however, the contractor decided to replace all of the columns with the new ones, this time steel columns with a shape reminiscent of the original one. This decision was also dictated by the concern about the efficiency of filling the columns with concrete. As shown in the subsequent inspection, in many cases the defects in filling the columns reached even 1/3 of their height, which significantly limited the effectiveness of the designed strengthening method.
