Article

Non-Destructive Failure Detection and Visualization of Artificially and Naturally Aged PV Modules

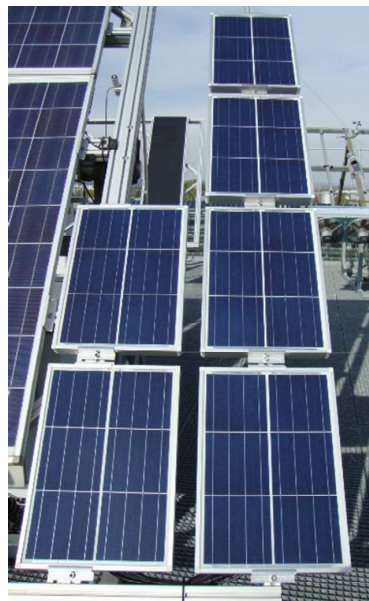
Figure 1. Outdoor test stand (Austrian Institute of Technology (AIT), Vienna, Austria).

- under accelerated ageing conditions, such as damp heat (DH in accordance with IEC61215 [23]) at 85 °C, 85% relative Humidity [r.H.] for 1000 h and 2000 h,
- under artificial irradiation (I) at 1000 W/m² of simulated sunlight with metal halide lamps (300–2500 nm) at a chamber temperature of 50 °C and 40% r.H. for 1000 h,
- under outdoor (OD) conditions (in middle Europe, Vienna and Austria) for 1.5 years (see Figure 1).

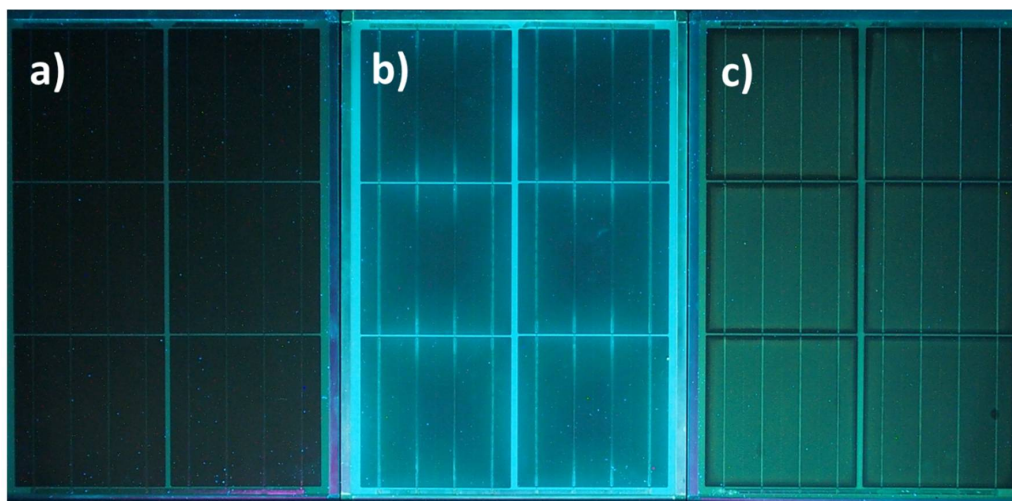
The original modules did not show any specific fluorescence behavior after manufacturing and light stabilization (see Figure 2a). Upon subsequent DH storage, however, the polymeric encapsulation showed fluorescing effects (Figure 2b). These effects were related to the ingress of water vapour into the polymeric encapsulant and were not homogeneously distributed over the whole module. The fluorescing effects were stronger above the backsheet and the rims of the cells. The broadness of the fluorescing rims increased with increasing storage time (related to water vapour permeating into the encapsulant via the polymeric backsheet).

Figure 2. UV-F images of three test modules: (a) one in the original state (stabilized); (b) one after storage under DH -conditions for 2000 h; and (c) one after exposition to artificial sunlight (1000 W/m^2) for 1000 h.

In contrast, upon irradiation with artificial sunlight, fluorescing groups were formed within the front encapsulant layer of the module (Figure 2c). The UV-fluorescence was evenly distributed in the polymeric encapsulation and increased in intensity with increasing irradiation doses. In our test setup, after 300 h of irradiation in the accelerated ageing test and after 12 months of outdoor storage, UV-F effects could clearly be detected in the encapsulation of the test modules. Between and at the rims of the cells, the fluorescence was extinguished by oxygen (bleaching) permeating into the encapsulation via the polymeric backsheet. The broadness of the extinct area at the cell rims increased with increasing weathering time.

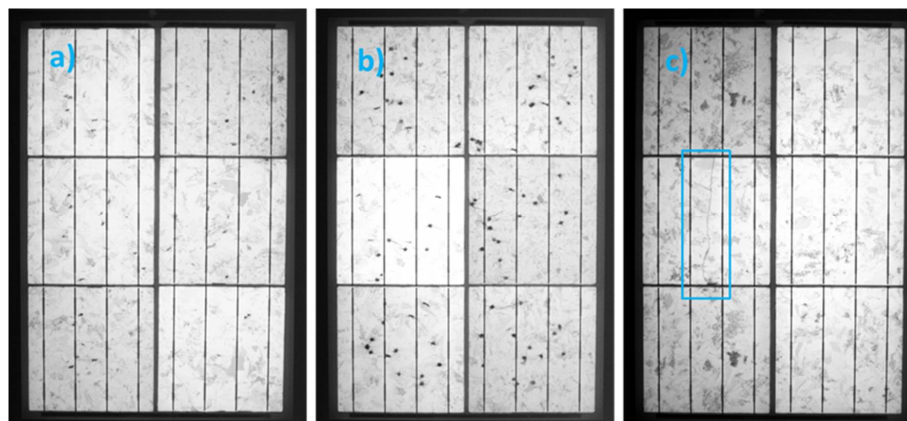
It has to be noted at this point that it was very difficult to generate a comparable number and size of (micro)cracks in the six test modules. As visualized in the EL images (see Figure 3), there were modules with few (*) and numerous (**) micro-cracks and others with cell cracks (+), and it was expected that their effects on degradation would be quite different.

Figure 3. Electroluminescence (EL) images at 10% short circuit current (I_{SC}) of three test modules with (a) few (*) or (b) numerous (**) micro-cracks or (c) with a cell crack (+).

One test module (no. 1-14), which showed a cell crack in the EL image (Figure 3c), supplied UV-fluorescence images upon DH storage, as shown in Figure 4. In addition to the fluorescence formed with increasing storage time above the backsheet and the rims of the cells, fluorescence was also observed above the cell crack making it detectable for the observer. It has to be noted that neither the performance (-0.1%) nor the EL image of this test module were changed drastically upon artificial ageing for 1000 h DH. With one module (no. 1-09), the cell crack increased in length following outdoor storage for 1.5 years by a factor of 2, and the performance increased slightly ($+1.1\%$).

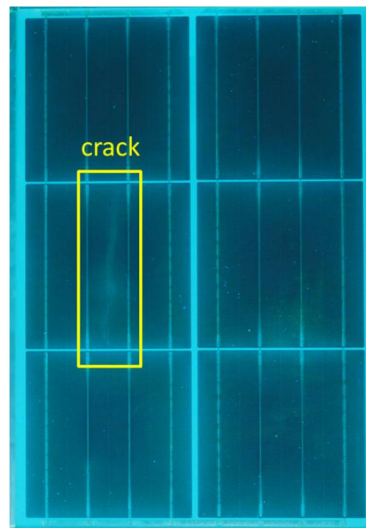
Figure 4. UV-F image of test module no. 1-14 after 2000 h DH showing a cell crack.

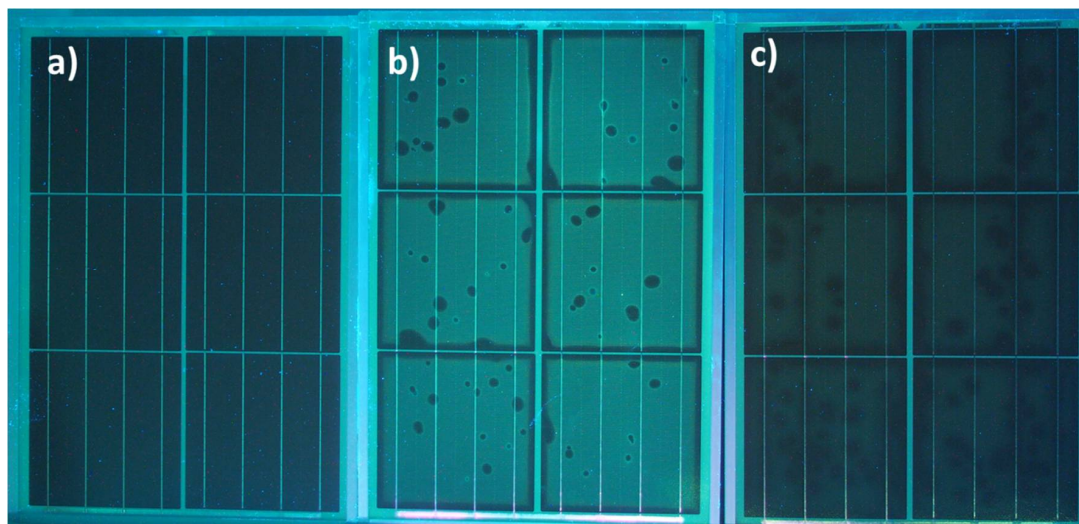
Upon irradiation with artificial sunlight and natural sunlight (see Figure 5b,c), the evolving fluorescence pattern of the test modules with micro-cracks clearly differed from those of the test modules without failures (see Figure 2).

Figure 5. UV-F images of three test modules with micro-cracks: (a) one in the original state (stabilized); (b) one after exposition to artificial sunlight (1000 W/m^2) for 1000 h; and (c) one after natural storage for 1.5 years.

The UV-F images taken every 100 h of accelerated weathering again showed a continuous increase in the intensity of fluorescence above the cells with unequivocally detectable intensities starting from 300 h. However, there were numerous dark spots where no fluorescence was generated (Figure 5b). In comparison with the EL image of that module, a clear correlation with the positions of the micro-cracks in the cells could be obtained. At the positions of the micro-cracks in the cells, the fluorescence was extinguished by oxygen (bleaching) permeating into the front encapsulation via the polymeric backsheets and cell cracks. In the outdoor weathering, the effect of UV-F in the front encapsulant was clearly detectable after 1 year showing extinctions (dark spots) at the locations of the micro-cracks in the cells (see Figure 5c; confirmed by parallel EL measurements).

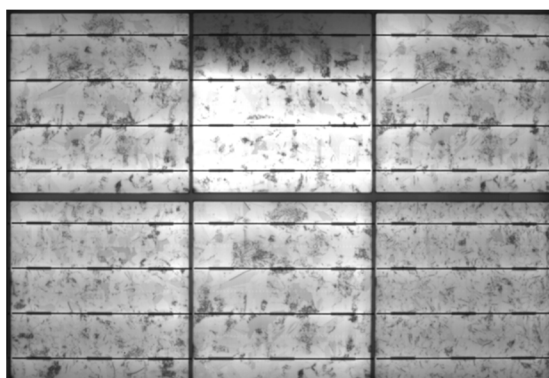
The EL images of the test modules with defects in the connection system (interruption of one connection ribbon of one cell in the six-cell test module) all showed—as expected—a darker region of one cell, with the rest of the affected cell being brighter (see Figure 6). This effect was visible in the EL image in the original state, after accelerated ageing (under DH or irradiation conditions) and outdoor testing. The electrical performances of these test modules (P_{MPP} , measured under STC- conditions) before and after ageing are summarized in Table 3. The power output of the original modules was only ~1% lower than that for the intact reference modules. This effect was due to a higher R_{SER} .

Figure 6. EL image at 100% I_{SC} of a test module with a defective cell interconnection in the original state.

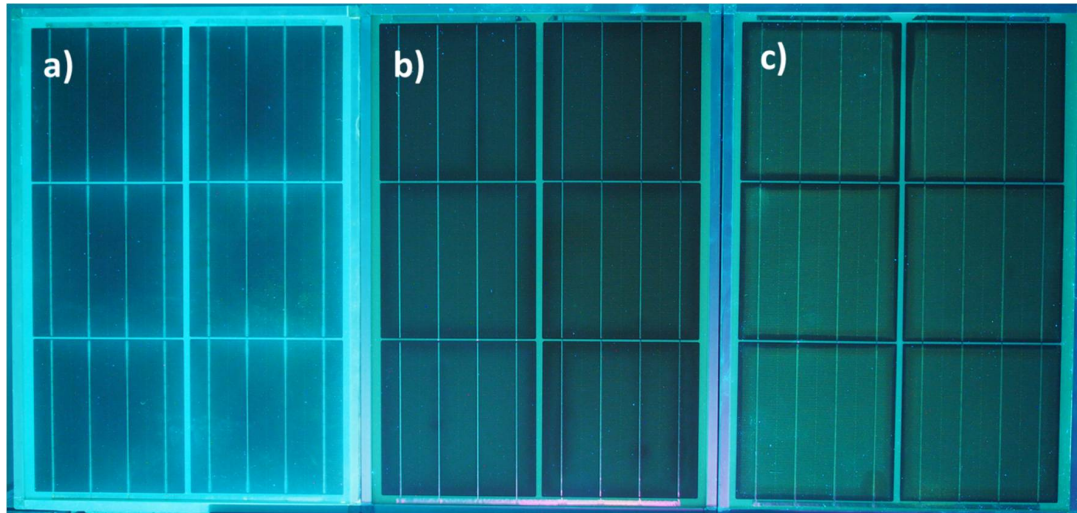
This comparison clearly shows that the UV-F pattern which appears under outdoor conditions (Figure 7b) resembles the fluorescence pattern observed after artificial aging (Figure 7c). However, the intensity of the UV-F above the cells is lower and the extinct area at the cell rims is broader, indicating a pronounced oxygen ingress.

Figure 7. UV-F images of three test modules with interconnector defects: (a) one after DH storage for 2000 h; (b) one after natural weathering outdoors for 1.5 years; and (c) one after indoor exposition to artificial sunlight (1000 W/m^2) for 1000 h.

Upon ageing, the test modules with a deliberately-generated connection defect behaved comparably to the intact modules (decrease in P_{MPP} after artificial irradiation by −1.2%, stable after DH storage, slight increase upon OD testing by +0.7%), and no stress-induced propagation of the failures could be observed in the test program applied. The UV-F images of the test modules with defects in the cell interconnectors were identical to those of the intact reference modules, irrespective of the stress treatment (see Figure 7).
