Article

# Physical Experiment and Numerical Modeling on the Failure Mechanism of Gob-Side Entry Driven in Thick Coal Seam

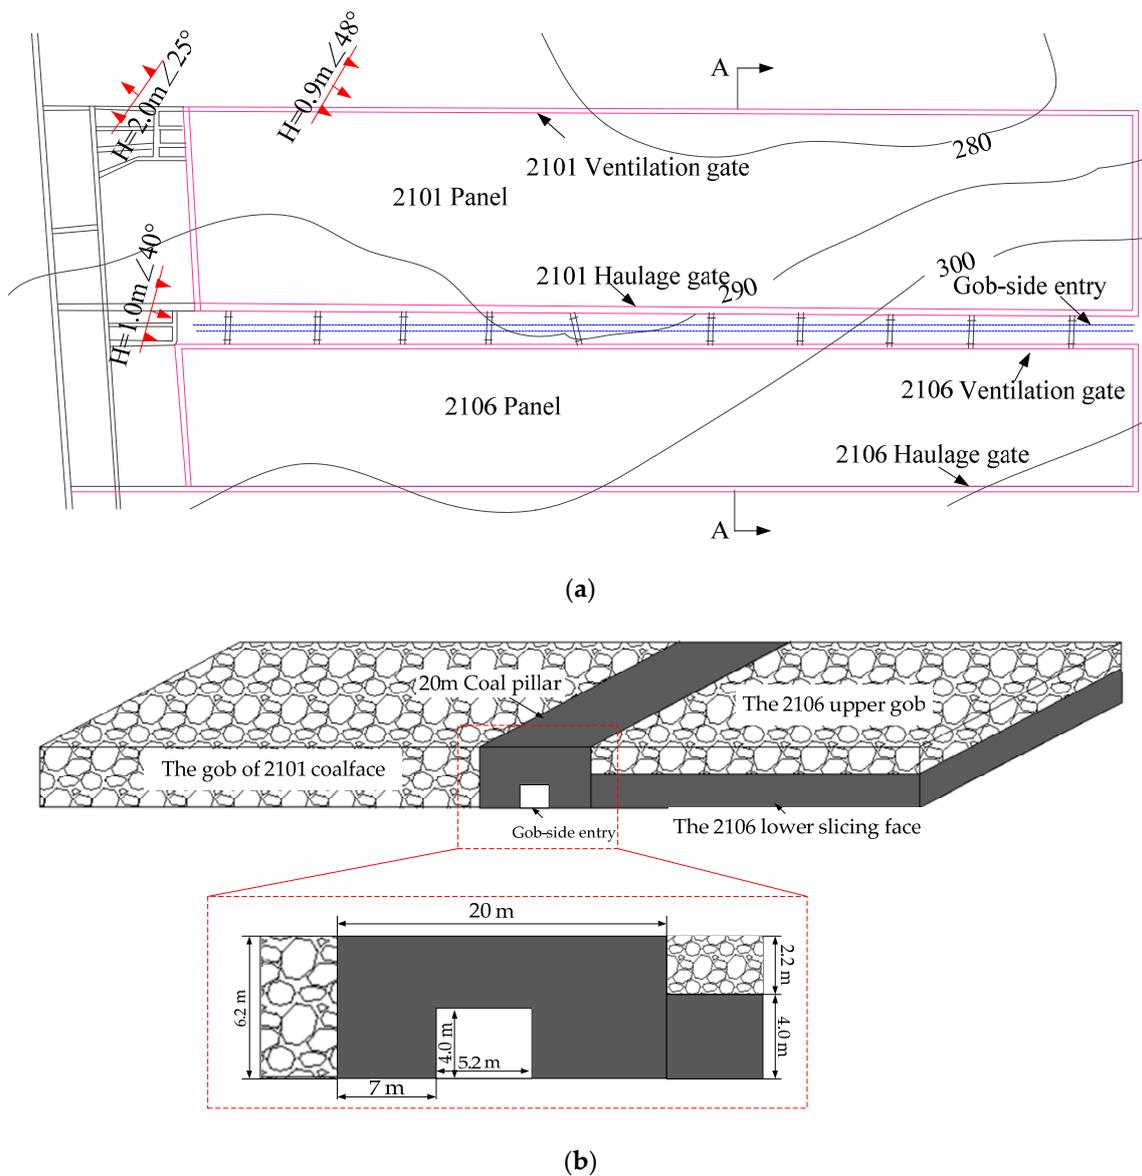
Figure 1 shows the working face position relationship and coal mining condition. Currently, the upper slice of the 2106 coalface has been excavated with a mining height of 2.2 m, and there was a 4 m-thick coal seam left in the lower slice. The 2101 panel was mined with a full seam. Finally, there was a 20 m-width coal pillar reserved between the 2101 gob and 2106 upper gob, which looks like an approximate isolated island coal pillar. Thus, in order to recover coal in the lower slice of the 2106 panel, the gob-side driving technology was applied in the current coalface. The roadway was driven along the 2106 gob with a coal pillar of 7 m-width. The roadway will experience a more complex stress environment, which leads to greater challenges for the support work.

**Figure 1.** Layout of working face and gob-side entry. (a) Working face location plan; (b) A-A section

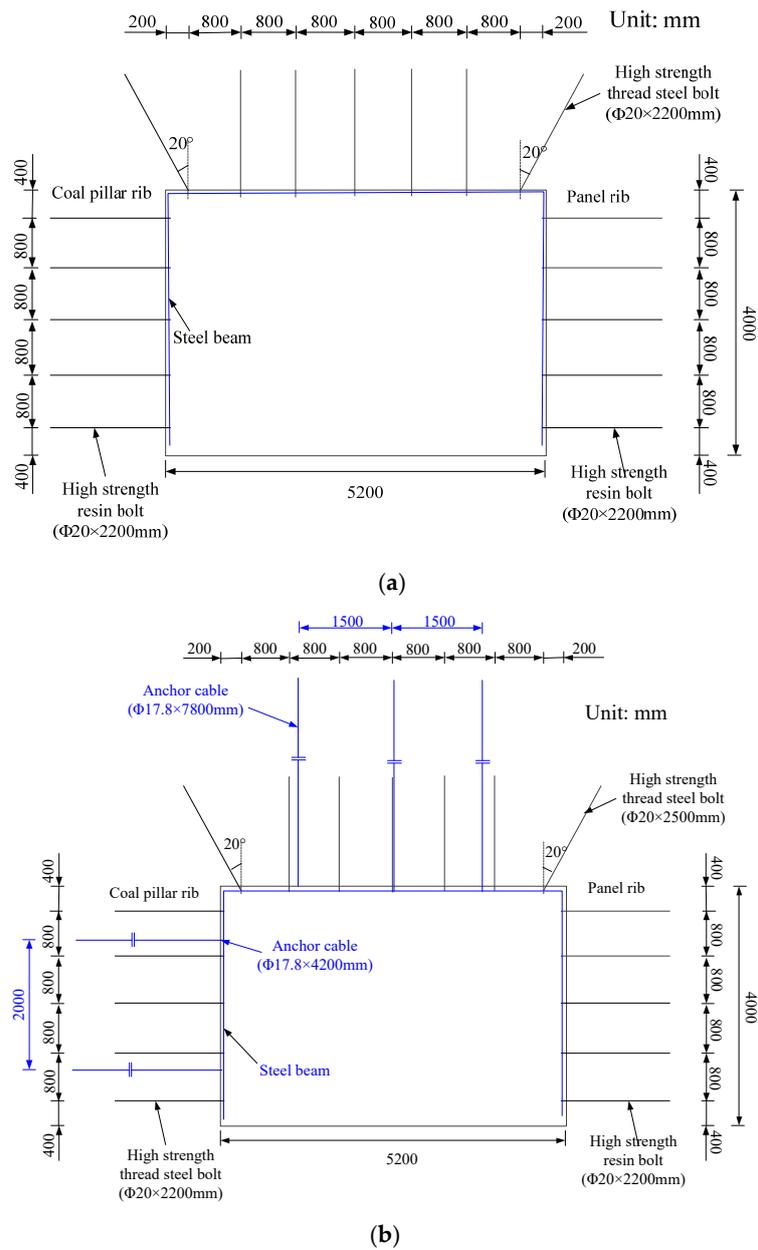
The roadway was arranged along the floor of the coal seam, with a cross-section of  $5.2 \times 4.0 \text{ m}^2$ . The roadway was primarily supported by a combination of bolts, cables, and W-shaped steel straps. The high-strength thread steel bolts were applied in the roof, and the two ribs were supported with the high-strength resin bolt of  $\Phi 20 \times 2200 \text{ mm}$ . The inter-row spacing of the roof bolts and rib bolts was  $800 \text{ mm} \times 1000 \text{ mm}$ . The detailed primary-support parameters were shown in Figure 2a. However, the gob-side entry underwent severe deformation under the primary-support parameters, as shown in Figure 3. The coal-pillar rib was seriously fractured and deformed, appearing to have larger expansion than the panel rib. Besides which, the roof also encountered large-scale sagging deformation (Figure 3c).

**Figure 2.** The primary- and optimized-support parameters. (a) Primary-support parameters; (b) optimized-support parameters.

Thus, to solve the large deformation problems of the roadway, the mine proposed the optimized-support parameters. First, three  $\Phi 17.8 \times 7800$  mm anchor cables were installed in the roof to strengthen the strength of the roof strata, and the length of the roof bolt was increased to 2.5 m respectively. In addition, the resin bolts used in the coal-pillar rib were adjusted as the high-strength thread steel bolt of  $\Phi 20 \times 2200$  mm, and two  $\Phi 17.8 \times 4200$  mm anchor cables were installed to improve the bearing capacity of the coal pillar. The detailed support parameters are displayed in Figure 2b.

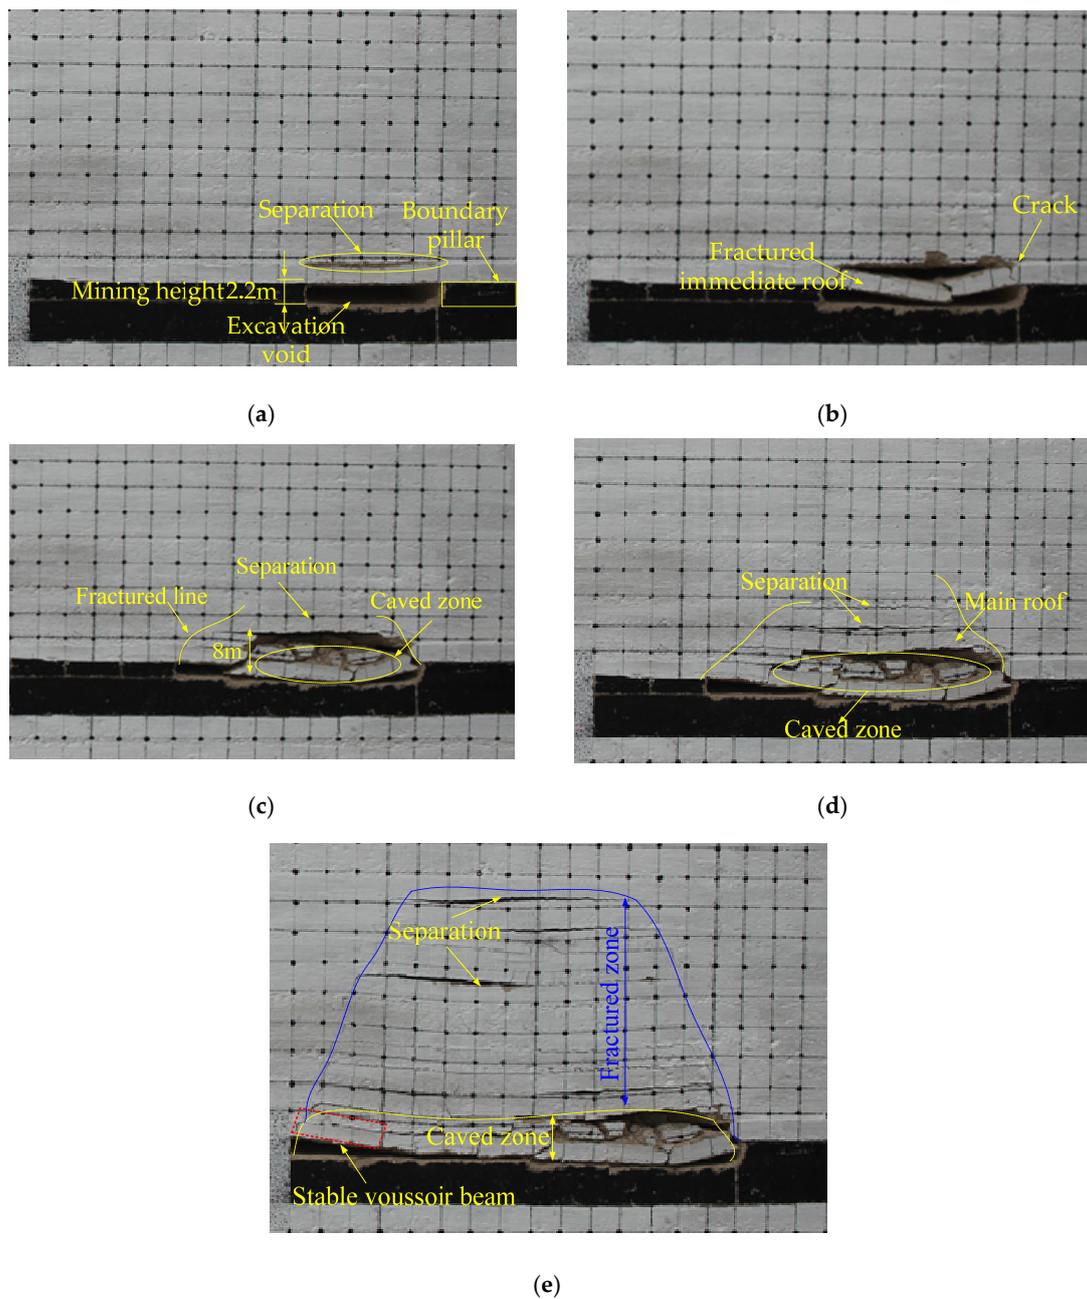
Figure 7 shows the roof strata movement and fracture evolution during the mining of the 2016 upper panel. When the coalface advanced 15 m (Figure 7a), an apparent separation crack could be observed in the immediate roof. As the coalface advanced 21 m (Figure 7b), the immediate roof began to break and caved in the gob, forming a voussoir beam structure above the gob. When the coalface advanced 33 m (Figure 7c), the above immediate roof continued to collapse, and a visible separation crack appeared in the main roof strata. When the coalface advanced 45 m (Figure 7d), the main roof began to bend and fracture, and the immediate roof caved in periodically. When the seam had been fully mined out (Figure 7e), the cracks and fractures further developed above the main roof, and the caved zone and fractured zone could be clearly observed. It also can be seen that the immediate roof broke in the form of a cantilever structure and caved in the gob with the advance of the coalface, and finally formed a stable voussoir beam structure above the edge of the coal wall.

**Figure 7.** Overlying strata movement process during the excavation of the 2106 upper panel. (a) Advanced 15 m; (b) advanced 21 m; (c) advanced 33 m; (d) advanced 45 m; (e) advanced 60 m.

The above experimental results indicate that: when mining the upper slice of the 2106 panel, the height of the excavation void is relatively smaller. The broken block can easily form a stable voussoir beam structure after a small rotation (Figure 7e). However, when mining the 2101 panel, the height of the excavation void increased to 6.2 m. With the increase of extraction height, the roof strata activity has been enhanced, and the movement space of the overlying rock has been enlarged. Thus, the stable voussoir beam cannot be developed under this condition—due to a large amount of rotation—and an overhanging cantilever beam was formed over the gob, as shown in Figure 8e. On the one hand, the heavy self-weight of the cantilever beam and the larger overburden pressure leads to a stronger abutment pressure in the lower coal pillar. On the other hand, the sudden breakage or rotation of the hanging roof may also result in a more considerable advanced abutment pressure or dynamic pressure, which greatly threatens the stability of gob-side entry [9,10,35]. Thus, it is vital to cut down the hanging roof to provide a more favorable stress environment for the excavation of the roadway.

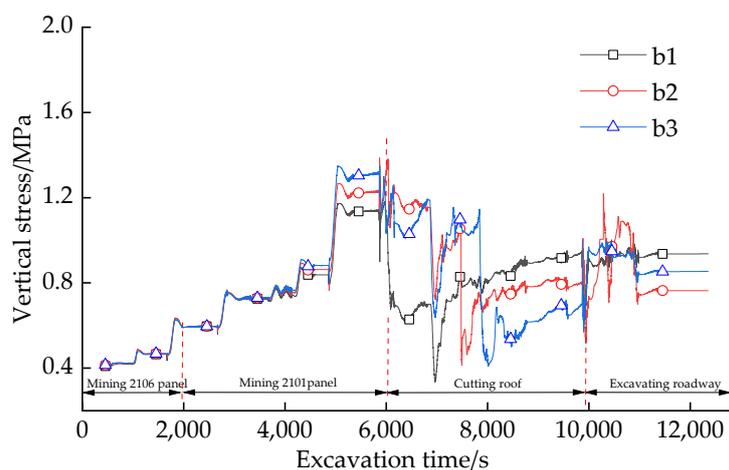
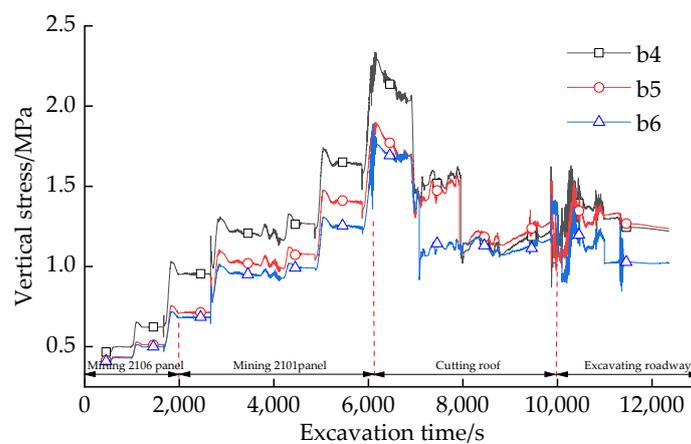
Figure 9 shows the stress evolution in the two ribs of the gob-side entry during the excavation of the two panels and the roadway. During the mining of the two panels, the vertical stress gradually increased with the advance of the coalfaces, forming a large stress concentration in the two ribs. It can also be observed that peak stress in the narrow coal-pillar rib (left rib) was more significant than that of the working-face rib (right rib). All of these may attribute to a large cantilever beam overhanging the lower coal pillar (Figure 8e), leading to a more substantial abutment pressure. After cutting the hanging roof, the vertical stress in the coal pillar gradually decrease to a stable state, providing a favorable stress environment for the gob-side entry.

**Figure 9.** The vertical stress evolution of the two ribs of the gob-side entry. (a) Panel rib near the 2106 lower panel; (b) coal-pillar rib near the 2101 gob.

Previous studies have proven that the overlying strata behaviors of mining a thick coal seam are different from those of a normal mining height [9,10]. The excavation of a thick coal seam can easily lead to a large hanging roof structure above the goaf, and a stable voussoir beam can be easily developed when mining with a normal mining height, which is consistent with the results of the physical experiments (Figures 7 and 8). The large hanging roof leads to more considerable concentrated stress in the underlying rock mass (Figure 9), which greatly threatens the stability of gob-side entry. According to the previous studies [35–37], the strong roof strata behaviors could be effectively solved by cutting down the hanging overlying roof strata. The physical experimental results also verified that the loads concentrated on the coal pillar were greatly reduced or released after the hanging cantilever caved into the gob (Figure 9).

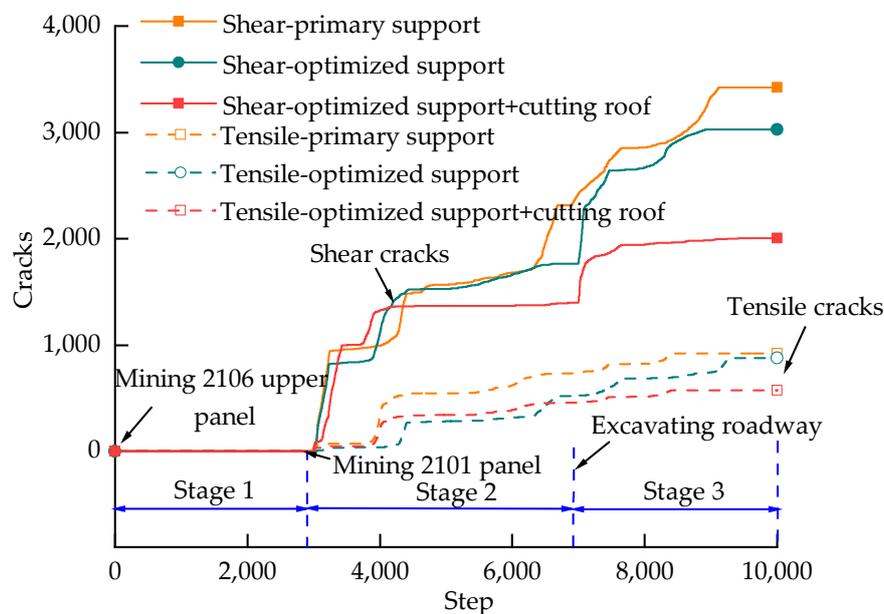
To further compare and analyze the evolution of cracks in the coal pillar at different excavation stages, a custom-made FISH program was developed to record the changes of tensile and shear cracks in the coal pillar with the same calculation steps, including the crack numbers and the accumulated length. The crack propagation of the coal-pillar rib at different excavation stages is shown in Figure 14. At the stage of mining the 2106 upper panel, there are almost no tensile or shear cracks generated in the coal-pillar rib, indicating that the excavation of the 2106 upper panel has a negligible effect on the crack development of the coal-pillar rib. When mining the 2101 panel, the abutment pressure applied on the coal-pillar rib increased significantly, resulting in a sharp increase of shear cracks and tensile cracks. After the roadway was excavated out, the concentrated stress formed in coal ribs caused further development of cracks around the roadway. It also should be noted that compared with the primarily supported roadway, the optimized-support roadway had a smaller increment in shear cracks during the roadway excavation stage. This is because the strengthened support improved the bearing performance of the coal pillar, thereby effectively suppressing the development of cracks. After adopting the roof-cutting measures, the propagation and generation of the cracks greatly decreased during the mining of the 2101 panel and the gob-side entry, which may be attributed to the concentrated stress caused by the hanging roof strata being significantly reduced.

**Figure 14.** Number of shear and tensile cracks with increasing calculation steps.

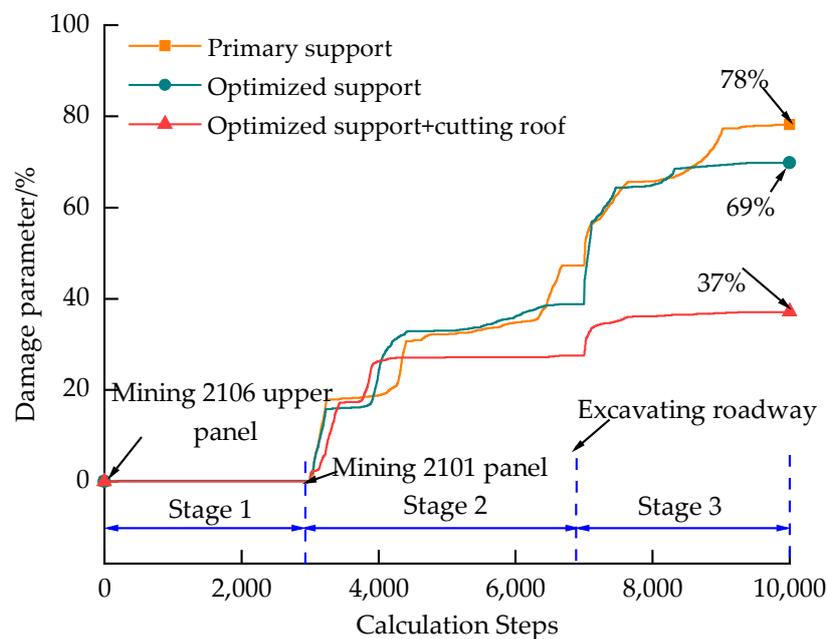
Figure 15 shows the damage evolution of the coal pillar during the excavation of the two panels and the roadway. During the excavation of the 2106 upper panel, the damage degree is close to zero, implying that the coal pillar underwent almost no damage. This is because that the coal pillar was still in the initial stress zone and not been affected by mining disturbance. When mining the 2101 panel, the damage parameter of the coal pillar increased rapidly and reached a steady value when the

movement of the overlying rock achieved a stable state. The cracks initiated and propagated from the edge of the coal pillar, and developed into a deeper area, which gradually deteriorated the integrity of the coal pillar. After the roadway was mined out, the equilibrium state of in-situ stress was broken, resulting in the stress concentration in the two ribs. As a result, cracks further developed around the roadway, which aggravated the damage to the coal pillar. Finally, the damage parameter of the coal pillar supported with the primary-support parameters reached 78%, implying the coal pillar almost lost its bearing capacity. After reinforcing the roof and the coal-pillar rib with the optimized-support parameters, the damage parameters decreased slightly, reaching 69%, which was still very dangerous for the stability of the coal pillar. However, after cutting down the hanging roof for the reinforced roadway, the damage parameters were greatly decreased to 37%, with a reduction of 52%, indicating that the integrity and stability of the coal pillar were significantly improved.

Figure 15. Evolution of damage parameters with increasing calculation steps.
