Effect of the Shape of Styrene–Acrylonitrile Water-Filter Housings on the Destructive Pressure, Crack-Initiation, Propagation Conditions and Fracture Toughness of Styrene–Acrylonitrile

Borut Zorc ^{1,2,*}, Matija Zorc ², Borut Kosec ² and Aleš Nagode ²

Abstract: A destructive pressure test of styrene–acrylonitrile (SAN) water-filter housings showed the influence of the shape and specific details of the housings on their critical areas and their destructive pressure. The destructive pressure varies by as much as 37 bar due to different dominant stresses in the individual types of housings. In critical areas of the housings, geometrical stress concentrators generally exist. For this reason, the stress caused by the internal pressure is locally 2.75–3.4 times greater than that expected based on the water pressure, which means that cracks are initiated in these places. However, the bottom of the housings can be in a form such that the maximum stress and the crack originates in its central part without the influence of local stress concentrators. The tensile strength of the SAN is theoretically estimated at 73 N/mm², which is comparable with the literature data. The fracture toughness

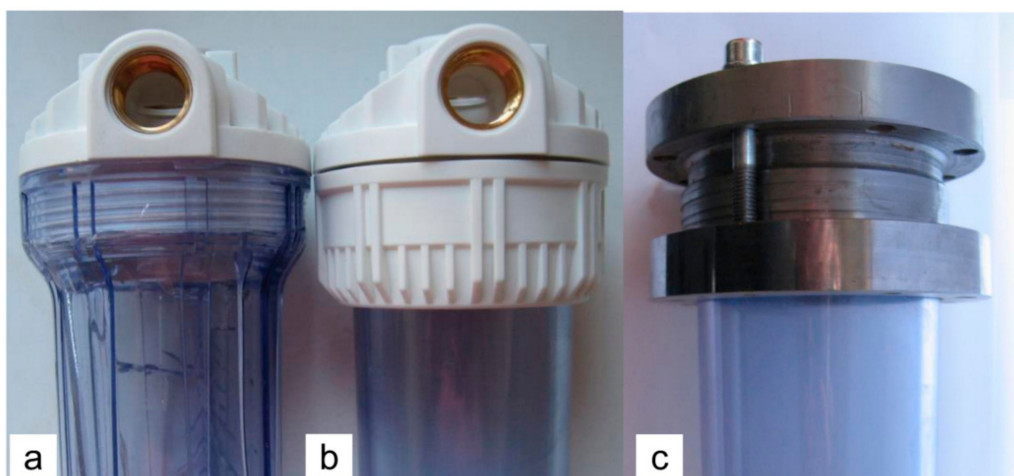
- A: the housing with the external ribs is directly threaded to the head of PP (Figure 2a),
- B: the housing without the ribs is fixed to the PP head with a PP nut (Figure 2b),
- C: the housing without the ribs is fixed to the steel head with a steel ring (Figure 2c),
- D: the housing without the ribs but a thicker base is fixed to the steel head with a steel ring (Figure 2c).

Figure 2. Different ways of fitting the housings to the head for the different samples (a) series A (b) series B (c) series C and D.

The critical area of the housing without the ribs, which is fixed on the filter head with the nut (both made of PP), is the nut. The fracture exists along the threaded groove of the nut, which divides the nut into two rings. Since the SAN housing was not damaged, we did not investigate this case.

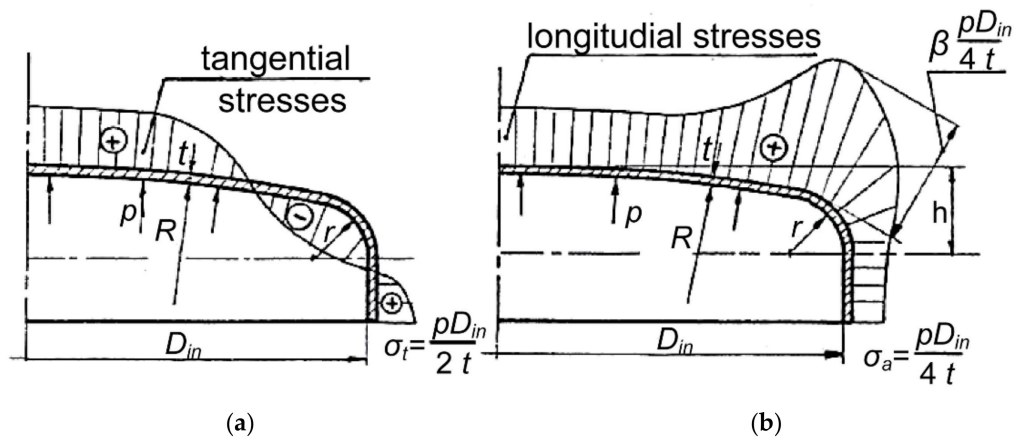
The critical part of the pressure vessel (if it does not have enough large stress concentrators on the wall) is always the transition of the cylindrical part to the bottom or its bottom. In this area the radial, tangential, and axial stresses are generated due to the internal pressure (Figure 9).

Figure 9. Stresses in the wall of the bottom due to the internal pressure in the vessel (a) tangential stresses (b) axial stresses [8].

The longitudinal (meridian) stresses are the greatest at the contact point of the arcs of the larger and the smaller radii. Therefore, they are decisive for the dimensioning of the bottom of the vessel and are usually always expressed as a multiple of the axial (longitudinal) tensile stresses of the cylindrical part of the vessel [8]. The less convex is the bottom and the smaller is the transition radius of the cylindrical part of the vessel into the base, the greater are the meridian stresses [8]. This means that the maximum stresses exist with a flat bottom, which is also characteristic for the base of the water-filter housings. Additionally, it is necessary to consider the method of fitting the base of the housing, which can be supported or fixed. Regardless of the fitting, radial and tangential stresses are the same in the center of the round bottom.

stress is only $\sigma_r \approx 34 \text{ N/mm}^2$. Some maximum stress in the wall thickness $t_w = 4.3 \text{ mm}$ therefore exists somewhere outside the region of maximum stresses (see the schematic distribution of the longitudinal stresses in Figure 9b). The stress is certainly greater than $\sigma_r \approx 34 \text{ N/mm}^2$ and due to the absence of the initial site, it is lower than the strength of the material. So what are the stresses on the edge in the curved part, where at the end of the pressure test, the base is torn off? Since the exact distribution of the meridian stresses in the region of curvature is not known, we assumed that the radial and tangential stresses were very similar in absolute value and then used Equation (5) to estimate the stress. The calculation shows that the tangential stress at the edge, taking into account $D_{in} = 60 \text{ mm}$, $t_w = 4.3 \text{ mm}$ and $p = p_d = 50 \text{ bar}$, is $\sigma_t \approx 55 \text{ N/mm}^2$, which is $0.75R_m$. If we take into account that the stress-intensity factor at the tip of the propagating cracks is maintained, this value of longitudinal stress is definitely sufficient for its stable growth. Since the transverse cracks between the triangular segments were propagated from the internal surface to the external surface of the housing, the stress-intensity factor is further increased by the effect of the water pressure, which further opens the crack. And since the crack along the wall grows much faster than in the depth, at the end of the destructive pressure test, a carrier cross-section in the curved part is small enough that the stress in the curved part exceeded the strength of the material. At the same time, the tangential stress in the cylindrical part of the housing without the external ribs is only $\sigma_t \approx 41 \text{ N/mm}^2$ ($D_{in} = 70 \text{ mm}$, $t_w = 4.3 \text{ mm}$, $p = p_d = 50 \text{ bar}$ and $K_t = 1$) according to Equation (1) and has no effect on the final bursting of the housing.
