Erosion–Corrosion of 30°, 60°, and 90° Carbon Steel Elbows in a Multiphase Flow Containing Sand Particles

Abstract: Erosion–corrosion in flow changing devices as a result of sand transportation is a serious concern in the hydrocarbon and mineral processing industry. In this work, the flow accelerated erosion–corrosion mechanism of 90°, 60°, and 30° long radius horizontal–horizontal (H–H) carbon steel elbows with an inner diameter of 50.8 mm were investigated in an experimental closed-flow loop. For these geometrical configurations, erosion–corrosion was elucidated for erosive slug flow regimes and the extent of material degradation is reported in detail. Qualitative techniques such as multilayer paint modeling and microscopic surface imaging were used to scrutinize the flow accelerated erosion–corrosion mechanism. The 3D roughness characterization of the surface indicates that maximum roughness appears in downstream adjacent to the outlet of the 90° elbow. Microscopic surface imaging of eroded elbow surfaces disseminates the presence of corrosion pits on the exit regions of the 90° and 60° elbows, but erosion scars were formed on the entry regions of the 30° elbow. Surface charact

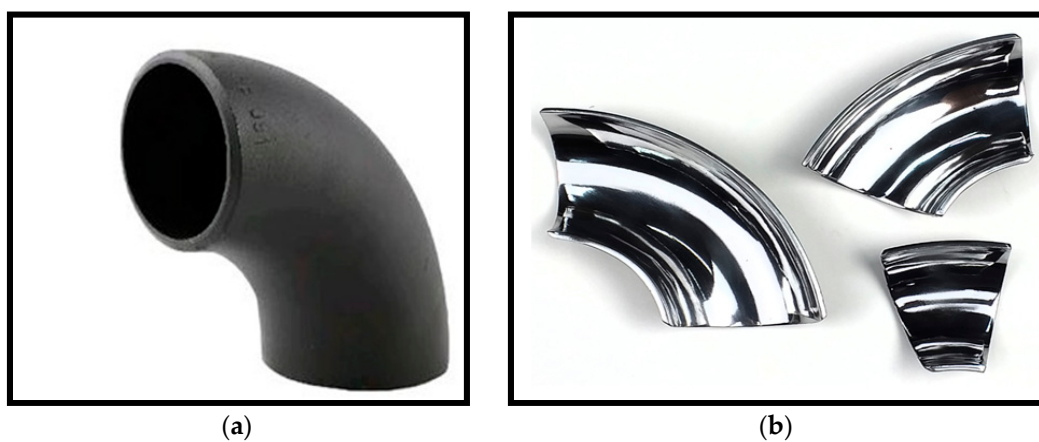
Figure 1. Carbon steel elbow specimen. (a) As received, and (b) fine polished axially cut sections.

The target carbon steel elbow configuration used for the erosion tests was axially cut using an EDM wire cut machine in two sections, the bottom half (BH) and upper half (UH), as outlined in Figure 1. The test elbows' inner walls were ground using 400, 600, 800, and 1200 grit size of the sandpapers and then polished using 1 μm crystalline diamond suspension, degreased in ethanol, dried, and placed in desiccators to avoid exposure of the sample to moisture before the tests. The material loss was measured using a METTLER TOLEDO precision balance and the test elbow chemical composition listed in Table 1 was extracted by the optical emission spectroscopy method. Carbon steel was used as the test material and fine silica sand was used as a dispersed phase in all erosion experiments. The

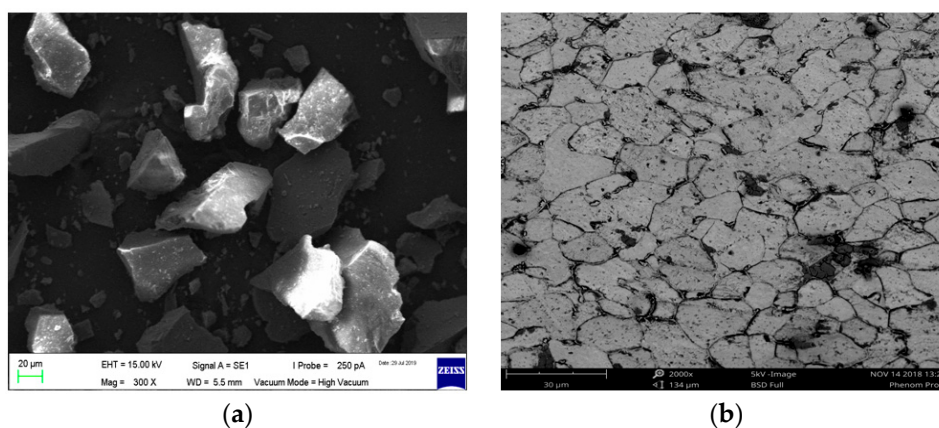
Figure 2. Microstructures of (a) silica sand and (b) carbon steel.

sand size distribution was quantified by means of a laser scattering particle size distribution analyzer. The result gives an average erodent size of $50 \pm 2 \mu\text{m}$. A microstructure of the silica sand and test material is presented in Figure 2. Surface characterization was done by a Sensofar S lynx microscope in confocal mode and the surface parameter was computed at the inlet, middle, and outlet sections of all tested elbows. Surface profiling was conducted to obtain 3D topographies of the worn surface and to determine the surface roughness of the 90° , 60° , and 30° elbows. Specimens of $10 \text{ mm} \times 10 \text{ mm}$ in size were cut using EDM from the entry, middle, and exit regions of elbows after the erosion–corrosion test for the surface characterization. The most significant surface roughness parameters are the arithmetic mean surface parameter and maximum pit depth. The arithmetic mean height (S_a) is the mean surface roughness of the worn surface, while the maximum pit depth (S_v) gives information about the pit depth distribution. In order to extract roughness parameters of the assessed 3D surface topography, waviness components are suppressed and filtered out using areal Gaussian filter (ISO 16610-61).

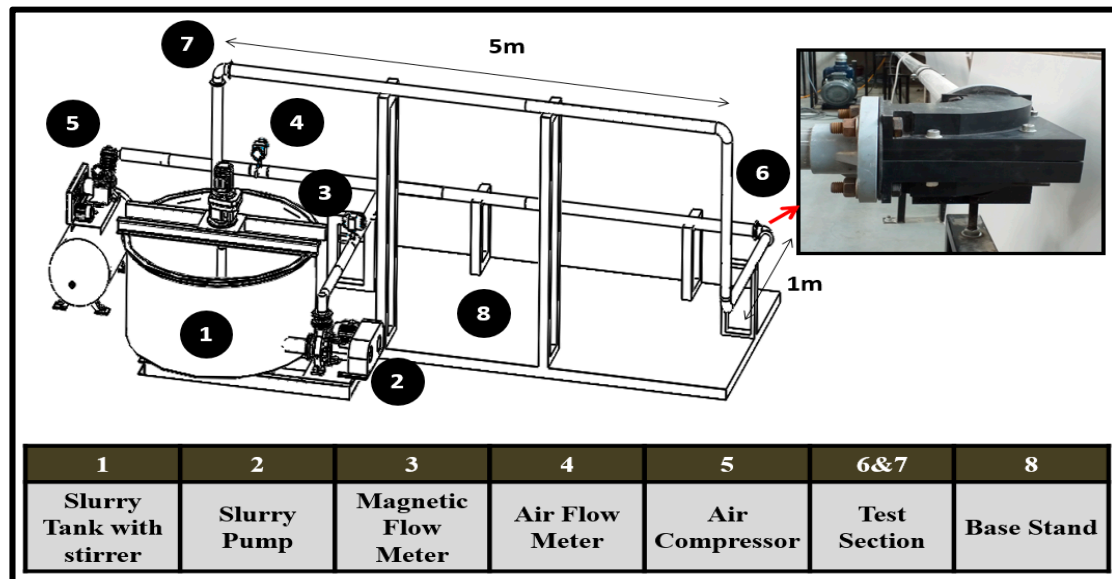
Figure 3. The experimental setup used for the present investigation.

The multiphase flow loop experimental facility at Universiti Teknologi PETRONAS is locally fabricated and configured (Figure 3), where different geometric elbow configurations can be tested for gas–liquid–solid slug flow conditions. The flow loop consists of a transparent pipe section of 5 m

in length to visualize flow pattern inside pipelines, and the 50.8 mm elbows test section (Figure 3) is mounted in a horizontal–horizontal orientation, where the elbow BH and UH sections are placed, and erosion-induced damage is studied using the multilayer paint modeling and material loss methods. The carrier phases are water and air for the present study, while the dispersed phase is sub-angular fine sand. The chemical compositions of silica sand are listed in Table 2. Although the experimental setup has two elbows mounted in a horizontal–horizontal and horizontal–vertical orientation, in this study, only the horizontal–horizontal orientation will be addressed. The experimental data point for slug flow is selected based on Madhane et al.’s [27] flow pattern map.

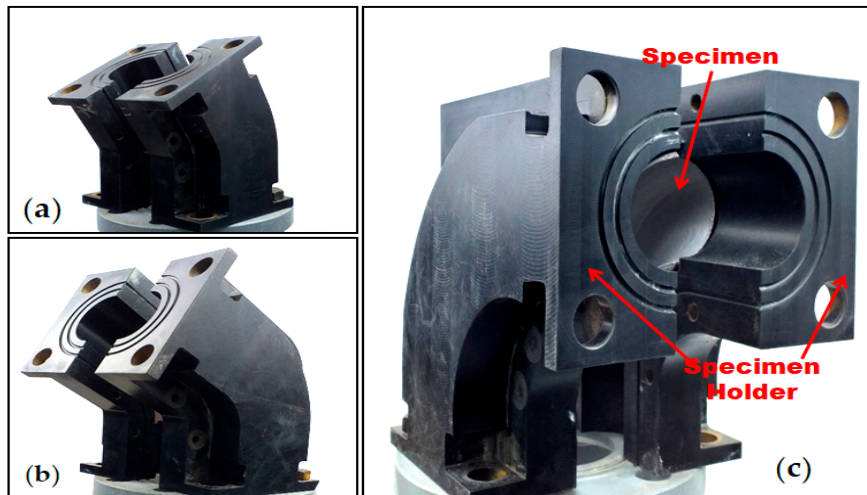
Figure 4. Section of (a) 30° (b) 60°, and (c) 90° elbows.

The test specimen holders of the experimental setup (Figure 4a–c) were fabricated with thermoplastic material with the cavity of the half elbow pipe configuration machined using a CNC machining unit to place the test elbow inside the test section. To identify the erosion zones and the erosion severity inside the elbow configuration, the elbow pipe is cut axially in two sections, the bottom half (BH) and upper half (UH), before the test and painted with two layers of enamel paint on the internal surface. From the paint removal of the first layer, it is possible to identify the maximum erosive location inside the elbow pipe. Figure 4c shows an elbow sample mounted inside the test section, fabricated with two thermoplastic blocks with the cavity of elbow inside the blocks. For each experiment, the block was bolted together after placement of the sample to make an elbow pipe, and three samples are tested for repeatability and accuracy of the test. Then, a visual inspection is performed to identify the removed paint locations, and those paint erosion patterns give an approximation of the location of the maximum particle collision. The maximum erosion observed utilizing paint removal patterns towards the end of the study is compared to that utilizing the paint removal patterns in different elbow angular configurations to understand erosion mechanism. After identification of maximum erosion zones, the test was repeated with the polished specimens for quantification of the erosion–corrosion rate. All multilayer paint tests were repeated multiple times to ensure accuracy. However, in the erosion–corrosion quantification, the uncertainty originates from the non-uniform

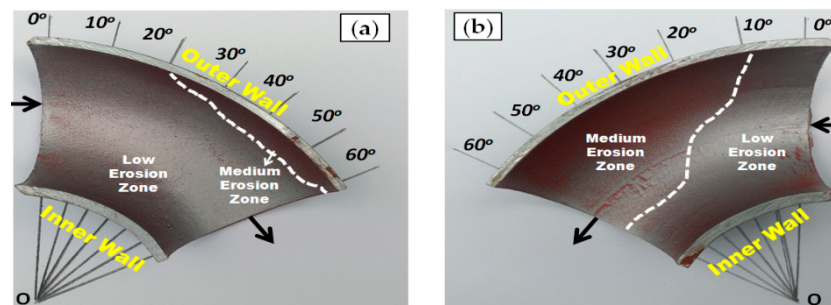
Figure 6. Paint erosion pattern for slug flow with $V_{SL} = 0.5$ m/s, $V_{SG} = 2.5$ m/s in a 60° horizontal–horizontal elbow section. (a) Bottom half; (b) upper half.

Figures 5–7 illustrate the qualitative indication of the paint erosion distribution in the bottom half (BH) and upper half (UH) of the three different elbow specimens for slug flow, respectively. The MPM test conditions were slug flow pattern ($V_{sG} = 2.5 \text{ m/s}$ and $V_{sL} = 0.5 \text{ m/s}$), fine sand particles with 2% (wt/wt) concentration, and flow time of 60 min for all cases (MPM tests without sand particles are reported in Figures S1–S3 (Supplementary Materials)). The extracted paint erosion distribution results in the bottom half (BH) and upper half (UH) sections of 90°, 60°, and 30° elbow configurations being compared to identify the highest erosion locations. A visual inspection indicates that an unsymmetrical erosion distribution is obtained for the horizontally oriented 90°, 60°, and 30° elbows, and less erosion is perceived in the bottom half (BH) section compared with the upper half (UH) elbow section for erosive slug flow conditions. The erosion distribution results with MPM techniques match closely with the research findings of other authors [20,22], and found that the top of the 90° elbow experiences more erosive damage in multiphase flow.

Figure 6 illustrates that the partially removed layers of paint on the outer wall were visible on the 60° elbow pipe surface, but are very minor compared with that of the 90° elbow pipe. In contrast, the medium erosion zone is observed in the inner wall of the 30° elbow (Figure 6) compared with the 60° elbow pipe with the medium erosion zone at the outer wall (Figure 7).

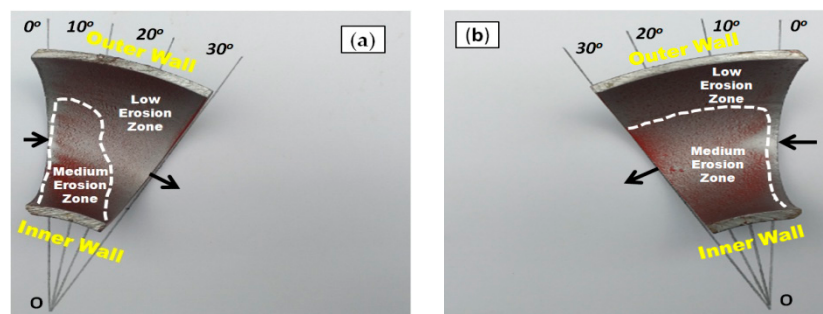
Figure 7. Paint erosion pattern for slug flow with $V_{SL} = 0.5$ m/s, $V_{SG} = 2.5$ m/s in a 30° horizontal–horizontal elbow section. (a) Bottom half; (b) upper half.

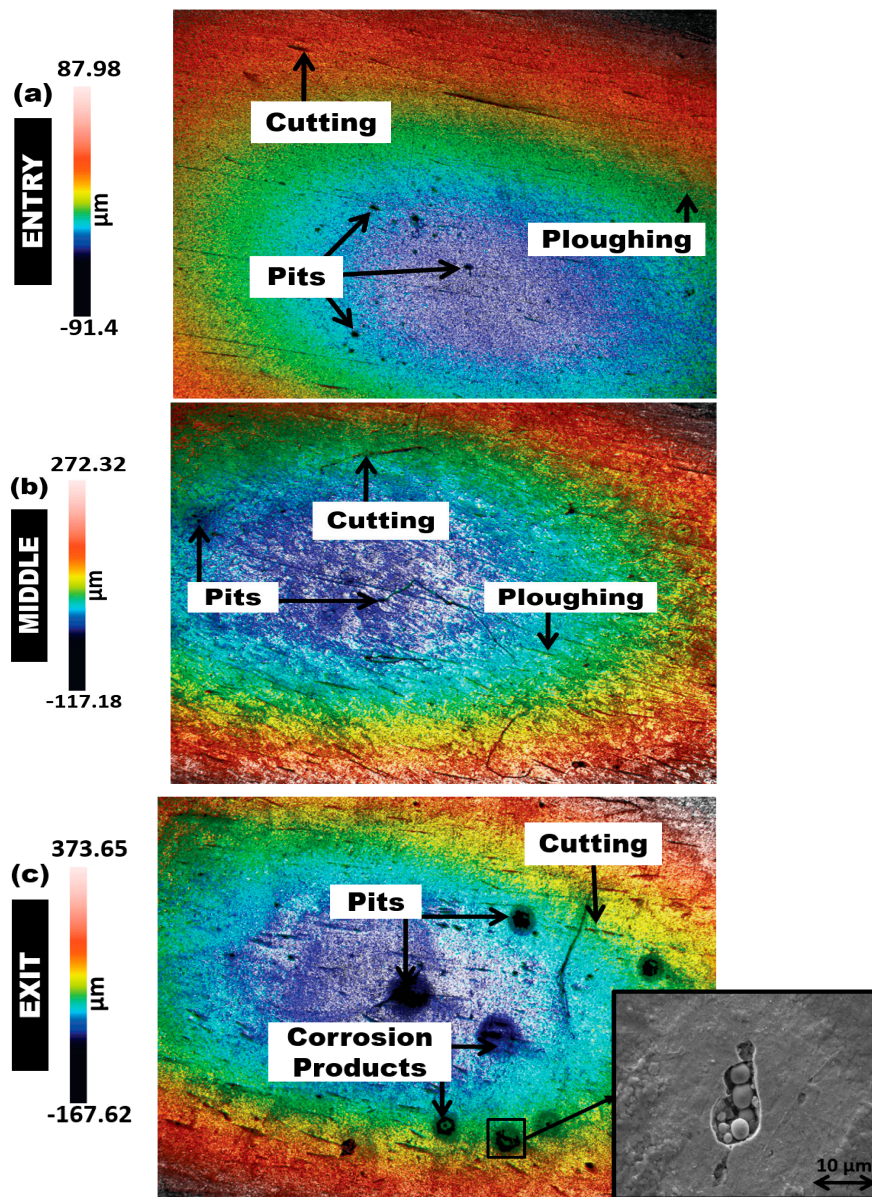
Figure 8. Confocal micrographs after erosion–corrosion: surface topographies of 90° carbon steel elbows. (a) Entry section; (b) middle section; (c) exit section.

Figures 8–10 show the 3D surface topography scan taken from non-contact surface profiling of worn surfaces of the inlet, middle, and outlet sections of the elbows tested under erosive slug flow for 2% (wt/wt) sand concentration (surface profiles after the test are reported in Figures S4–S6 (Supplementary Materials)). It can be observed that the downstream section of the 90° and 60° eroded elbows are similar, while the 30° elbow shows more cutting wear with several erosion scars compared with the 90° and 60° elbow inlet section (Figure 8a, Figure 9a, and Figure 10a). In contrast, the magnitude of the erosion–corrosion degradation at the downstream adjacent to an outlet is severe for the 90° elbow configuration, which suggests that pitting action contributing to the overall erosion wear could be the dominant degradation mechanism, as shown in Figure 8c.

In the slug flow regime, micro-sized pits with cutting wear were spotted in the middle region of the 90° and 60° elbow configurations (Figures 8b and 9b), while that of the entry region (Figures 8a and 9a) appears to be less rough for the 90° and 60° elbow. In contrast, large pits with corrosion zones are observed adjacent to the outlet of the 90° and 60° elbows tested for the slug flow regime (Figures 8c and 9c). This could be because the wide-angled elbow strongly influences particle–wall interactions and escalates the kinetic energy of particles and the consequent increase in material degradation. Generally, the difference in the wear mechanism across the elbows’ surface can be ascribed to the observation that the fine sand was transported with both air and water phases inside the pipe. In slug flow, sand mostly settles at the bottom of the elbow, and then the moving carrier phase aggregates the sand and induces acceleration. In addition, the sand concentration and impact velocity seem to be higher in the upper half section for slug flow [22,31], and resulted in a high turbulence zone owing to the high particle concentration and impact velocity in the upper half section of the elbow configurations.

The confocal micrographs of the wear surfaces of the 90°, 60°, and 30° elbows after performing the erosion–corrosion test, presented in Figures 8–10, clearly indicate that the internal surfaces are dominated by corrosion attack and pitting erosion with cutting wear. This material degradation process seems to increase the extent of erosion–corrosion in the wide-angle elbow for slug flow conditions. However, the magnitude of the flow accelerated erosion–corrosion damage in the wide-angle elbow is more than those of the small-angle elbows under the same operating conditions. Under slug flow conditions, material removal in the 60° elbow also occurs by pitting, ploughing, and abrasive wear, but because of less penetration energy of particles, the magnitude of surface damage is disparaging, which is consistent with the internal surface topographies presented in this section.

In the cutting mechanism (occurs at the exit surface of the 90° elbow), the erodent penetration energy is higher and the observed scars are shorter than the scar pattern obtained in the entry and middle sections. In addition, corrosion products with large pitting in the 90° and 60° exit section of the

elbows (Figures 8c and 9c) are symbols of plastic deformation owing to the repeated impact of the erodent. This implies that, in the wide-angle elbows' configuration, the cumulative effect of cutting wear and impact wear enhances the erosion–corrosion damage.

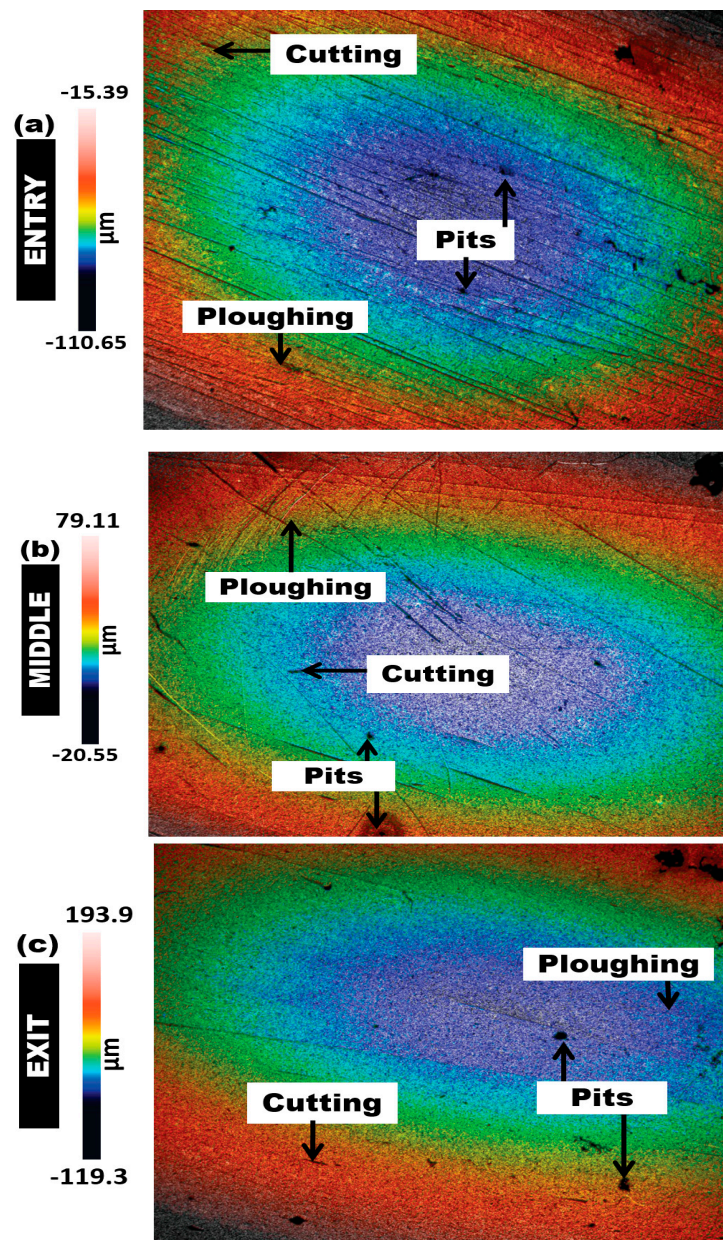
Figure 10. Confocal micrographs after erosion–corrosion: surface topographies of 30° carbon steel elbows. (a) Entry section; (b) middle section; (c) exit section.

On the basis of microscopic analysis, the identified dominant erosion–corrosion mechanisms are cutting and pitting, which occur at the surface of all specimens, regardless of angular configuration. However, larger erosion and/or corrosion pits only occur at the exit section, when the angular configuration is 90° and 60°, respectively. Corrosion attack and pitting dominates within an exit section of 90° and 60°, while the dominance of cutting wear in the case of the small-angle elbow is clearly visible in Figure 10.

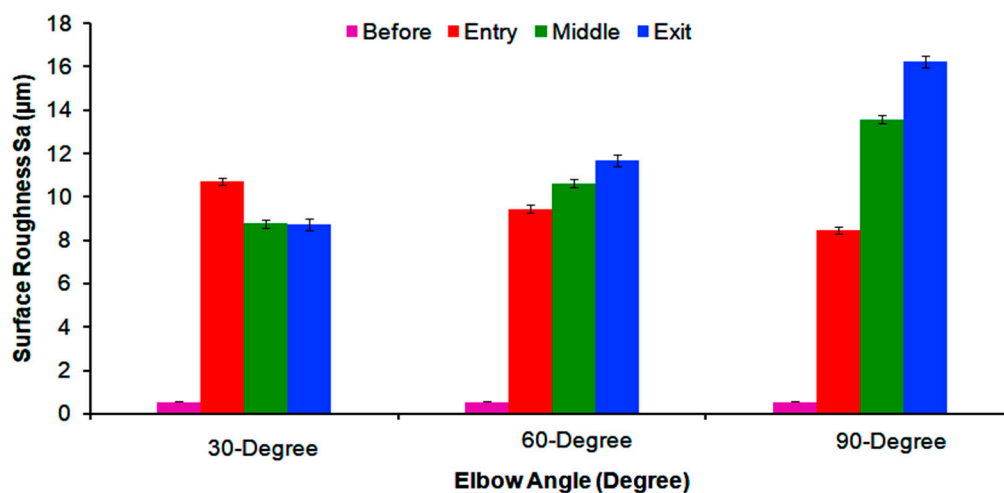
Figure 11. Surface roughness of the 30°, 60°, and 90° carbon steel horizontal elbow sections before and after erosion–corrosion.

Figure 11 shows the disparity in the surface roughness parameter, S_a , for three different bend-angles before and after the test. The surface roughness increases as the flow approaches downstream and is consistently higher in the exit section of the 90° and 60° elbow after erosion–corrosion than that before erosion–corrosion, as well as those of the entry and middle sections, except at the 30° elbow, where the dominance of erosion scars on the entry section proliferates its surface roughness. This is because, with a small bend-angle, more particle wall collisions attribute to high turbulence at the upstream in the 30° elbow configurations. This observation supports previous speculation [16,32,33] that increased local turbulence/mass transfer resulted in a significant increase in surface roughness. In the 90° and 60° elbows, the exit region is dominated by cuttings wears and pitting actions with severe metal corrosion, which escalates the surface roughness. This implies that repeated impact by the fine sand adjacent to the outlet generates high penetration energy, which causes initiation and propagation of cutting wear and erosion–corrosion pitting. It was noticed that the surface roughness adjacent to the outlet after exposure to erosive slug flow increased from $8.64 \pm 0.25 \mu\text{m}$ to $16.21 \pm 0.46 \mu\text{m}$ as the elbow angle changed from 30° to 90°. In contrast, the surface roughness in the upstream section after the test decreased from $10.72 \pm 0.34 \mu\text{m}$ to $8.46 \pm 0.31 \mu\text{m}$ with an increase of the elbow angle from 30° to 90°, respectively.

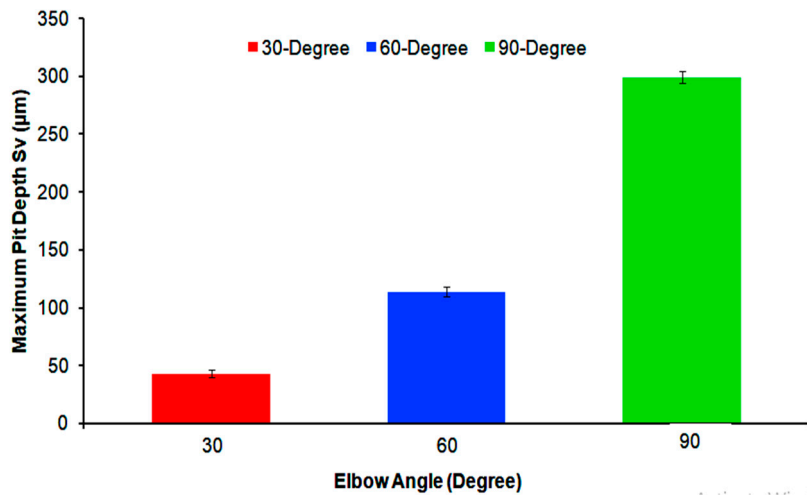
Figure 12. Maximum pit depth of 30°, 60°, and 90° carbon steel horizontal elbows outlet sections after erosion–corrosion.

It is clear from Figure 12 that, in the wide-angle elbow, the pit depth (S_v) was increased, which indicates an increase in penetration energy. The maximum pit depth was observed at the exit section of the 90° elbow, and it was found to be $298.78 \pm 9.71 \mu\text{m}$. However, in the small-angle elbow case of erosion–corrosion, the fine particle impacts the surface with less penetration energy, and the maximum depth of $43.23 \pm 5.48 \mu\text{m}$ was observed at the 30° elbows. At the 60° angle elbow, particles' impacts at the exit section generate deeper pits, with a maximum depth of $113.89 \pm 7.73 \mu\text{m}$ compared with the 30° elbow, as shown in Table 3.

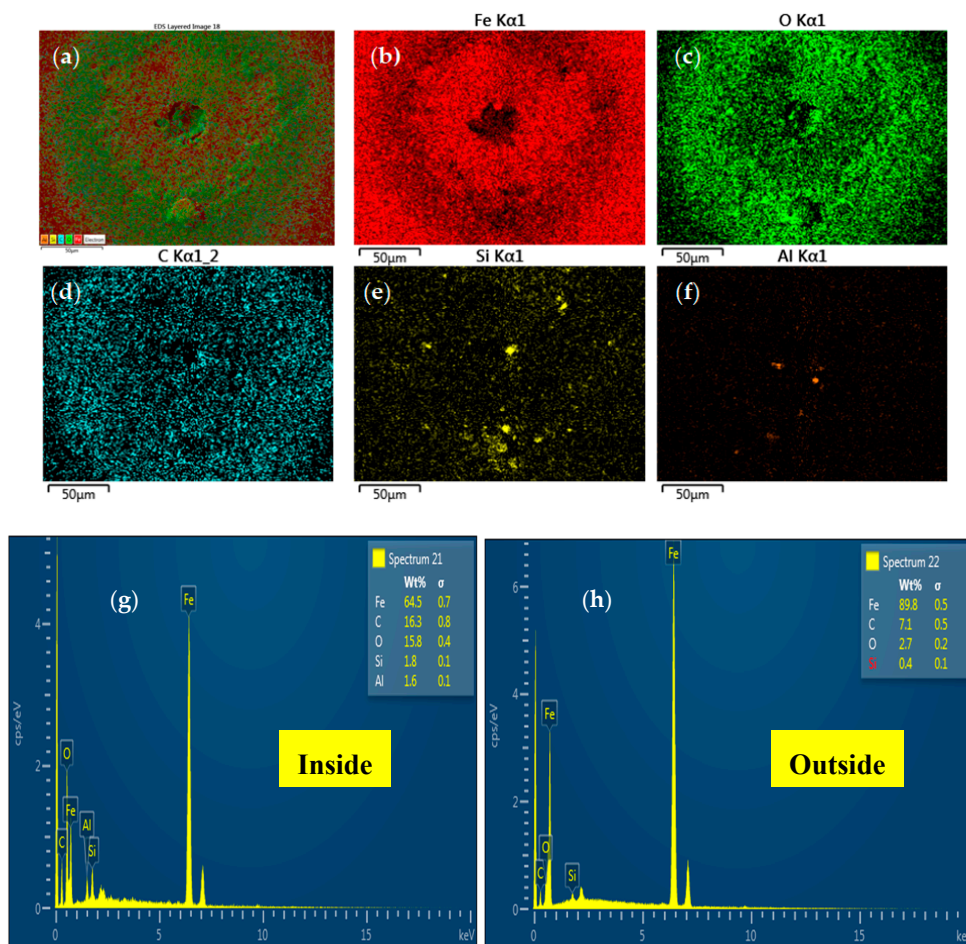
Figure 13. EDS analysis after erosion–corrosion. (a–f) Elemental map; (g,h) elemental phase spectra of the inside and outside of corrosion pits.

An EDS analysis of the worn surface was conducted to investigate the X-ray spectrum and distribution of the elemental phase after the erosion–corrosion test. Point scans were performed inside and outside the pit, and color-coded dot maps are shown for the individual phases in Figure 13.

The EDS spectrum reveals the dominance of iron atoms outside the pit on the surface (Figure 13h). However, the detected level of iron atoms reduced inside the pit (Figure 13g), while an escalation of the oxygen atoms was detected inside the pit. Therefore, it can be elucidated that the escalation in the level of the oxygen atom is a symbol that the pit contains iron oxide deposits and enhances localized corrosion inside the pit. It is important to highlight that the presence of Si (almost 0.4 wt.%) outside the pit and the increase in the level of Si (about 1.8 wt.%) inside the pit are evidence of severe particle impingement.

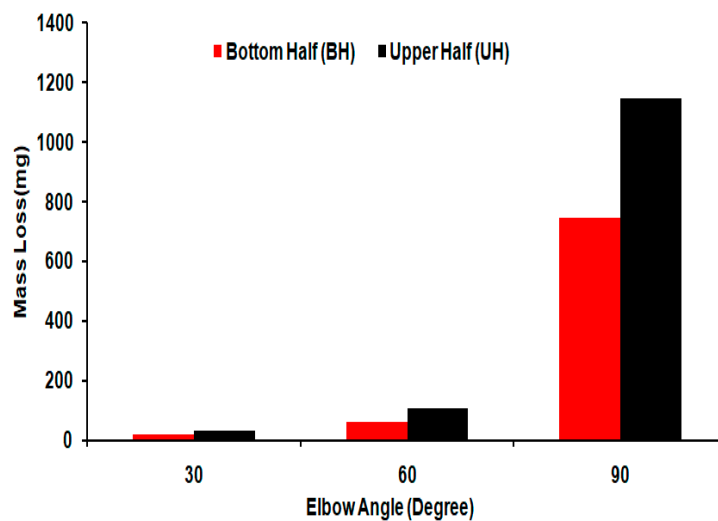
Figure 14. Mass loss in the carbon steel BH and UH elbow sections after exposure to slug flow for 10 h.

Figure 14 illustrates the representative mass loss for the 90°, 60°, and 30° elbows tested in slug flow containing 2 wt.%, particle concentrations, and fine silica sand. The mass loss of specimens was measured in the bottom half (BH) and the upper half (UH) elbow sections after being exposed to abrasive slug flow (Figure 14). As evident from Figure 14, the mass loss increased significantly with the change of elbow configuration to wide-angle, which may indicate that high erosive wear has taken place in the 90° elbow. Table 4 presents the influence of the elbow angle on the cumulative mass degradation rate after erosion–corrosion for the slug flow regime. In the present study, the mass-loss rate in the 90° angle elbow was 12 times higher than the mass loss rate in the 30° elbow, which implies severe particle–wall interaction in the wide-angle elbow, consequently increasing the erosion–corrosion rate of the wide-angle elbow (Table 4). This was because the 90° curvature angle resulted in higher turbulence as a result of the redirected and sliding particle, which may increase the erosive wear on the internal surface [33]. However, with the change in the elbow configuration from 30° to 60°, the increase in mass loss is minimal compared with the 90° elbow, which is evidence of less erosive wear for the slug flow conditions in the small-angle elbow configurations. It could also be because the decreasing elbow angle may decrease the direct particle to wall impact on the internal surface of the elbow [23,34]. It can be observed that mass loss is higher for UH than BH, and creates approximately 1.5 to 1.7 times greater metal loss in all cases. This implies more entrained sand in the gas core with high kinetic energy for slug flow, and resulted from sand impingement in the elbow upper half (UH) section, causing much more mass loss, which is consistent with the MPM pattern observed in Section 3.1. Similar experimental findings were reported by M. Parsi et al. [22].
