Review

# Thermal Stress Relaxation and High-Temperature Corrosion of Cr-Mo Steel Processed Using Multifunction Cavitation

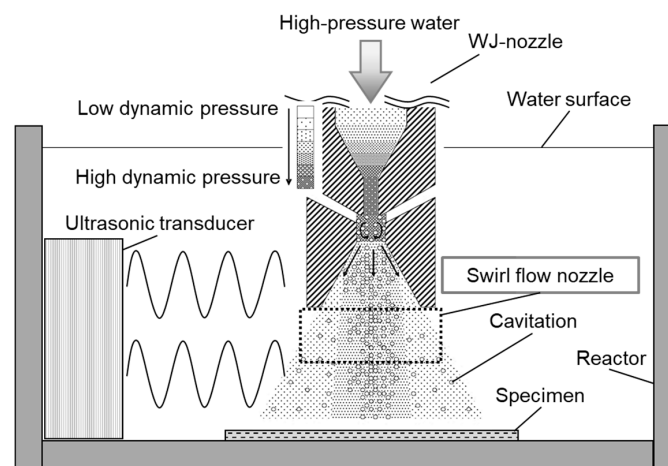
**Figure 1.** Equipment used for surface machining using water jet peening (WJP) with ultrasonic waves.

The material used for the tests was Cr-Mo steel, which is a structural machine steel. Its chemical composition is shown in Table 1. Rectangular specimens with dimensions of  $100 \times 100 \times 3 \text{ mm}^3$  were cut. Figure 1 shows the MFC processing equipment, in which an ultrasonic transducer (WD-1200-28T, Honda Electronics Co., Ltd., Aichi, Japan) emits acoustic pulses towards the water jet as it emerges from the nozzle. A swirl flow nozzle [14] is used at the tip of the WJP nozzle to increase the number and size of cavitation bubbles. The swirl flow nozzle [11,14] suppresses the erosion marks that form in the central part of a surface treated with WJP or MFC, and reduces surface damage due to cavitation bubbles. The discharge pressure of the pump was about 35 MPa, the nozzle diameter was 0.8 mm, and the distance between the nozzle and the specimen was assumed to be 65 mm. Processing was performed in a tank (JIS-SUS310S) with dimensions of  $41 \times 44 \times 60 \text{ cm}^3$ . In a previous study [12], the effects of ultrasonic cycle conditions on the MFC-processed specimen surface were reported. It was found that dual mode most improved corrosion resistance and residual stress; dual mode was thus used in the present study. The output in this mode was 800 W and the frequency was varied from 25 to 27 kHz in steps of 10 Hz. The processing time was 2 min for all specimens.

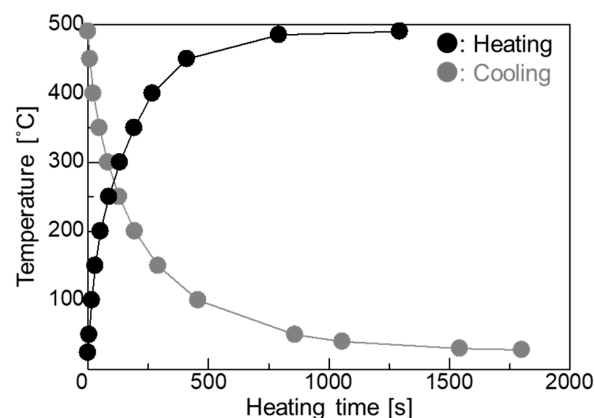
Figure 2. Relationship between heating time and temperature.

A thermocouple was welded to the specimen surface to determine the time at which the specimen surface temperature reached 500 °C. An electric furnace was heated to 500 °C, and the specimen was inserted until its temperature reached 500 °C. The relationship between the specimen surface temperature and the heat treatment time is shown in Figure 2. This condition was adopted as the condition for high-temperature corrosion since the temperature reached around 500 °C at about 7 min 50 s. To test corrosion, an embedding test and a coating test were adopted. A mixed ash of  $K_2SO_4$ - $Na_2SO_4$  at a weight ratio of 1:1 was used. The melting point of this synthetic ash was above 870 °C, as determined from the corresponding phase diagram [15]. Using the embedding test, Cr-Mo steel was placed at the bottom of an alumina crucible (height: 67 mm; outside diameter: 52 mm; capacity: 90 mL), covered with the synthetic ash, and heated in an electric furnace at 500 °C in the atmosphere. After heating, the specimen was immersed in an aqueous solution of sodium hydroxide (18%), potassium permanganate (3%), and pure water (79%) for 15 min to remove the oxide scale attached to the specimen surface. The specimen was then immersed in an aqueous solution of diammonium hydrogen citrate (10%) and pure water (90%) for 15 min. Finally, the specimen was cleaned with an ultrasonic washer. In the coating test, 5 g of mixed ash and 20 mL of acetone were placed in a beaker and stirred for 5 min with an ultrasonic washer. Then, about 1.26 g of the mixture was applied to the specimen surface with a brush. The oxide scale was removed in the same way as done in the embedding test. The coating test and embedding test were each repeated 20 times. After the corrosion test, specimens were evaluated using mass loss measurements, optical microscopy (OM), and scanning electron microscopy (SEM). For OM observation, each specimen was mirror-polished and then corroded with 5 vol% nital.

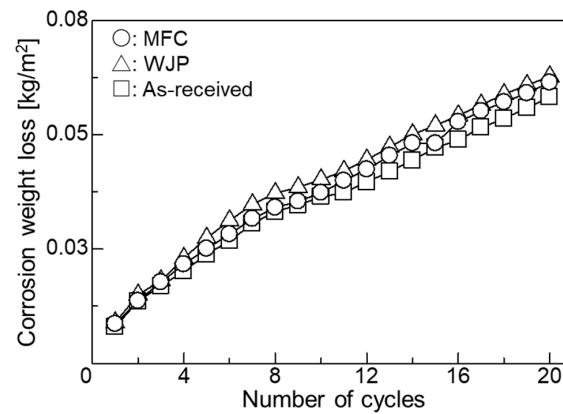
**Figure 3.** Relationship between corrosion weight loss and number of cycles in embedding test.

Figure 3 shows the relationship between corrosion loss and number of cycles in the embedding test. Corrosion weight loss was small; it was smallest for the as-received specimen, followed by the MFC-treated specimen and the WJP-treated specimen. OM observations (images not shown) indicated no change in phase transformation or particle size after heat treatment.

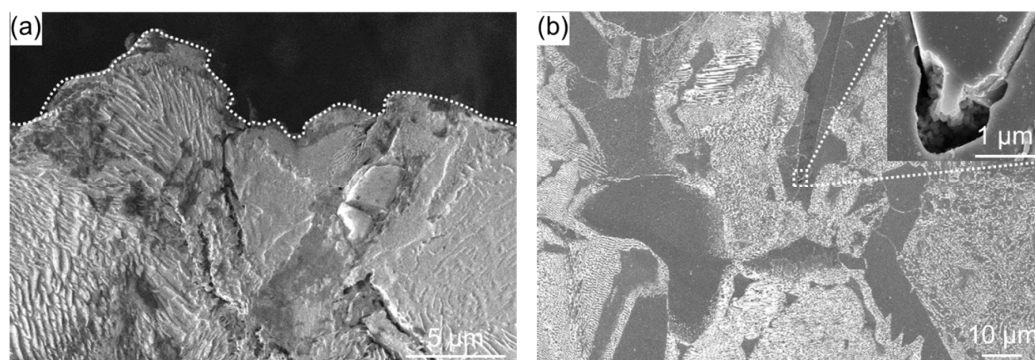
**Figure 4.** Cross-sectional SEM image of as-received specimen (a) near the surface (broken line is the specimen surface) and (b) away from the surface. Inset in (b) shows an enlarged SEM image of the region indicated by the dashed box.

Figure 4 shows cross-sectional SEM images of the as-received specimen after the embedding test. Figure 4a shows that several cracks formed on the surface. These cracks occurred at the grain boundaries. Cracks also formed near the surface. Figure 4b shows that voids formed at the grain boundaries of ferrite inside the specimen. In addition to the effects of high-temperature corrosion, the internal tension caused by the temperature difference between the surface and the interior generated during heating due to the difference in thermal shrinkage caused the stress corrosion cracking and voids. The cracks propagated mainly from grain boundaries. Grain boundary stress corrosion cracking may have occurred.

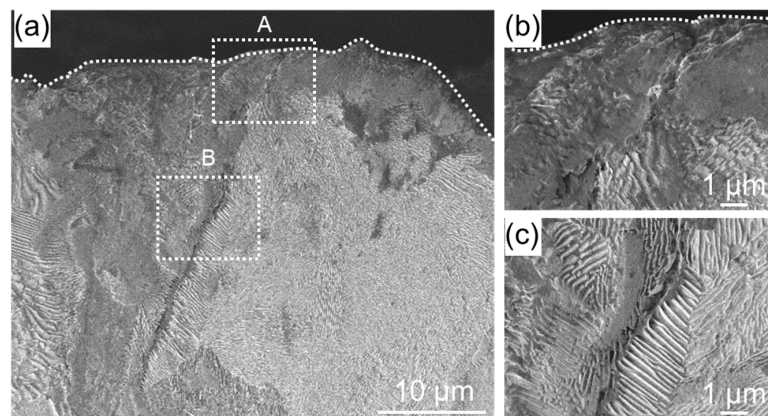
**Figure 5.** (a) Cross-sectional SEM images of a specimen after WJP treatment for 2 min. Enlarged SEM images of the regions indicated by dashed boxes (b) A and (c) B in (a). The dashed lines indicate the specimen surface.

Figure 5 shows cross-sectional SEM images of a WJP-processed specimen after the embedding test. Compared with Figure 4, the cracks are narrower and do not branch. The cracks formed along the grain boundaries of pearlite and ferrite. Grain boundary stress corrosion cracking may have occurred, as in the as-received specimen. The WJP-processed specimen had fewer cracks at the surface compared to the as-received specimen. Improvement in residual stress has been reported for WJP-treated steel [9,10]. This compressive residual stress seems to suppress the thermal stress due to high-temperature corrosion.

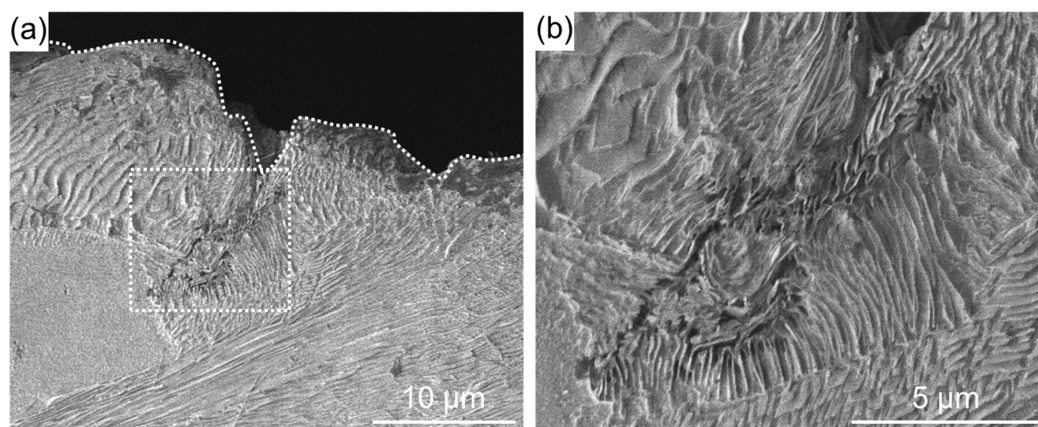
**Figure 6.** (a) Cross-sectional SEM image of a specimen after multifunction cavitation (MFC) treatment for 2 min; (b) Enlarged SEM image of the region indicated by the dashed box in (b). The dashed line indicates the specimen surface.

Figure 6 shows cross-sectional SEM images of an MFC-processed specimen after the embedding test. Although the width of the cracks is narrow, cracks on the surface did not propagate to the interior, unlike in Figure 5. A previous study [10] found that an oxide film forms on the surface when the surface potential of Cr-Mo steel is increased by MFC. Improvement in residual stress [9] has been reported for MFC-treated steel. The thermal stress due to high-temperature corrosion was alleviated by the heat-insulating effect of the coating and the compressive residual stress on the surface. It is assumed that the interior had no voids and cracks, and resisted the deformation caused by thermal stress.

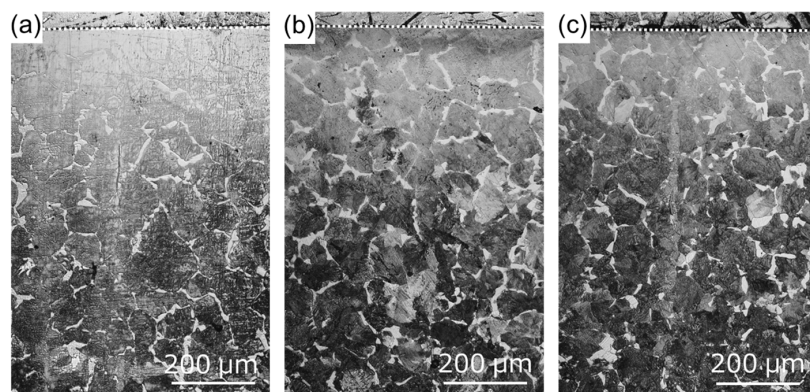
**Figure 7.** Cross-sectional OM images of (a) as-received specimen and specimens treated with (b) WJP and (c) MFC for 2 min after the thermal cycling test. The dashed lines indicate the surface of each specimen.

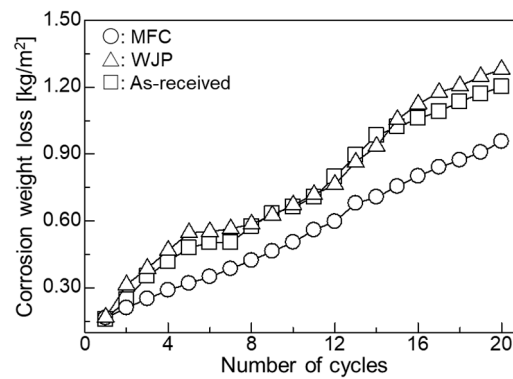
**Figure 8.** Relationship between corrosion weight loss and number of cycles in the coating test.

Figure 8 shows the relationship between the corrosion loss and the number of cycles in the coating test. The corrosion weight loss was small; the MFC-treated specimen had the smallest weight loss, followed by the WJP has larger weight loss than as-received. The results for high-temperature corrosion of the MFC-processed specimen for the coating test are different from those for the embedding test.

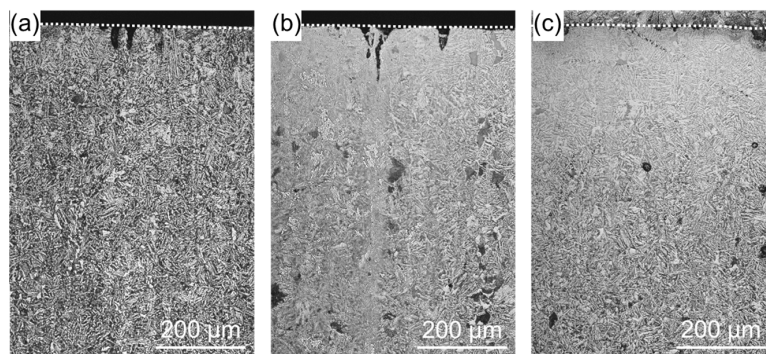
**Figure 9.** Cross-sectional OM images of (a) as-received specimen and specimens treated with (b) WJP and (c) MFC for 2 min after the coating test. The dashed lines indicate the surface of each specimen.

Figure 9 shows cross-sectional OM images of the specimens after the coating test. Unlike the as-received specimen, the treated specimens exhibited a microstructure mix of cementite and ferrite after high-temperature corrosion. Cementite may have transformed into spheroidized cementite when pearlite and ferrite were annealed at 500  $^{\circ}\text{C}$ ; it eventually became spheroidized cementite if heating was conducted for a long period. In the embedding test, it took time for the whole container to warm up, and adhesion between the powder and the sample was poor; the mass reduction was thus small. On the other hand, in the coating test, there was no container for the powder and the specimen received heat directly in the electric furnace. It is thus considered that the surface cracked because the thermal stress increased and adhesion between the powder and the specimen was strong.

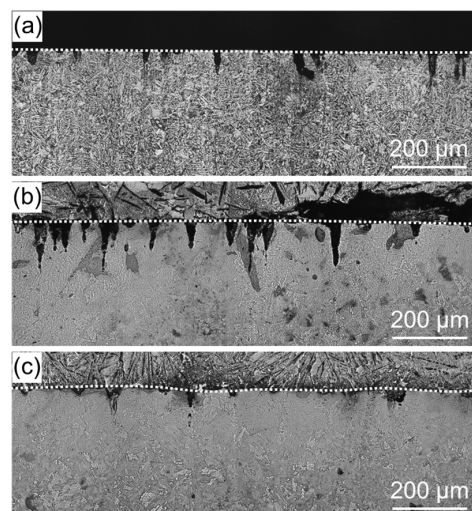
**Figure 10.** Enlarged cross-sectional OM images (a) as-received specimen and specimens treated with (b) WJP and (c) MFC for 2 min after the coating test. The dashed lines indicate the surface of each specimen.

Enlarged images of the vicinity of the specimen surface are shown in Figure 10. For the as-received specimen, large cracks did not occur in the vicinity of the surface, but the amount of high-temperature corrosion was large. For the WJP-processed specimen, the corrosion amount was large, as with the as-received specimen, and the density of surface cracks was the highest of all specimens. For the MFC-processed specimen, the amount of high-temperature corrosion was small and the density of surface cracks was low.
