Article

## Remote Sensing Monitoring of Changes in Soil Salinity: A Case Study in Inner Mongolia, China

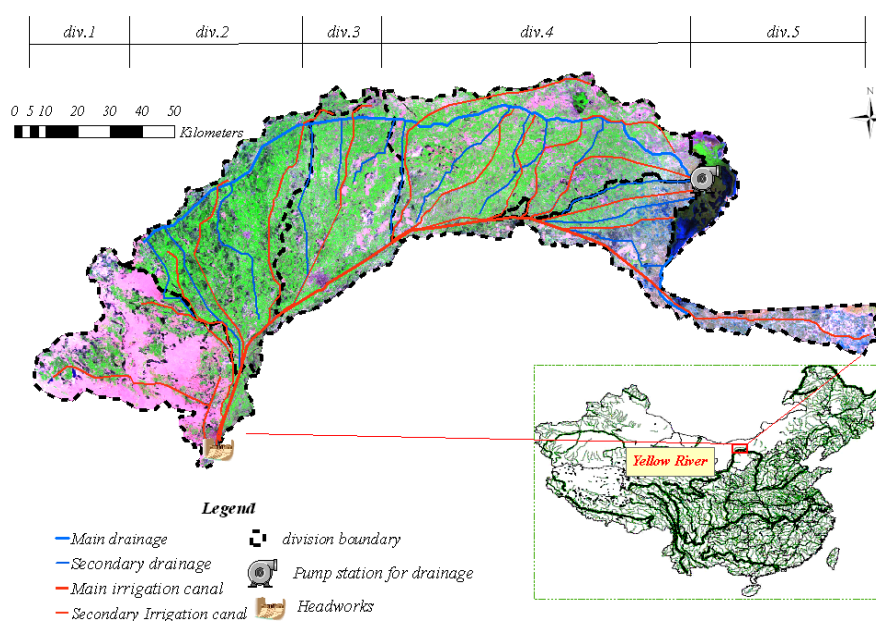
**Figure 1.** Schematic map of Hetao irrigation District (HID), Inner Mongolia, North China (Based on mosaiced LANDSAT images acquired on August 9, 2001).

The Hetao Irrigation District (hereafter HID) is located in the Inner Mongolia Autonomous region of China, at latitude  $40^{\circ}19'$  to  $41^{\circ}18'$  and longitude  $160^{\circ}20'$  to  $190^{\circ}19'$  (Figure 1). It covers a total area of 1,100,000 ha, including 570,000 ha of agricultural land irrigated by water from the Yellow River and is one of the three largest irrigation districts in China. For management requirements, it was divided into five divisions, hereafter named div.1, div.2, div.3, div.4 and div.5, respectively. Physiographically, it is an alluvial river plain with a mean altitude of 1,030 m and a very gentle slope of 1/10,000. However, its microtopography is partly characterized by paleochannels, oxbow lakes, sand dunes, lake marshes and hollows.

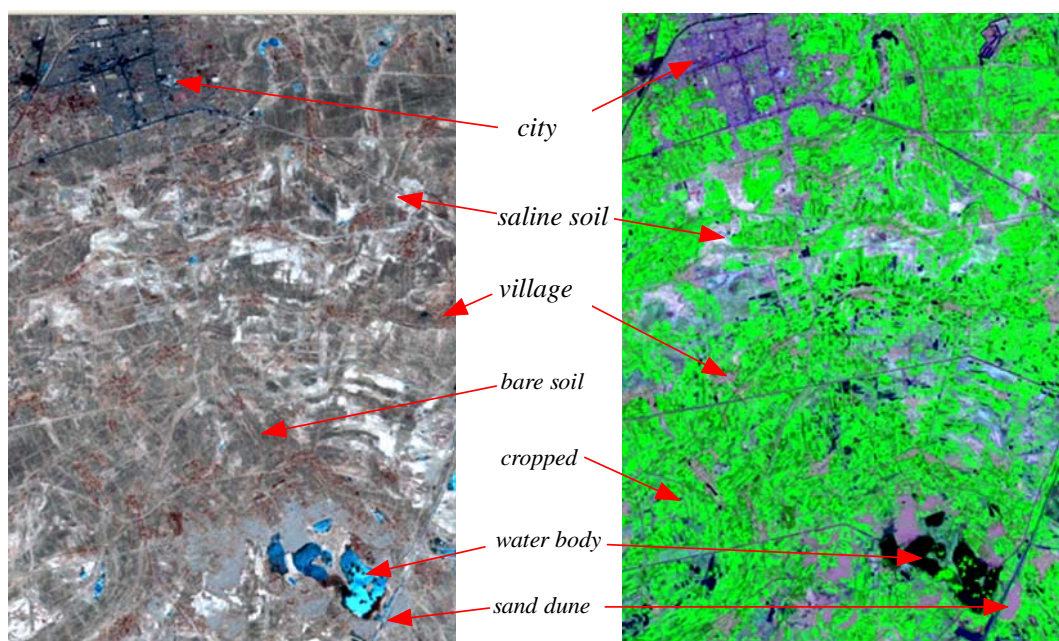
**Figure 2.** Typical terrain features (Left: 2001-03-11, Band 432; Right: 2001-08-02, Band 7-4-2).

For each classification, the spectral characteristics of different terrain features were first collected to check the possibility of differentiating them from other features. In this study, six major classes were chosen for comparison: vegetation (crops), inhabited areas (villages and towns), saline soils, normal bare soil, water bodies like lakes/ponds, and sand dunes (Figure 2).

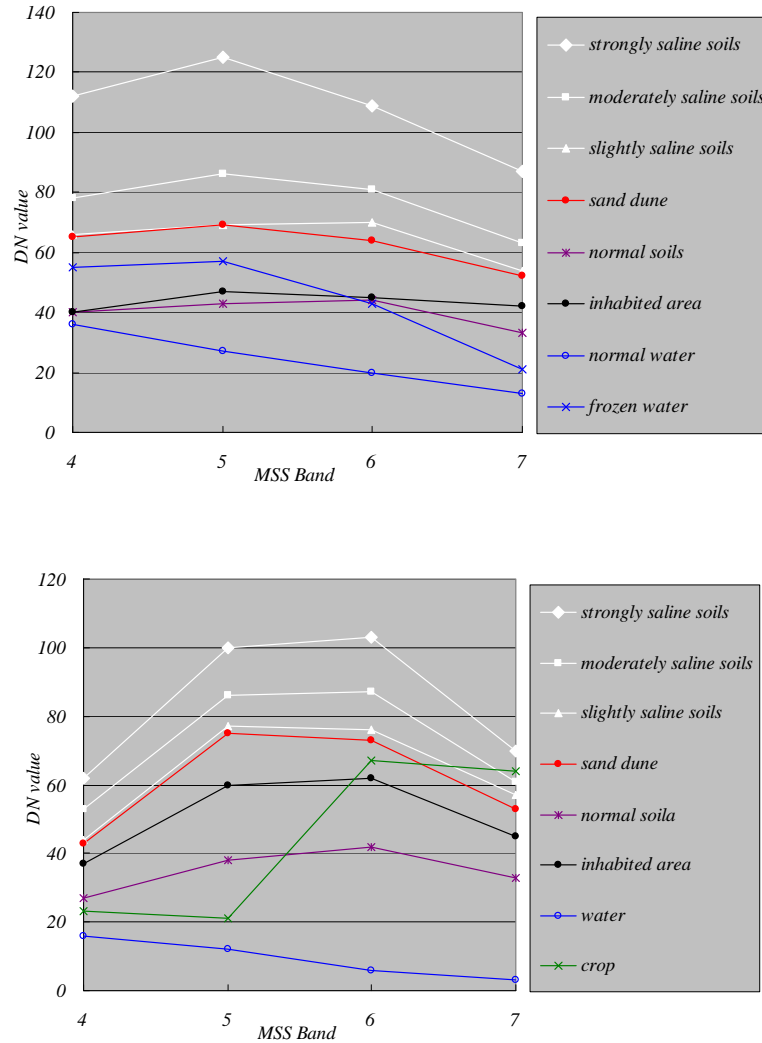
**Figure 3.** Typical spectral response in Landsat MSS (upper: 1973-03-20, lower: 1977-07-30).

The vegetated area is bare in the fallow season and is normally irrigated in October to store water for spring wheat. The water bodies are frozen from late October to the following March. The saline soils may be vegetated if the salinity level allows it. Figure 3 and Figure 4 present examples of spectral response patterns for all these classes in both the crop and fallow seasons. These results showed that the spectral response of salt-affected soils, especially strongly and moderately saline soils, is higher than the other classes in all bands and in all images whereas vegetation (mainly crops) displays maximum reflectance in the Landsat TM band 4. The water bodies reflect much less incident energy than other land features, which makes them easy to differentiate. Vegetation has low reflectance in the red band and high reflectance in the near infrared band, which also makes it easy to differentiate it from saline soils. Normal soils, which are generally irrigated and wet, also display lower reflectance than saline soils in all bands, making it possible to differentiate the two. Figures 3 and 4 also show that the difference between slightly saline soils and sand dunes is quite small, especially in MSS images. This can result in major errors when extracting salinity information with the supervised classification method. Fortunately it was possible to minimize this error by using the thermal band in Landsat TM (Band 6). The thermal band is related to the thermal properties of the materials. Sand dunes are much drier than soils and have a lower thermal capacity, so that their temperature tends to be higher in

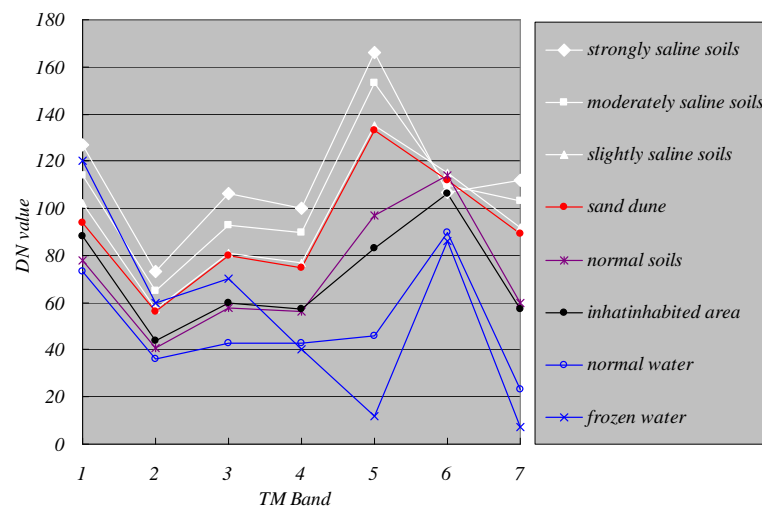
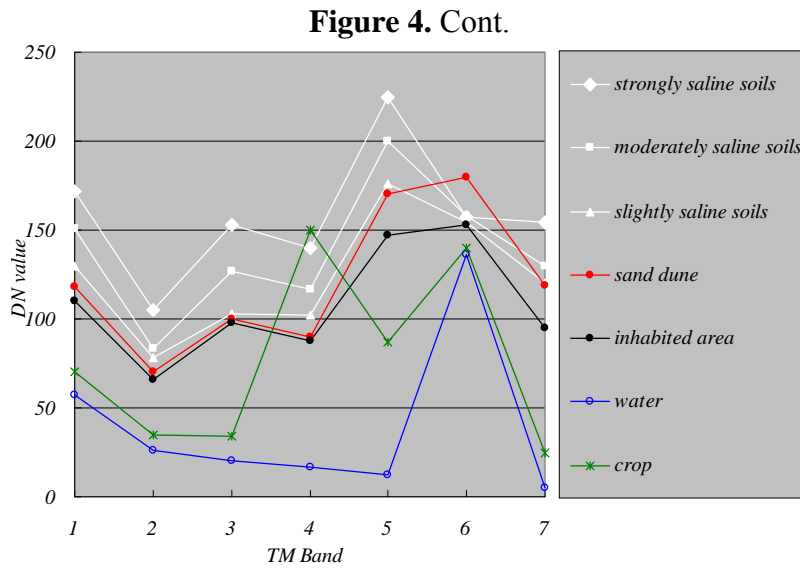
**Figure 4.** Typical spectral response in Landsat TM (upper: 2001-03-11, lower :2001-08-02).

summer (See Figure 4). We were able to take advantage of this thermal characteristic to generate a binary sand dune map from Landsat TM images and then correct the wrongly labeled pixels.

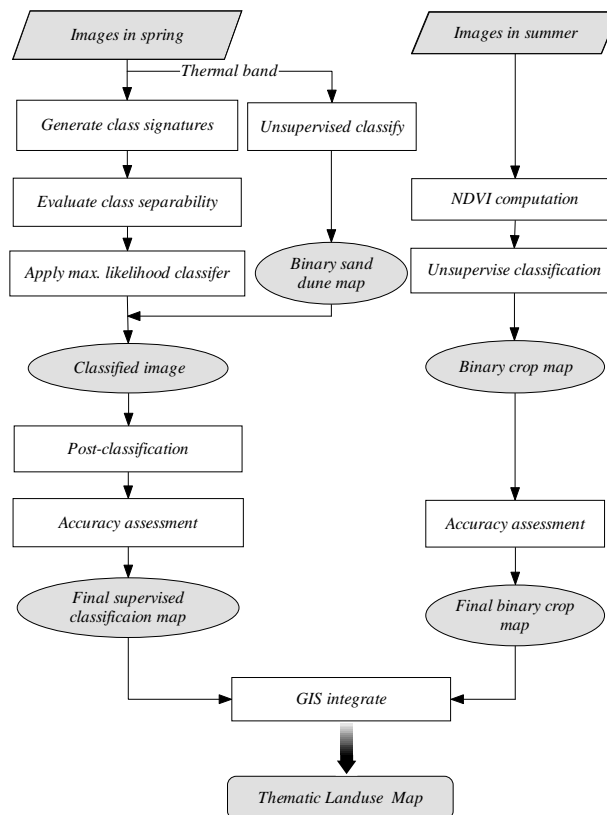
**Figure 5.** Procedure of image classification and land use mapping.

By overlaying these classified images with the corresponding original images using swipe utility, and changing the threshold values, they were finally recorded into binary images (cropped or non-cropped). By adding the binary images in the summer to those acquired in the same autumn, images of the cropped area for the respective year were acquired. Next the classified images acquired during spring (i.e. salt-affected areas) and the images of the cropped area were integrated into one thematic land use map for the corresponding year using the GIS module in ERDAS. In each thematic land use map, nine categories of land use were indexed, i.e. salt-affected bare soil, bare soil, sand dunes, villages, towns, two classes of surface water bodies (one reedy, one reed-free.) salt-affected areas, and salt-free cropped areas. The above procedure is summarized in Figure 5.

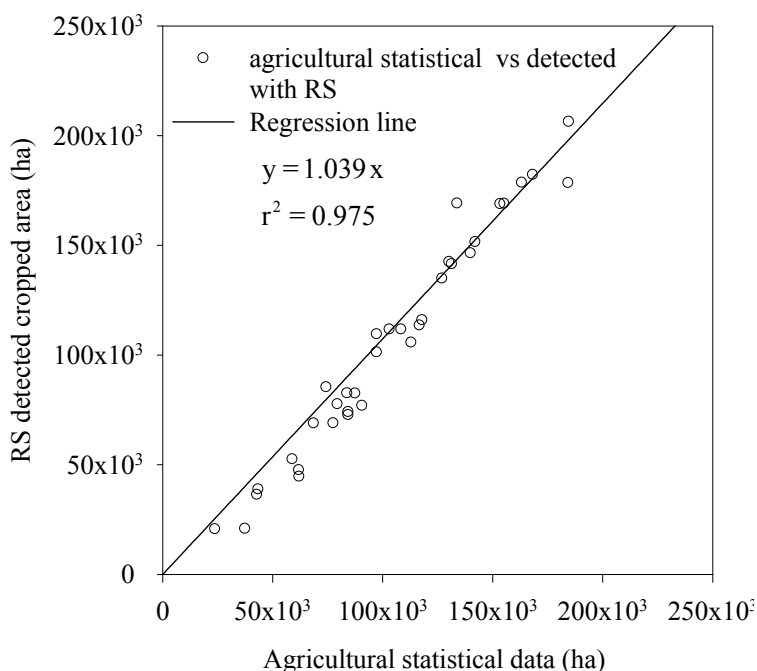
**Figure 6.** Validation of cropped area using agricultural statistical data.

Figure 6 plots the cropped areas detected by remote sensing vs. those derived from the agricultural statistics for the different divisions supplied by the administration office of HID. It shows a good agreement between the cropped areas from two sources. Calculation shows that the average difference was about 2%.

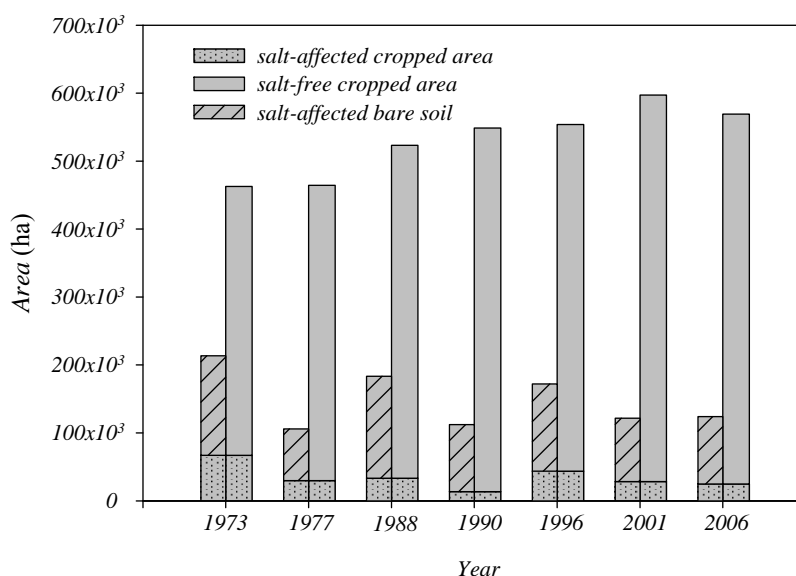
**Figure 7.** Salt-affected area, bare soil and salt-free cropped area in HID.

The cropped areas and salt-affected areas detected by remote sensing for the years 1973, 1977, 1988, 1990, 1996, 2001, and 2006 are presented in Figure 7. The cropped area includes two parts: salt-affected cropped areas and salt-free cropped areas. The total salt-affected area also includes two parts: salt-affected cropped areas and salt-affected fallow areas.

The cropped area increased from 453,000 ha in 1973 to 596,000 ha in 2001 and decreased slightly from 2001 to 2006. On the other hand, the total salt-affected area decreased from 213,500 in 1973 to 124,000 in 2006. The corresponding ratio of salt-affected area to system command area decreased

from 19% (=213,500/1,100,000) to 11% (=124,000/1,100,000). The salt-affected cropped area also decreased from 67,100 ha in 1973 to 24,900 ha in 2006. In spite of two rebounds in 1988 and 1996, the general extent of salinity in HID remained relatively stable. Moreover, the salt-affected cropped area decreased from 43,800 ha in 1996 to 28,400 ha in 2001, while the corresponding cropped area increased from 554,000 ha to 597,000 ha. This decrease in salinity indicates that the installation of a pumping station for drainage in 1975 and the improvement of the field drainage system completed in 1996 had obvious positive effects on salinity control.

Figures 7, 8 and 9 show that dry drainage plays an important role in maintaining salinity in the cropped area at an acceptable level. It can be used as an effective alternative method for salinity control when artificial drainage is not feasible or affordable. For the land manager, it may be more satisfactory to set aside part of the land as fallow rather than maximize land cropping. To complete this analysis, it would be necessary to conduct a comparative cost-benefit analysis of dry drainage, and conventional drainage, vs. agricultural product loss due to soil salinity.

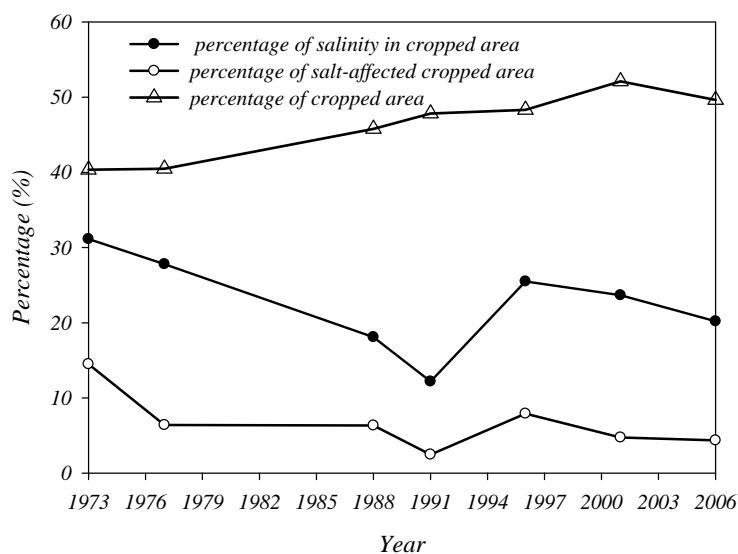
**Figure 8.** The percentages of cropped area, salinity in cropped areas and salt-affected cropped areas.

In HID, as described above, around 70% of the inlet salt is left inside the system every year. However the percentage of salt-affected cropped area ranged from 2.5% to 14.5% with an average of 6.6% (the line with open circle symbols in Figure 8) in the last 34 years. This success is attributed to both the artificial drainage system and the dry drainage. The percentage of cropped area (the line with triangle symbols in Figure 8) ranged from 40% to 52%, meaning that half of the land was available to drain excess water and salt when topographic and geo-hydrological conditions allowed it. Figure 9, a snapshot of a LANDSAT image acquired on August 9, 2001, shows the general land cover in HID. The cropped area is surrounded by abandoned sand dunes, ponds, lakes, and salty low land that form the natural outlet for salted groundwater. This practice ensures that salt is drained laterally from the cropped area to avoid serious salinity hazard, even in the absence of artificial drainage. For instance, the salt-affected cropped area represented only 14.5% in 1973 when there was no effective artificial drainage (Figure 8). Additionally, the percentage of salinity in the cropped area (the line with filled circles in Figure 8) remained lower than 30%, meaning that salinity mainly occurred in the fallow area, where salts continuously accumulated.
