Article

Evaluating the Infiltration Performance of Eight Dutch Permeable Pavements Using a New Full-Scale Infiltration Testing Method

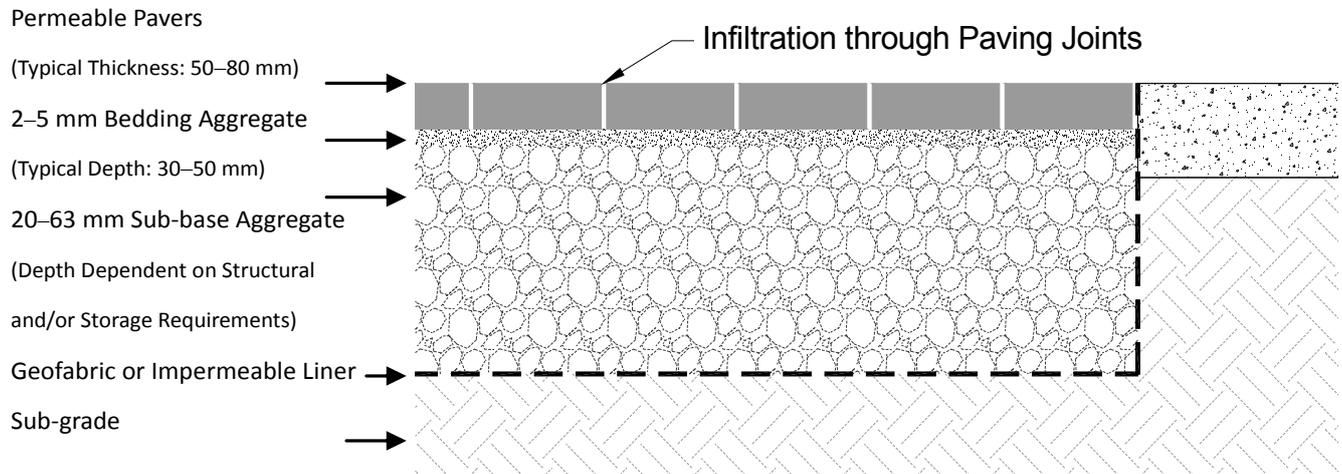
Figure 1. Typical permeable pavement structure.

- Construction: While the construction of the test pavements were generally similar to that shown in Figure 1, there were slight differences between the sites. These included the size of the paving joints, different types of bedding aggregates and different pavement laying processes.

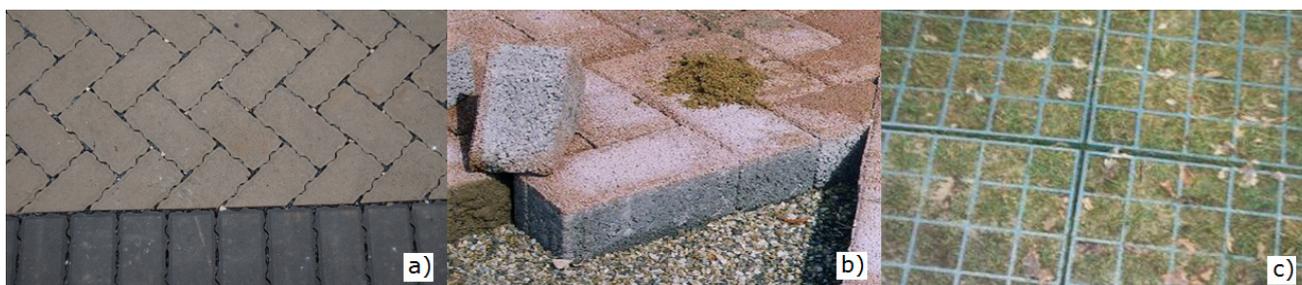
There are several types of permeable pavements typically used in Europe, including concrete pavers with wide joints or apertures (Figure 2a) and porous concrete pavers, either with or without wide joints (Figure 2b). These are usually manufactured as blocks and are generally referred to as permeable concrete interlocking pavers (PCIP). Concrete and plastic grid pavers (CGP and PGP) are also often used in Europe. The design and function of CGPs and PGPs are similar to PCIP; however, the areas of the individual pavers are generally much larger than those used for PCIP systems. They also have more open void spaces to promote infiltration. Stormwater is able to infiltrate through the large gaps in these pavers, which are usually filled with gravel, or topsoil planted with grass (Figure 2c).

Figure 2. (a) Impermeable concrete PCIP (permeable concrete interlocking pavers); (b) porous concrete PCIPs; (c) grass-filled plastic grid pavers (PGPs).

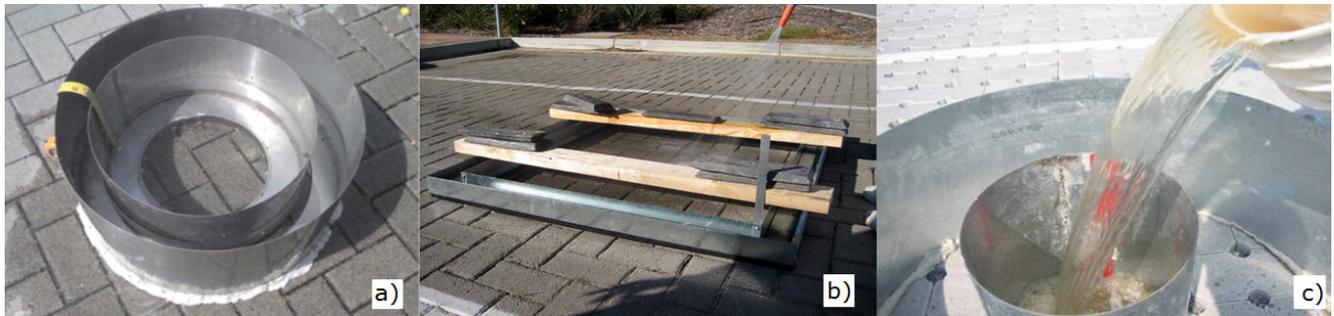
A number of previous permeable pavement infiltration studies [4,10,13,15] have been based on results using a modified version of either the single- or double-ring infiltrometer test (ASTM D3385-09) [17]. In these tests, rings are sealed to the pavement surface and filled with water. The time taken for the water to infiltrate through the permeable surface area is used to estimate an average infiltration rate (usually in mm/h) for the test location. Both the constant head and the falling head methods can be utilised in these testing procedures. Double-ring infiltrometer tests (DRIT) have generally been the preferred method in the past. This is because the outer ring is thought to reduce measurement errors and to prevent lateral flow from occurring beneath the rings. However, on pavements where the infiltration rate is so high that it is difficult to supply enough water to both rings, the single-ring surface infiltration test [4] has been used (Figure 3c).

Three variations of ring infiltrometers used in past permeable pavement studies are shown in Figure 3. Other permeable pavement infiltration research has been undertaken using specially fabricated rainfall simulation infiltrometers [6,9]. A new Standard Test Method for the Surface Infiltration Rate of Permeable Unit pavement Systems (ATSM C1781M-13) [18] has recently been published. However, to date, there have been no studies published using this method.

Figure 3. Modified ring infiltrometers used for permeable pavement testing: (a) double-ring infiltrometer tests (DRIT) [15]; (b) square, double-ring [13]; (c) single-ring surface inundation test [4].

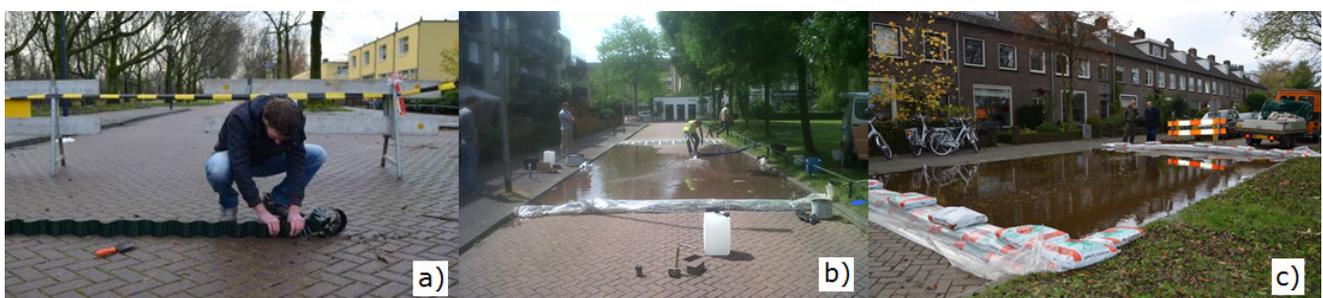
To accurately define the infiltration testing area and to contain the water used to infiltrate the pavement, it was necessary to construct small, temporary dams at the ends of the pavement test sections. The roadway kerb and gutter system retained the water on the sides of the pavement test sections. A number of dam variations were trialled at the eight different test locations (Figure 4). These included:

1. Soil core wrapped in plastic sheeting;
2. Sand core wrapped in geotextile;
3. Soil- or sand-filled plastic bags;
4. Impermeable barriers inserted into paving gaps; and
5. Use of existing traffic calming devices (speed-humps).

Figure 4. Various dam variations used at the different test locations; (a) impermeable barriers; (b) plastic wrapped soil core; (c) soil-filled plastic bags.

Where possible, one of the preferred methods of containing the water within the test site is to choose a section with an existing raised traffic calming device (speed hump) at one (or both) ends. This saves considerable setting-up time and also minimises leakage problems during testing. It is also advisable to select the section of pavement with the least number of existing drainage gullies within the pavement surface or gutter. Drainage gullies need to be properly sealed to prevent water from

leaking from the test area and entering the underground stormwater drainage system. This can be both difficult to accomplish and time consuming. Of all the methods trialled to create temporary dams, the soil-filled were found to be the most effective. This was due to their ability to properly seal the test sections, the rapid filling and emptying characteristics of the bags, the ability to reuse the material and the ease of construction by hand without the need for heavy machinery.

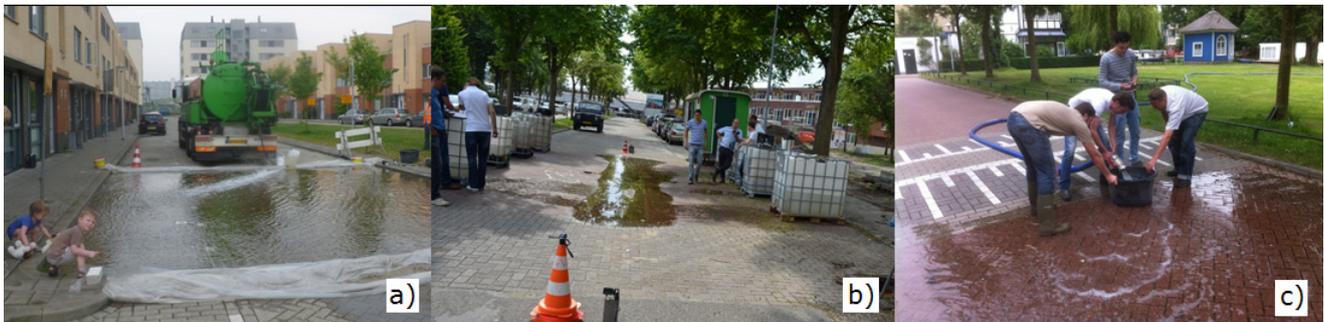
The new infiltration test requires large volumes of water to be discharged onto the test paving section in order to inundate the pavement surface. Depending on the site location, a number of different water supply options were trialled in this study, including transporting water directly to the site with water trucks (Figure 5a) or water tanks (Figure 5b) and pumping water directly from nearby canals (Figure 5c).

Figure 5. (a) Water truck supply; (b) water tank supply; (c) pumping from canal.

Of the three water supply methods trialled, it was found that pumping the water from a nearby canal was the easiest option, where this option was available. This method offered total flexibility with types of testing and also offered an unlimited availability of water. It is recommended to include a flowmeter in the water supply line to allow accurate monitoring of water inflow rates. Water trucks were the second easiest option. However, these had the disadvantages of being expensive and difficult to arrange, manoeuvre and park, and they generally had only limited water supply capacity. When a water truck must be used, it is advisable to ensure that the outlet is fitted with a flowmeter to measure flow rate into the test pavement area.

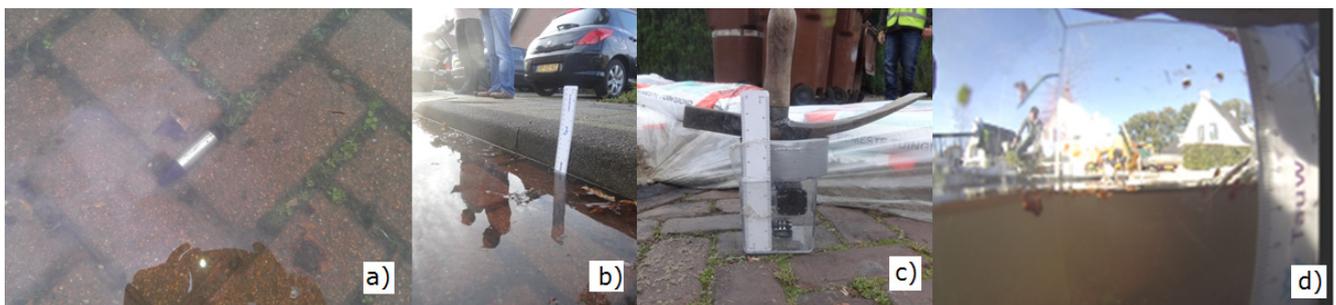
Three different measurement methods (Figure 6) were used in conjunction with the pressure transducers in order to calibrate and verify the transducer readings. The three methods were:

1. Hand measurements;
2. Calibrated underwater camera;
3. Time-lapse photography.

Figure 6. (a) Minidiver installed at lowest point of pavement; (b) hand measurement point; (c) underwater camera set-up; (d) underwater camera view.

Water level measurements were taken using a simple 300-mm hand ruler (Figure 6b) at strategic locations on the pavement surface throughout the duration of the testing. These measurements were used to verify the functionality and accuracy of the self-logging pressure transducers, as described above. Photographs of each hand measurement were also taken for documentation and verification purposes.

A high-definition video camera was also used at a number of strategic locations to record the decrease in pavement water levels over the duration of the tests. The camera was placed inside a waterproof, calibrated, transparent box, so that it could capture the entire infiltration process (Figure 6c). This system allowed real-time monitoring of the entire infiltration process and also facilitated precise verification of the pressure transducer measurements.

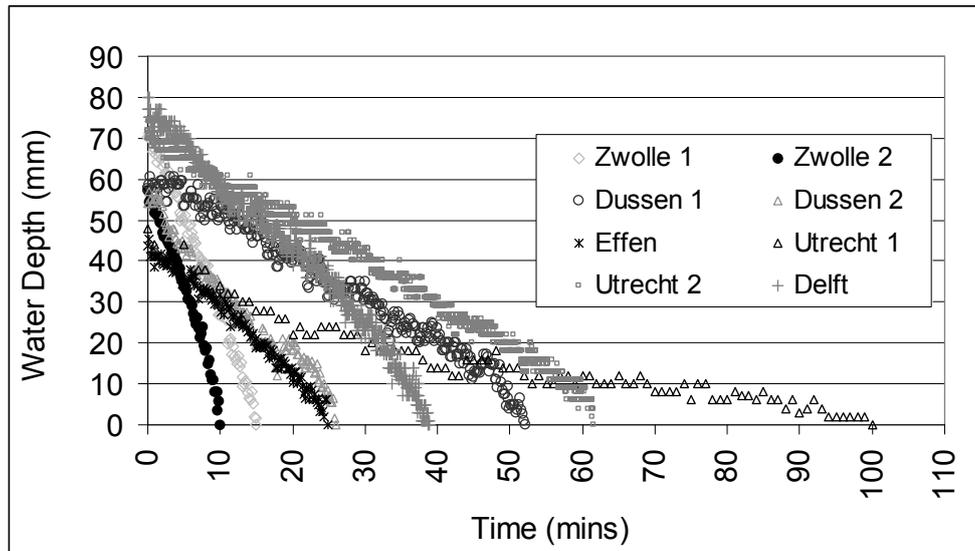
All eight test pavements (Table 1) were sealed, inundated and monitored as described above. The pressure transducer readings were then plotted against time to generate precise infiltration curves for each of the test sites (Figure 7). Simple linear regression analysis was used to generate lines of best fit for the transducer readings from each site. The equations of the linear regression lines were then used to calculate the average infiltration rate in mm/h for each test site (Table 1).

Figure 7. Infiltration curve results for the eight permeable pavements tested in the study.

The surface infiltration rates recorded for each of eight test pavements using the new experimental test procedure are shown in Figure 7.

Although the eight permeable pavements tested in this study were of a similar construction type and of similar age, Table 2 shows a large variation in the calculated infiltration rates between the eight study pavements. This variation in results is similar to the findings of a number of previous studies that have attempted to quantify the infiltration rates of permeable pavements [4,13,16,21–23]. The infiltration rates of the eight test pavements differed from between 29 and 342 mm/h.
