Article

Industrial Round-Wood Damage and Operational Efficiency Losses Associated with the Maintenance of a Single-Grip Harvester Head Model: A Case Study in Russia

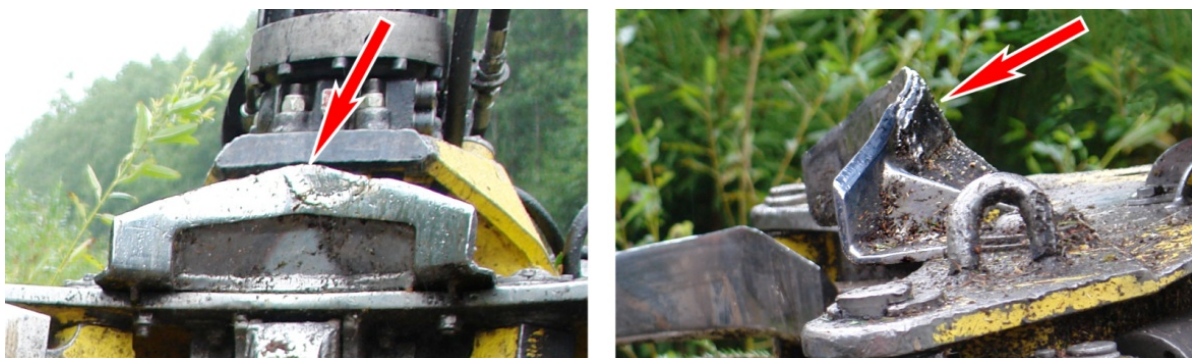
Figure 2. Damaged top of supporting knife.

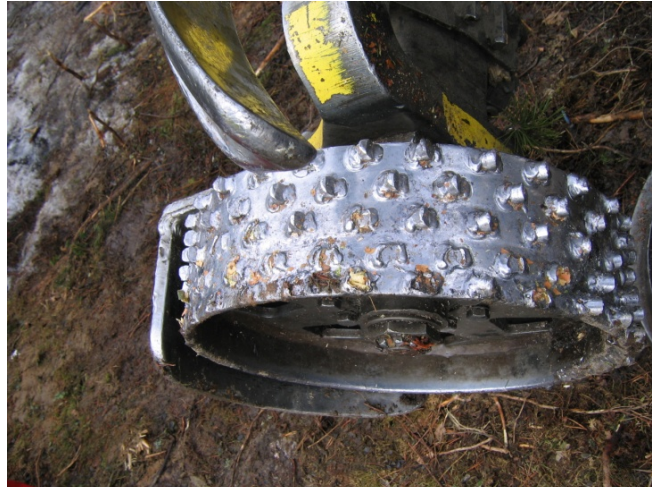
Figure 3. Damaged spikes of the movable feed roller.

15 logging companies in Northwest Russia exposed the fact that most of the harvesters did not meet the requirements of the manuals for sharpening delimiting knives during maintenance. The delimiting knives were sharpened neither regularly nor correctly. The experience of using harvesters in Russia shows that while harvester operators pay proper attention to the sharpening of saw chains, there is a challenge with the maintenance of delimiting mechanisms. As delimiting is done by feeding the stem through the head at high speed (up to 5 m/s), there are high quality demands on the delimiting knives in terms of their durability and ability to retain the optimal geometry of the cutting edge and sides of the knife. Blunting of the cutting edges and changes in the geometry of their shape reduce the capacity of the machines and lower the quality of IRW. The knives wear out faster during the snow-free time, when the branches carry mineral substances and particles of soil during harvesting. Most of the upper movable knives investigated (Figure 1) demonstrated incorrect sharpening of cutting edges for delimiting of thick stems. The reason was that, due to wear, the geometry of the cutting edge changed and was not corrected during subsequent sharpening. Besides the incorrect maintenance of delimiting knives, some cases of failure to observe operational requirements were registered that resulted in mechanical damage to knives. Quite often, when working with a tree, the upper supporting knife is bumped into the machine frame. Such collisions lead to damage to the knife that has to be repaired (Figure 2). Moreover, the incorrect maintenance and operation of the knives and the poor condition of the feed rollers influence both the operational efficiency and the quality of delimiting. According to our observations (Figure 3), damage to the spikes was the most common form of wear on movable feed rollers.

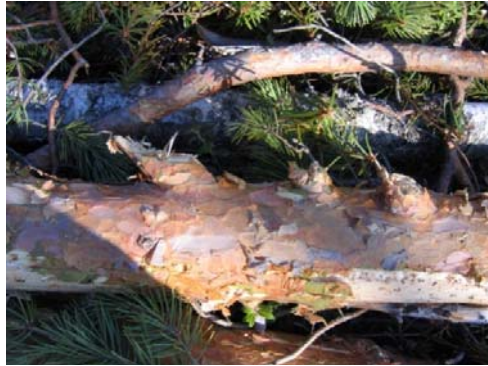
Figure 4. Unprocessed branches.

The study of delimiting with incorrectly sharpened knives shows that often such knives cut into the stem or went off the stem and failed to cut it, leaving unprocessed branches (Figure 4).

During the field study, no serious problems associated with IRW damage caused by spikes and bark stripping were revealed in either winter or summer seasons. The most common IRW damage was associated with unprocessed stump branches with a height over 10 mm, which are rejected as either saw logs or pulpwood. Brunberg *et al.* [23] show the high level of bark damage in the sap season, but harvesting operations are usually interrupted during this period in Russia due to road closures for the passage of heavy trucks. Improved maintenance of delimiting knives at the logging company studied can reduce the rejected rate of IRW by 5% on average and thus avoid an annual loss in IRW value at the logging company of up to €7,000 per harvester, assuming an annual output of 50,000 m³.
