Article

Influence of Abrasive Waterjet Parameters on the Cutting and Drilling of CFRP/UNS A97075 and UNS A97075/CFRP Stacks

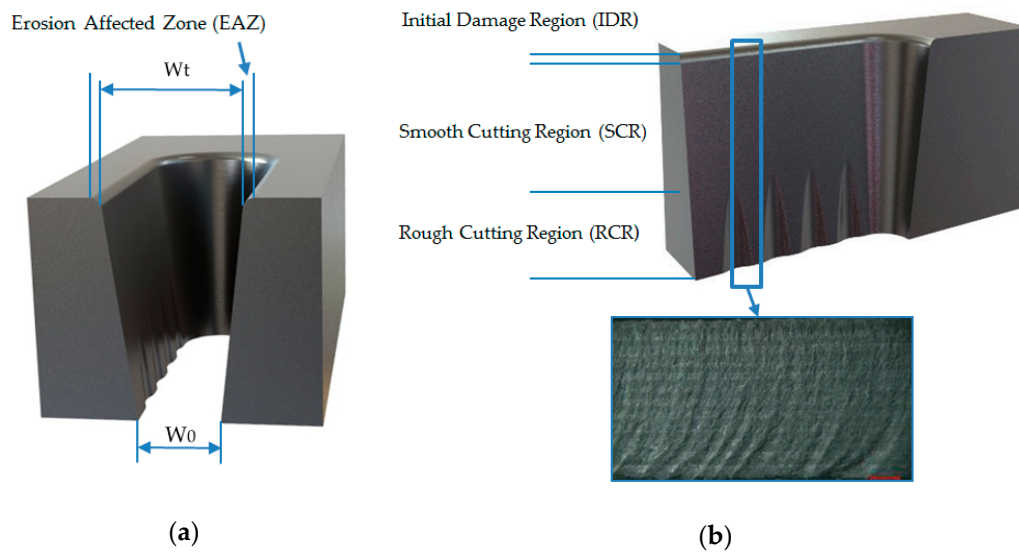
Figure 1. Scheme with the main defects associated with Abrasive Waterjet Machining (AWJM): (a) Erosion affected zone and kerf taper defined by inlet width (W_t) and outlet width (W_b); (b) different roughness zones that can be formed in AWJM.

However, the AWJM process shows its own limitations that lead to the appearance of specific defects during the cutting process (Figure 1). The most common defects in the process are the kerf taper, the Erosion Affected Zone (EAZ) and the formation of three possible different roughness zones along the machined surface [22]:

- Initial Damage Region (IDR). The area where the water jet hits on the material producing EAZ. The roughness in this region is high due to the abrasive particles impacting the material.
- Smooth Cutting Region (SCR). The region of variable thickness depending on the cutting parameters. It is the region with the best surface quality because it does not suffer the impact of particles and the jet still has enough kinetic energy to cut.
- Rough Cutting Region (RCR). The final region where the jet ends of cut material. The jet has lost enough cutting capacity and produces macrogeometrical defects as striation marks.

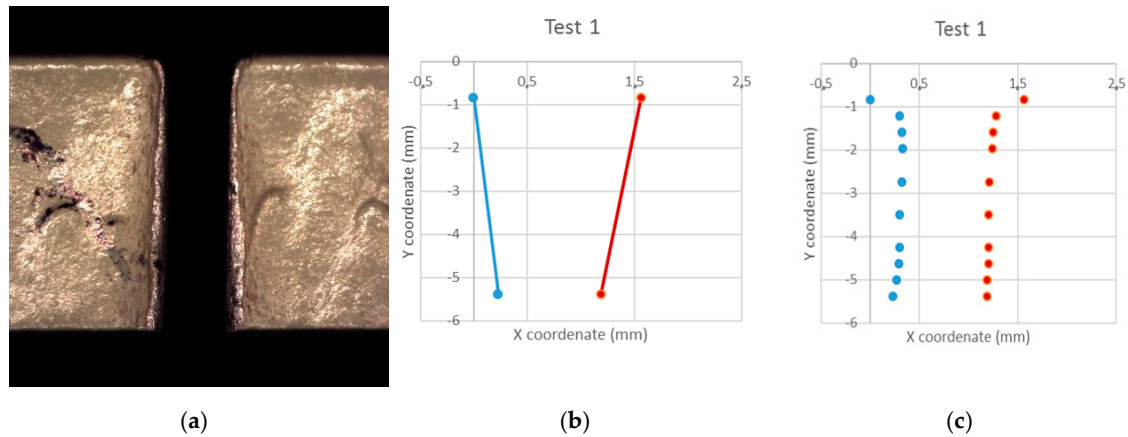
Figure 2. Proposal of measurement of the kerf taper from: (a) Stereoscopic Optical Microscopy (SOM) image; (b) geometry discretization; (c) traditional kerf assumption.

For the evaluation of straight cuts, on the one hand, optical evaluation of the machined material has been used by means of Stereoscopic Optical Microscopy (SOM) and Scanning Electronic Microscopy (SEM) techniques, and on the other hand, electron dispersive spectroscopy (EDS) was used to analyze the compositional state of the samples. A Nikon SMZ 800 stereo optical microscope was used for the SOM inspection and the Hitachi SU 1510 microscope was used for the SEM inspection. These techniques were used to study the incrustation of abrasive particles in the IDR zone and in the delaminations produced. In addition, it was used to generate a deeper measurement of the kerf taper. The literature tends to evaluate the taper as the difference between the cutting width of the water inlet and the cutting width of the water outlet depending on the thickness of the plate [19,20,33] as shown in Figure 2b. However, this process concurs in a high variability depending on two width measures (W_{top} and W_{bottom}). Since the IDR may interfere with that extent, this paper proposes a new methodology based on image processing methods, for which ImageJ and Microsoft Excel[®] software were used. It consists of capturing the image of the cut and its subsequent digitalization in 10 points

with a non-linear distribution, as shown in Figure 2c. Then, a coefficient between W_{top} and W_{bottom} is usually obtained, however as it can be observed in Figure 2c, the representation of the cut would be unreal. Regarding Figure 2c, once you remove the IDR the shape of the cut is almost a vertical line. That is why, in this paper, measures to calculate the average width of the cut have been used.

This new methodology does not provide a coefficient as taper measure, but an average distance. A distance that represents, in a more realistic way, the profile of the cut. However, in order to obtain an accurate result, data from the IDR has to be rejected, as is already regarded by some authors [34]. That way, the cut depth was divided into 10 measures with cosinoidal distribution, ensuring more measures density near the top and the bottom. Then, the measures that maintained a height variation regarding the next measure have been disposed, that is the case of the upper measure and the second one in Figure 2c. Taking all other measures, an average is calculated and that is the kerf taper vale proposed.

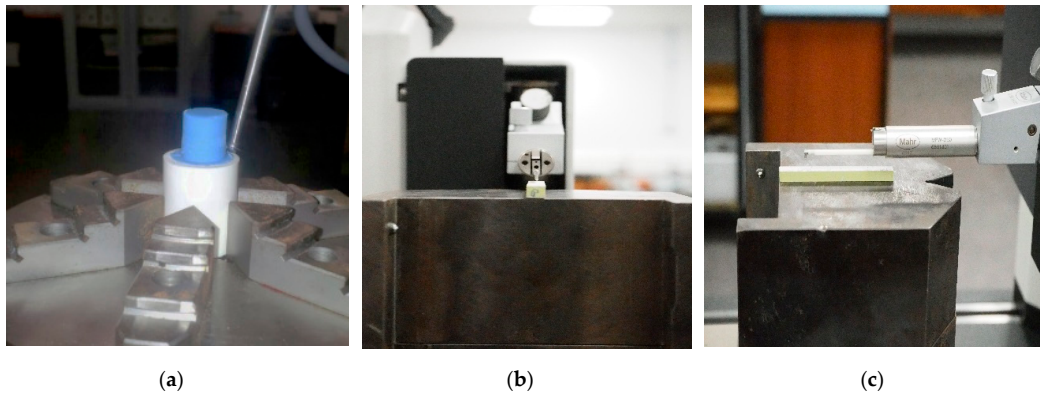
Figure 3. (a) Measure of replica to obtain geometrical results; (b) measure of roughness of UNS A97075, front view; (c) measure of roughness of UNS A97075, side view.

For the measurement of roughness, the Mahr Perthometer Concept PGK 120 (Mahr, Göttingen, Germany) was employed, as shown in Figure 3. This measurement was focused on the parameter Average Roughness (R_a), since it is one of the most used roughness parameters in the literature.

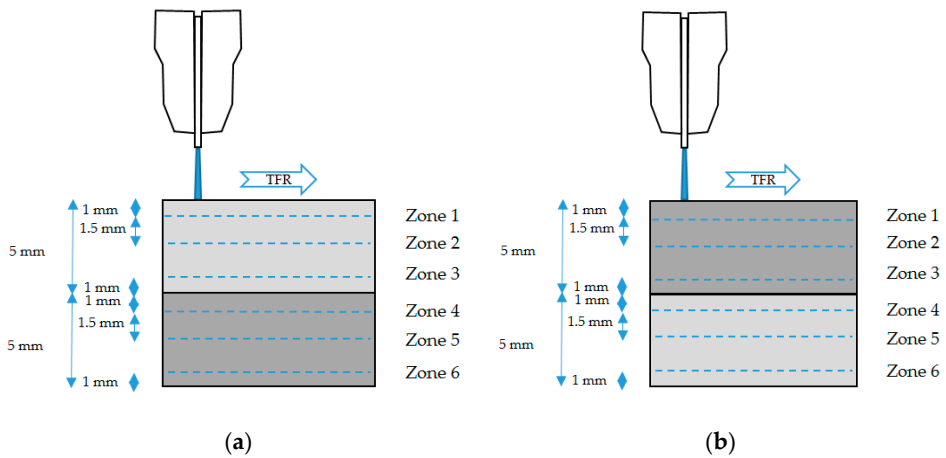
Figure 4. Schematic representing the roughness measurement zones and the distance between them for: (a) UNS A97075/CFRP configuration; (b) CFRP/UNS A97075 configuration.

R_a analysis performed to the specimens in each test was carried out in three different zones coinciding with IDR, SCR and RCR (Figure 4). That way, six measures were obtained for each test performed, making a total of 144 roughness measurements.

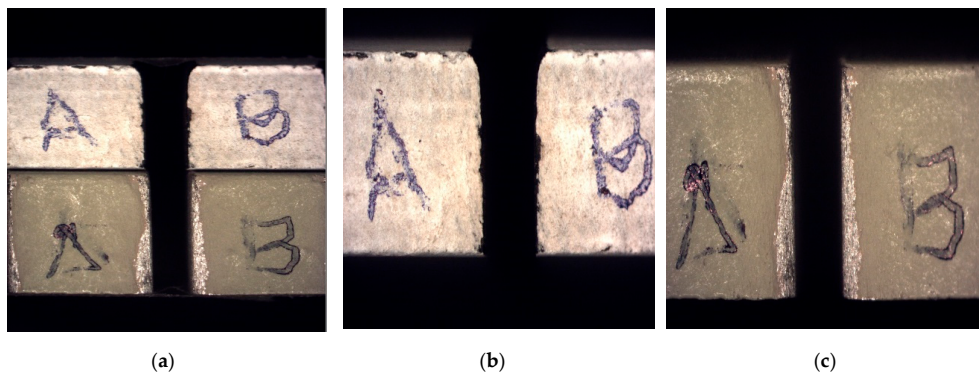
Figure 5. SOM image of the cutting front in: (a) Stack CFRP/UNS A97075; (b) CFRP plate; (c) UNS A97075 plate.

SOM inspection was carried out of both jet entrances into the stack (Figure 5), and along the cut profile. This way, the jet variations contribution to the kerf profile can be observed, phenomenon related to damages produced in the IDR zone [31].

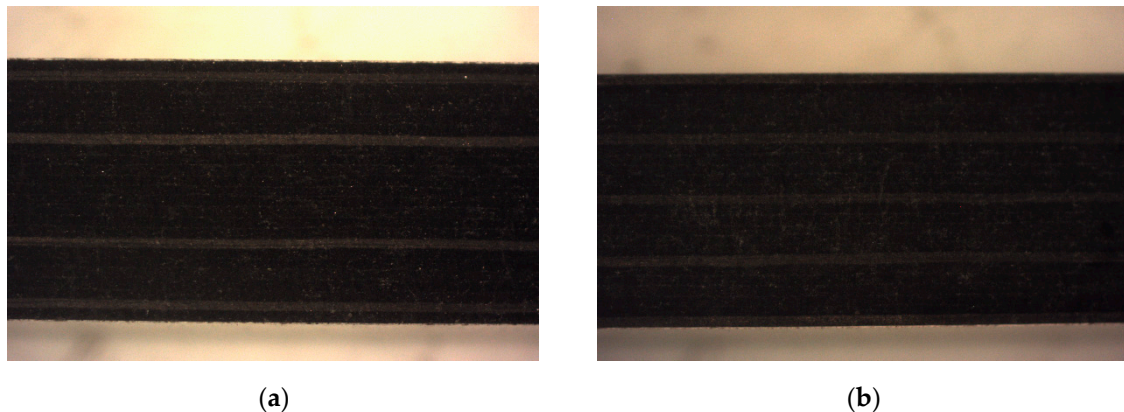
Figure 6. SOM image of CFRP profile. Test 2. Water pressure (WP) = 2500 bar, traverse feed rating (TFR) = 15 mm/min and abrasive mass flow rate (AMFR) = 340 gr/min for: (a) UNS A97075/CFRP; (b) CFRP/UNS A97075.

On the other hand, Figure 6 shows the profile of CFRP specimens in order to identify delaminations. In order to visualize the delamination along the machined surface, several images were taken showing the absence of visible delamination after machining in the test performed with the parameters considered to be the most aggressive.

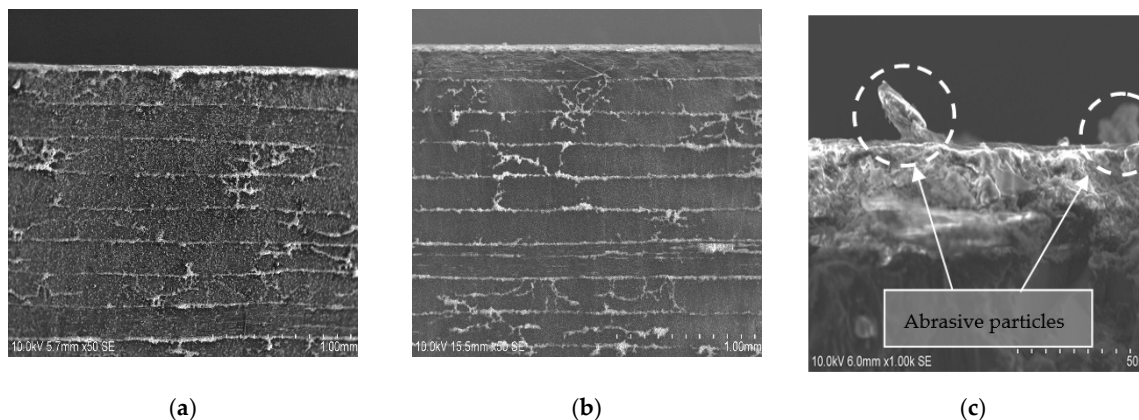
Figure 7. SEM image of CFRP profile. Test 2. WP = 2500 bar, TFR = 15 mm/min and AMFR = 340 gr/min for (a) UNS A97075/CFRP; (b) CFRP/UNS A97075; (c) Abrasive particles in the interface over CFRP.

Figure 7 shows the results of the SEM inspection in CFRP showing that no delamination was detected. However, Figure 7c shows in detail the state of the specimen entrance zone where signs of impact deformation and particle drag were observed. This state extends to the interface reflecting that a percentage of particles have lodged in the space between the two materials.

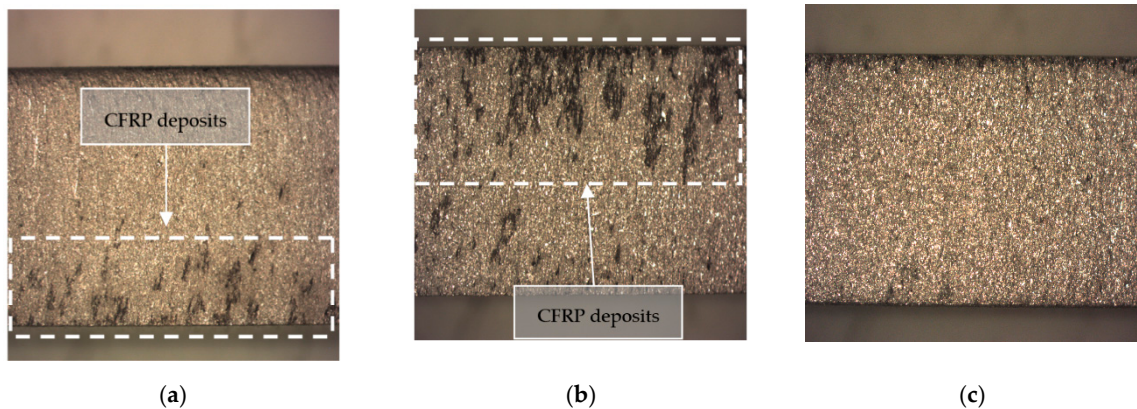
Figure 8. Profile SOM of UNS A97075 from: (a) UNS A97075/CFRP. Test 2. WP = 2500 bar, TFR = 15 mm/min and AMFR = 340 gr/min; (b) CFRP/UNS A97075. Test 2. WP = 2500 bar, TFR = 15 mm/min and AMFR = 340 gr/min; (c) CFRP/UNS A97075. Test 11. WP = 1200 bar, TFR = 45 mm/min and AMFR = 170 gr/min.

As for aluminum alloy, SOM study showed a series of dark colored streaks along the profile that repeated for both configurations to a greater or lesser extent depending on the energy of the jet. Specifically, Figure 8a shows the marks mentioned at the bottom while Figure 8b at the top. This phenomenon, together with the color of the stretch mark, seems to indicate that they are located in the zone close to the contact with the carbon fiber. Finally, Figure 8c shows the result of the study for test 11 where no transfer of carbon fiber to aluminum is observed, possibly due to the lower WP and AMFR and thus, lesser jet kinetic energy resulting in an inferior material removal rate [10].

In an attempt to obtain more information on the marks observed in Figure 8, the SEM/EDS inspection of aluminum was focused on discovering the state of the aluminum and the nature of these marks. Initially, Figure 9a,b shows the state of the material at the inlet. In a detailed way, the embedded particles and the deformation produced during the cutting process are appreciated, coinciding with the IDR or zone 1.

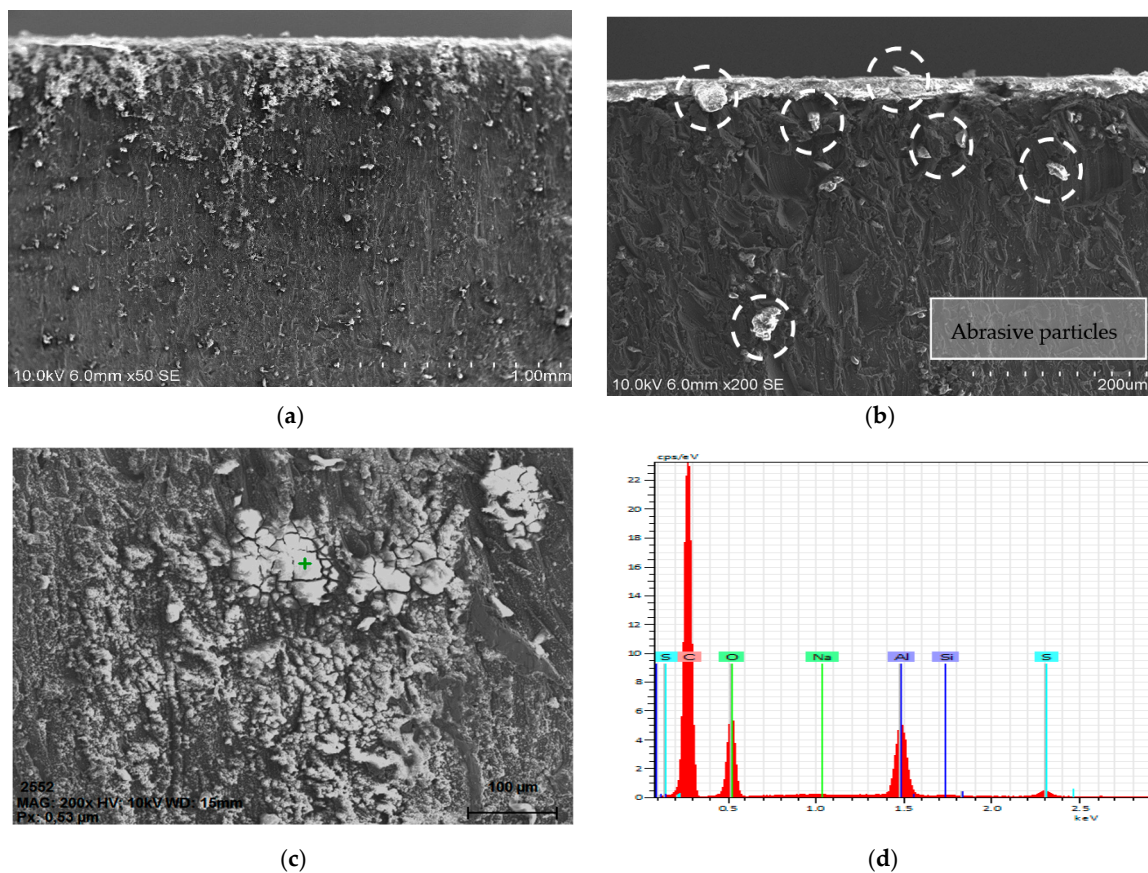
Figure 9. Test 2 Scanning Electron Microscopy (SEM) evaluation: (a) Abrasive imbedded into UNS A97075; (b) abrasive particles in the interface and channel created over the material; (c) remains of carbon and point of EDS; (d) EDS results with a peak on the carbon.

On the other hand, Figure 9c,d shows the stain examined in the striations observed by SOM microscopy and the results of the EDS analysis, respectively. The EDS analysis revealed the high presence of carbon at this point, confirming the carry-over of carbon particles during machining from one material to another. It should be noted that no traces of aluminum deposited on the carbon fiber were detected.

To analyze the state of the aluminum outside the zone of the stretch marks, another EDS spot was carried out outside those stains and showed almost no carbon and a huge peak on aluminum. As a direct conclusion, it appears that particles from composite are swept for the water beam and because of the water high energy, they end up embedded into UNS A97075. It seems like composite deposition over aluminum has a direct correlation with beam penetration capacity.

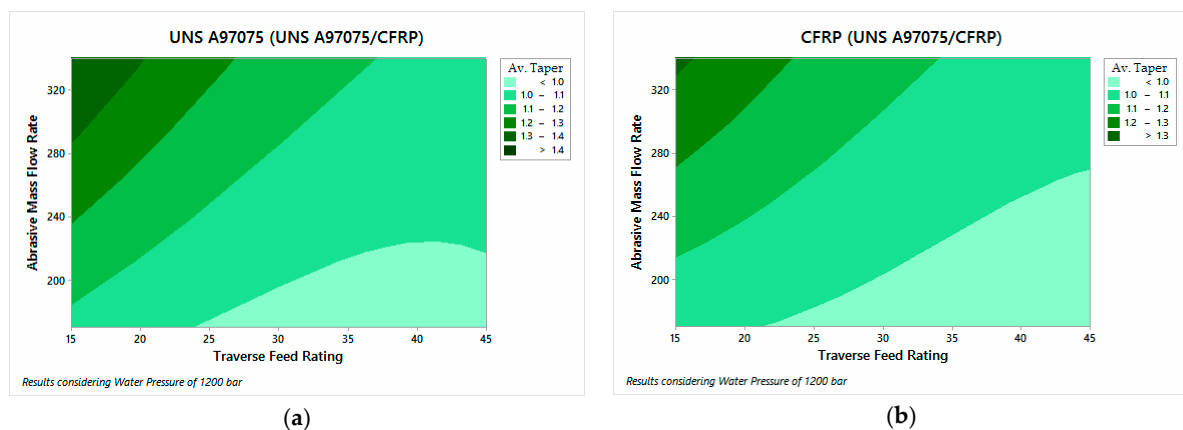
Figure 10. Average kerf taper for UNS A97075/CFRP configuration: (a) UNS A97075; (b) CFRP.

The ANOVA analysis performed showed that AMFR and TFR parameters were the most influential in taper formation. Average kerf taper values for each material when the configuration UNS A97075/CFRP is set are shown in Figure 10. The same values for configuration CFRP/UNS A97075 are shown in Figure 11. For deeper research, Appendix A shows the average taper for each test and its standard deviation.

Figure 10 shows a wide parameters combination that maintain kerf taper below 1.0 mm. This means a wide parameters combination that minimizes material removal percentage and leaves a more precise cut.

In this way, the data represented in Figures 10 and 11 show that the taper is reduced as AMFR decreases and TFR increases, showing the best results for TFR = 45 mm/min and AMFR = 170 gr/min, in accordance with [33].

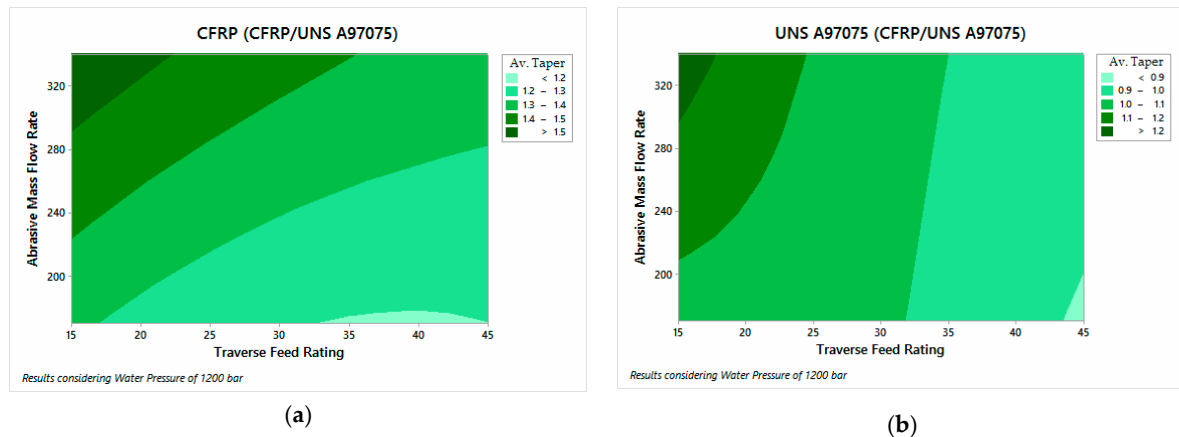
Figure 11. Average kerf taper for CFRP/USN A97075/ configuration: (a) CFRP; (b) UNS A97075.

This behavior is shared with the CFRP behavior in CFRP/UNS A97075 configuration. Figure 11b, however, shows a very different behavior. This change is due to the lesser energy of the water beam when it collides with the aluminum. Since a percentage of energy is transformed during the CFRP machining, it appears that the AMFR is the determinant parameter when the cut's width is examined. As for the differences between the two material configurations, Figure 11 shows that when the jet directly affects the carbon fiber, the taper generated for the best parameter ratio reaches values higher than 1.2 compared to the value 1 reached for the UNS A97075/CFRP configuration. This shows the

difference in the mechanical properties of each material, offering greater resistance to penetration of the metallic material.

Overall, a similar behavior is observed between the materials located in the upper and lower part of the stack. Despite this, a smaller taper is always observed in UNS A97075 than in CFRP.

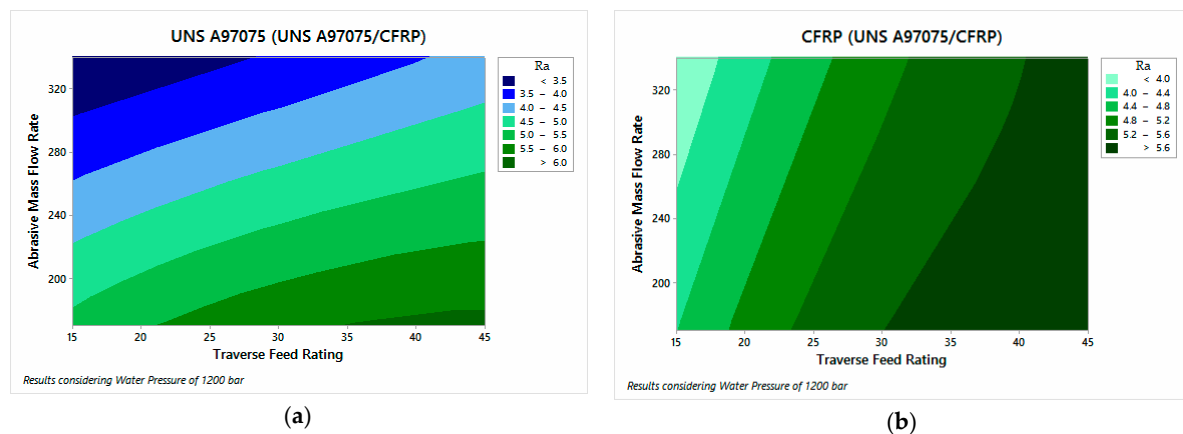
Figure 12. Roughness for UNS A97075/CFRP configuration: (a) UNS A97075 and (b) CFRP.

Figure 12 shows the results of the UNS A97075/CFRP configuration. A tendency to increase the roughness can be observed as TFR increases and AMFR decreases. Figure 13, on the other hand, shows the results of CFRP/UNS A97075 configuration. The same trend as in Figure 12 is observed although exist difference between the material placed at the top and bottom.

The data show that the AMFR parameter has a greater influence on aluminum, especially when it is at the exit of the material. This effect can be seen in the horizontality of the contour graph studied (Figure 13b). As for the composite material, it presents influence of TFR and AMFR for both configurations. In this sense, the data show that the composite material has slightly lower values than the metal alloy because the use of low pressures favors a better surface quality in CFRP to oppose less resistance to cutting. On the other hand, this means that the aluminum registers higher roughness data due to the low kinetic energy of the jet, favoring the appearance of defects in the different areas studied.

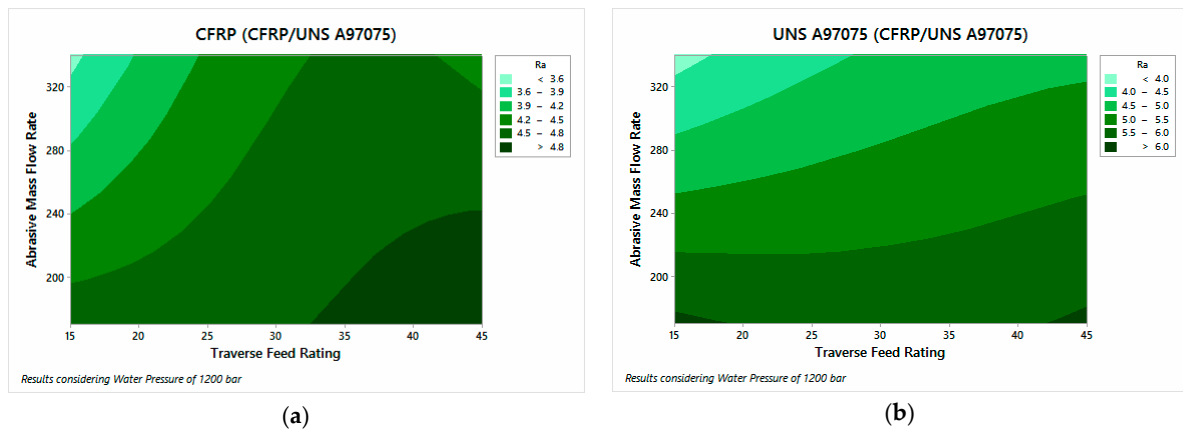
Figure 13. Roughness for CFRP/USN A97075 configuration: (a) CFRP and (b) UNS A97075.

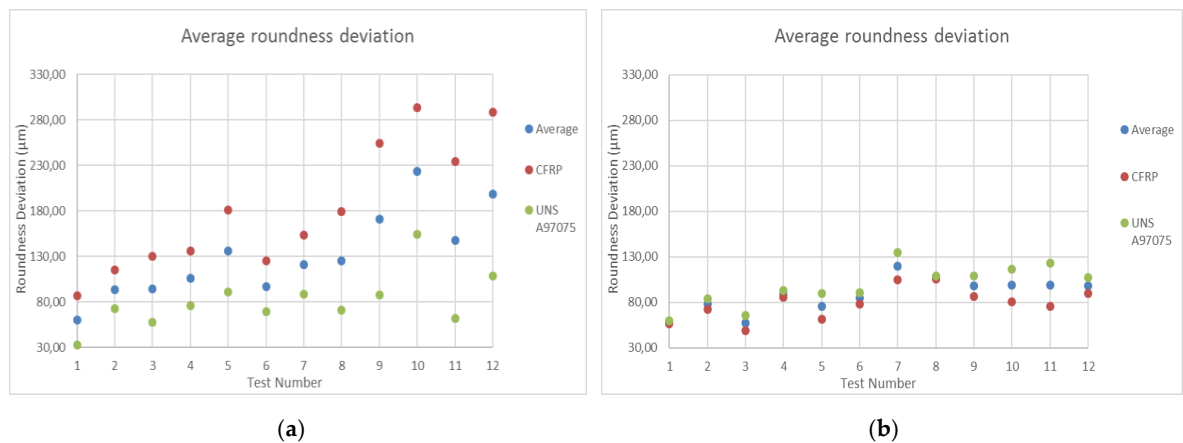
Figure 14. Average roundness: (a) UNS A97075/CFRP configuration; (b) CFRP/UNS A97075 configuration.

Figure 14 shows the data obtained from roundness deviations for each material and the total average of both materials. Readers can also find Appendix C with measured data and its standard deviation. In this way, the results can be analyzed separately.

Figure 14a shows the data for UNS A97075/CFRP configuration. The data show that in all tests the deviation is higher for CFRP, even though it is the material located at the bottom of the stack. This is due to the fact that the erosion and removal of composite materials is different from that produced in metallic materials. Thus, in CFRP the particles weaken and remove the matrix of the compound to subsequently break the fibers of the adjacent zone and in Al the process of material elimination

takes place due to the micromachining produced by the edges of the abrasive particles, being more homogeneous the elimination of material in metallic materials. [2]. This phenomenon, combined with the material's resistance to jet dispersion as a result of the loss of energy after cutting the aluminum, leads to an increase in the deflection in this material. This deflection increases considerably as WP decreases and TFR increases, which makes sense because these are tests with lower shear power.

On the other hand, Figure 14b shows the results of CFRP/UNS configuration A97075. In this particular case, the deviations follow a similar relationship to that of the previous case in terms of parameter influence, although it is true that the difference in the measured values is high. Thus, although in this case the aluminum is at the bottom of the pile, it seems that the expansion of the water jet does not deform the entry zone due to the differences in terms of removal of material explained in the previous paragraph. This results in homogeneous deviations in roundness between the two configurations, which favors a subsequent joint by means of rivets.

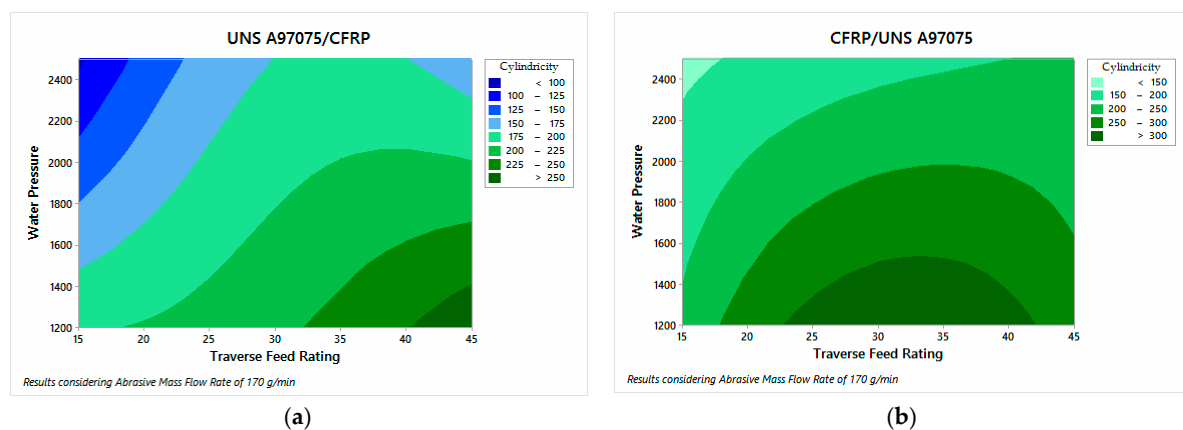
Figure 15. Cylindricity results on: (a) UNS A97075/CFRP configuration; (b) CFRP/UNS A97075 configuration.

Cylindricity deviation was also measured with two measures for each material and configuration. However, due to the nature of the test, only one value results as output. Appendix D contains all collected data. Nevertheless, an ANOVA description of variables influence is shown in Figure 15.

The ANOVA analysis carried out shows that the parameters that have the greatest influence on the formation of the deviations are WP and TFR. Specifically, Figure 15 shows that the UNS configuration A97075/CFRP has lower cylindricity deviation values, which is in good agreement with the taper values obtained. This is due to the close relationship between both parameters. In order to offer a better correlation of results, the profiles measured for test 11 are presented as an example (Figure 16).

A more detailed description of the data reflects that cylindricity decreases as TFR decreases and WP increases. Specifically, Figure 15a reveals that TFR has a superior influence when the alloy is at the inlet of the material which reflects the importance of employing reduced feed rates to prevent its formation. As for Figure 16, both (a) and (b) show CFRP on the bottom and UNS A97075 on the top of the cone. It can be observed how it affects the energy loss to the generated hole, especially in Figure 16a.

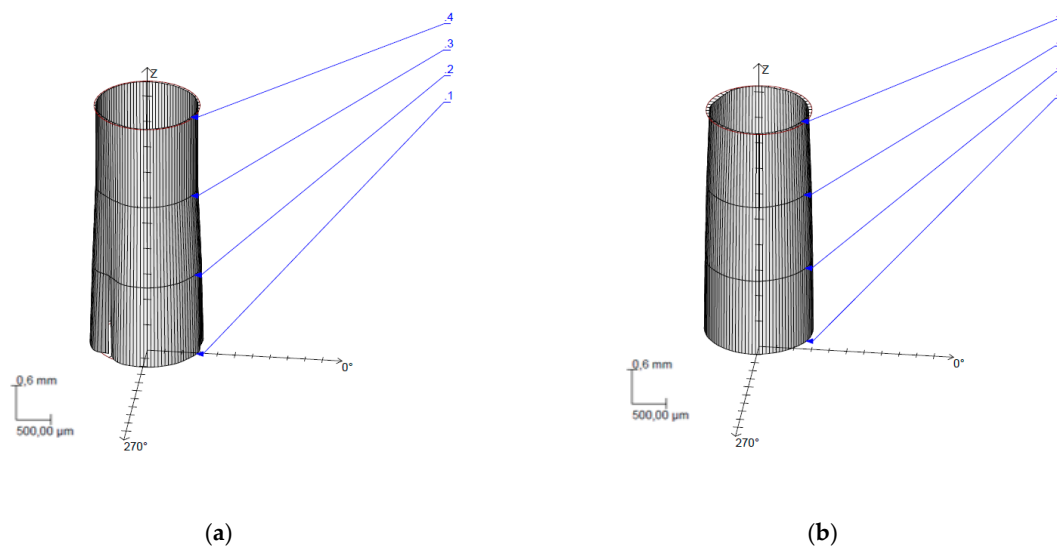
Figure 16. Cylindricity deviations. Test 11. WP = 1200 bar, TFR = 45 mm/min and AMFR = 170 gr/min for: (a) UNS A97075/CFRP configuration; (b) CFRP/UNS A97075 configuration.

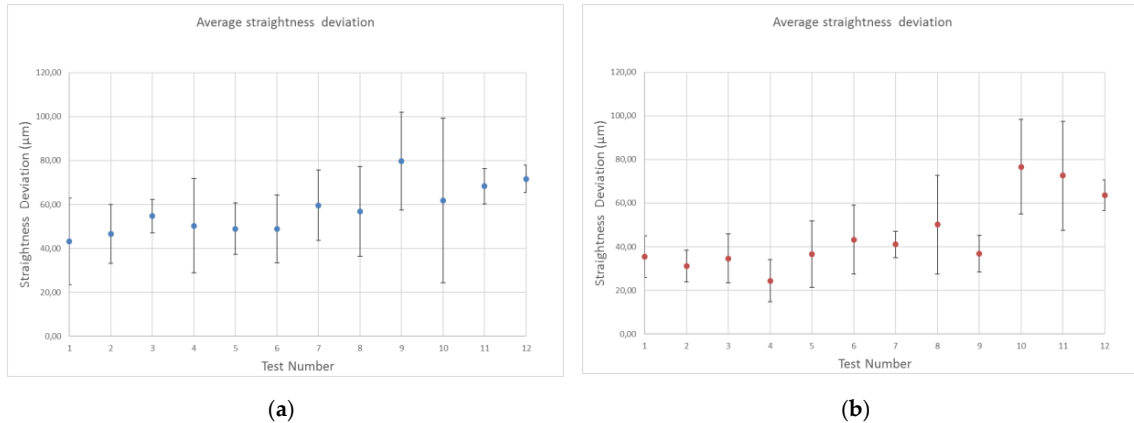
Figure 17. Straightness deviations results on: (a) UNS A97075/CFRP configuration; (b) CFRP/UNS A97075 configuration.

In this case, there is no distinction between materials and straightness was evaluated throughout the entire profile. Thus, Figure 17 shows a comparison between the values obtained for the two configurations. However, Appendix E shows all measured data with the numerical value of the standard deviation.

As a general conclusion, a higher water jet drilling capacity means less straightness deviation. It is also observed that the CFRP/UNS A97075 configuration shows better results for the same test number except for the last three tests which, due to their lower drilling capacity due to the use of lower WP and TFR, are not able to maintain a uniform cutting profile of the aluminum alloy and therefore cannot maintain straightness along the hole.

The results reveal that the data in configuration UNS A97075/CFRP are slightly lower than those recorded in configuration CFRP/UNS A97075. In addition, it should be noted that for high pressures the straightness deviation increases when the compound is located at the top.

On the other hand, it should be noted that the standard deviation presented by the results is high, which makes it difficult to establish relationships between the results. This major standard deviation is directly related to the greater cylindricity deviation of some tests.
